Article No.: TC_EL_09-05

740/1740 Codes and Chrysler Converter Flow

By Ed Lee

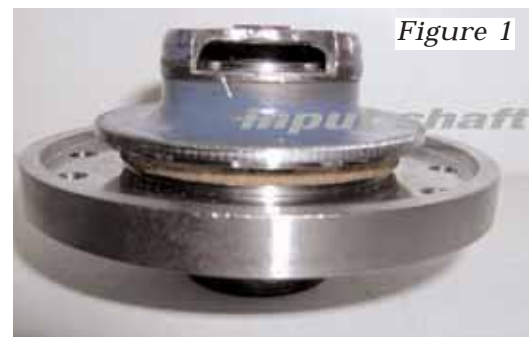
Figure 1

When the input (turbine) shaft is in its proper position in relation to the inside of the pilot (cover), it will look like the cut-away in Figure 1. The input shaft is

about .125" away from the cover when the converter is installed to its proper depth. The proper way to check converter-to-flex-plate clearance is to push the converter back until the hub bottoms in the pump, then measure the distance between the flex plate and the converter pad. This measurement needs to be a minimum of .125", but no more than

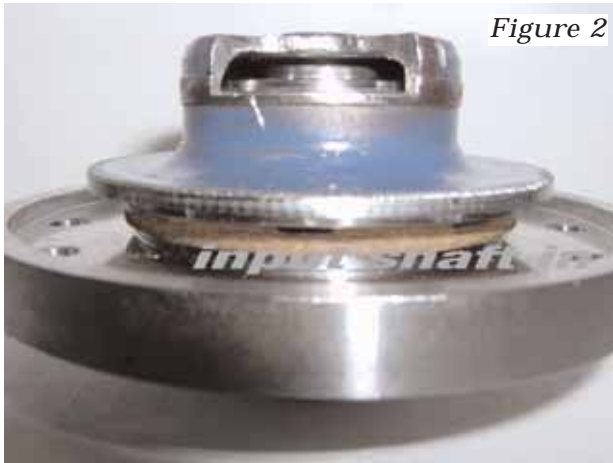
.250". The minimum of .125" is important to allow for a certain amount of converter expansion (ballooning), and to allow for a certain amount of movement by the flex plate. If the flex plate is bent, it could allow the converter to move rearward and restrict the flow of oil between the input shaft and cover. The example shown in Figure 2 was close enough to cause a 740 code.

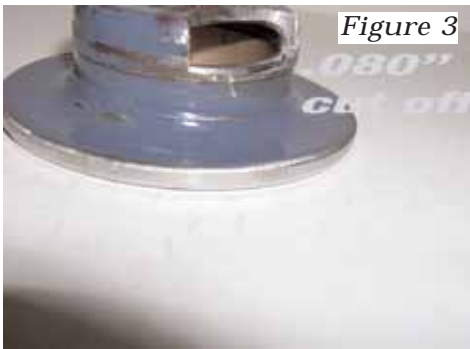
The turbine hub bushing is the next element that may cause a restriction. When the bushing is installed properly, the top of the bushing is flush to .020" up from the top of its bore. The bore for the bushing is in the pilot area of the cover and the top of the bushing bore is recessed about .028" below the thrust area for the turbine hub. The cut-away in Figure 3 shows a bushing that was installed .080" (twice the thickness of a dime) below flush. You are viewing the bushing from the bottom side so you can see that flow was completely restricted. This, too, caused a 740 code.

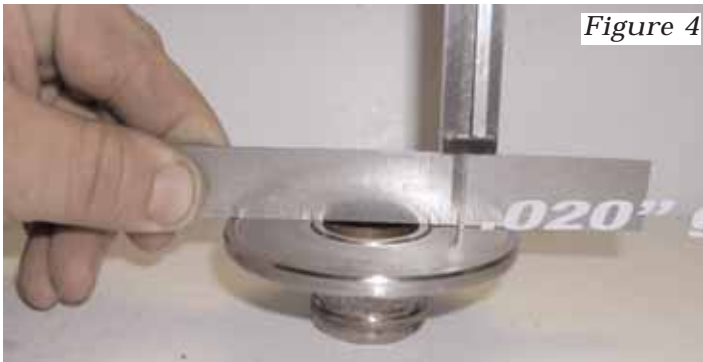
paid to the position of the bushing. Since the inner race of the O.E. bearing is only .015" below the thrust surface of the outer race (see Figure 4), it may come into contact

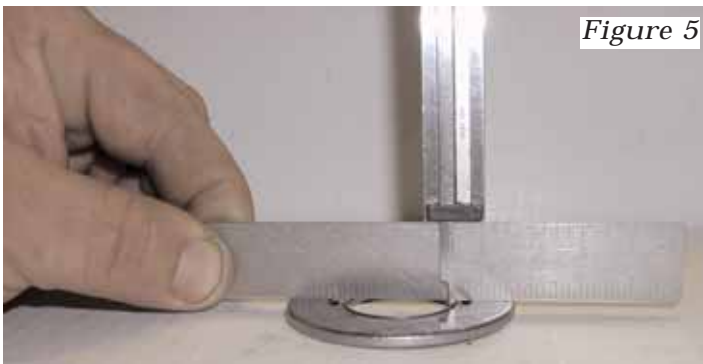
with the bushing if the bushing is up .020" above flush as shown in Figure 5. The .005" of wear shown in Figure

6 is the result of that contact. This is a bad thing for two reasons: First, the material from the bushing that was worn away by the bearing race has to pass through the bearing, and secondly, the pinpoint contact of the inner race of the bearing to the bushing may cause the race to flex and eventually fail. Either of these two concerns may help to explain the failure rate of the bearing.
