Small Tips for Big Rebuilding Headaches

By Frank Biolsi

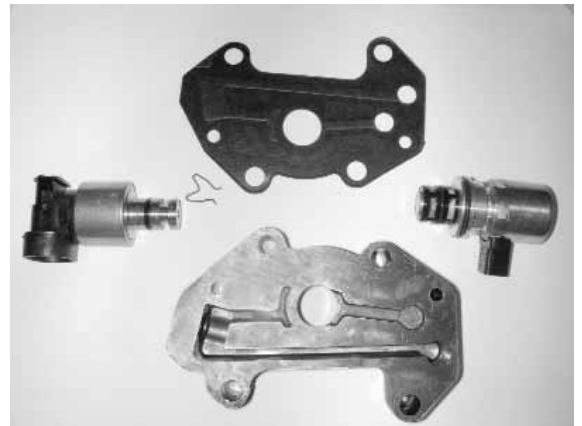
The flat wire-style clip that secures the governor sensor in the housing tends to disappear while the unit is being rebuilt. You can replace that clip in your 42-47RE ('95-'99) with a governor sensor retainer, OEM part number 4617219.

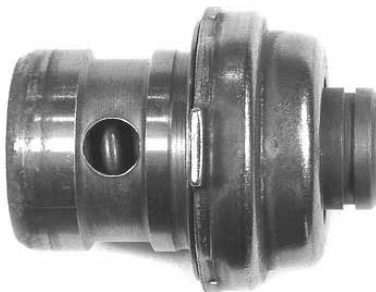
140277-01-51

On many 722 series units, the thrust pin (strut) on the anchor side of the bands are held in the case mounted thrust element by a small plastic retainer. The plastic retainers become brittle and break during disassembly or reassembling the bands. These plastic retainers are used on all the bands on the 722.1 and 2 units and for the rear bands on the 722.3, .4 and .5. These are available as OEM part number 140277-01-51.

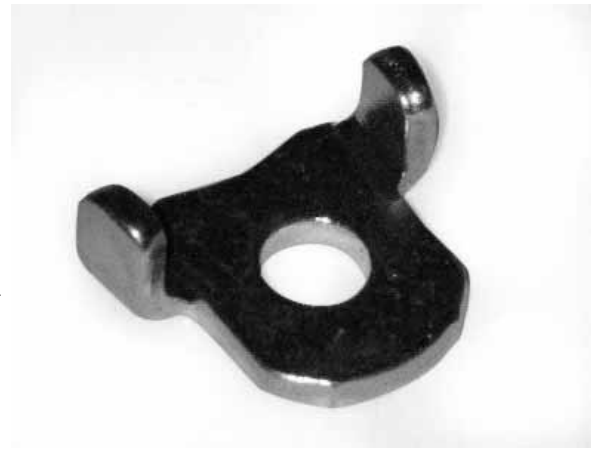
Most of the Honda/Acura 4-speeds have mainshaft and countershaft speed sensors that drop in and are bolted flat to the case. In some cases, at least on the B7TA units, a washer or spacer sits on the case, underneath the countershaft sensor mount. Like many of those small, easy-to-miss but necessary items, this puppy has a habit of not being around when it's time to reinstall the sensor after a rebuild. So if you are building a unit and notice it is locked up and the shafts will not turn or, worse, has torn up a speed sensor after installation, you are going to need a countershaft speed sensor washer, OEM part number 90561-P7T-000

Sensor washer, OEM part number 90561-P7T-000

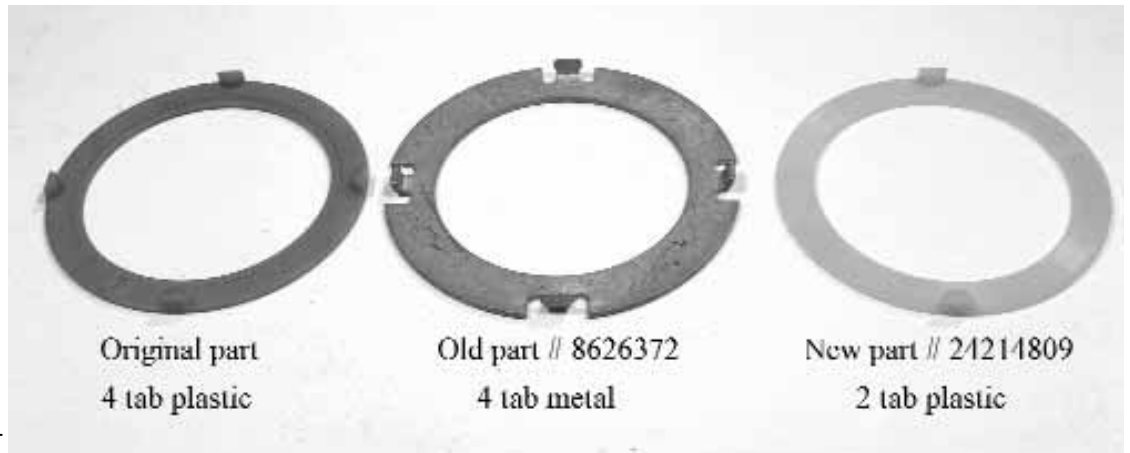
In the past the plastic 4-tab washer between the two planets in the 4L80-E/400 has never been available separately. The plastic 4-tab washer has always been serviced with the metal 4-tab washer that is also used between the output shaft and the selective spacer. In 2002 GM changed the output carrier by eliminating two of the washer locating holes and changing the 4-tab plastic washer into a 2-tab plastic washer. This new 2-tab plastic washer back-services all years of 4L80-E & 400, regardless of whether the carrier has 2 or 4 locating holes. The good news is the new plastic washer is available as GM part number 24214809.

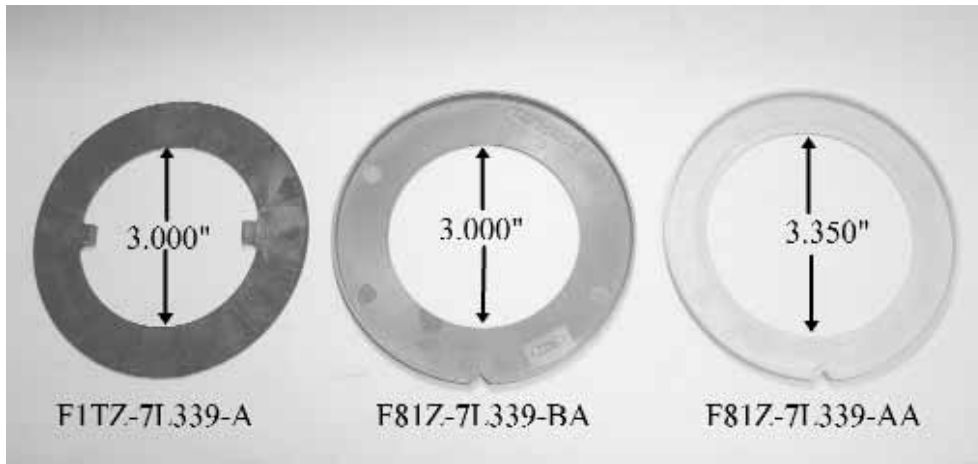
E4OD No. 3 Thrust Washer Versions

Problems can occur in your E4OD if you are updating the overdrive planet only and try to use the late style No. 3 washer with a sprag style overdrive one-way clutch. The late-style washer has a larger inner diameter and will not properly support the OD sprag inner race, allowing the inner race to move out of position and contact the OD planet. In OE production there are two versions of the No. 3 thrust washer, depending on what overdrive planet and one-way clutch the unit came with. The early OD planets have two cut-outs to accept the No. 3 thrust washer. The later planets eliminated the cut-outs and the No. 3 thrust washer is located by a lip and notch on the outer diameter. Ford has a hybrid service No. 3 washer that allows the late planet to be used with the early OD sprag. The hybrid washer has the outer diameter lip like the later washer and the smaller inner diameter like the earlier washer.
