Front Pump Bushing

12502-01

Sonnax Part Summary

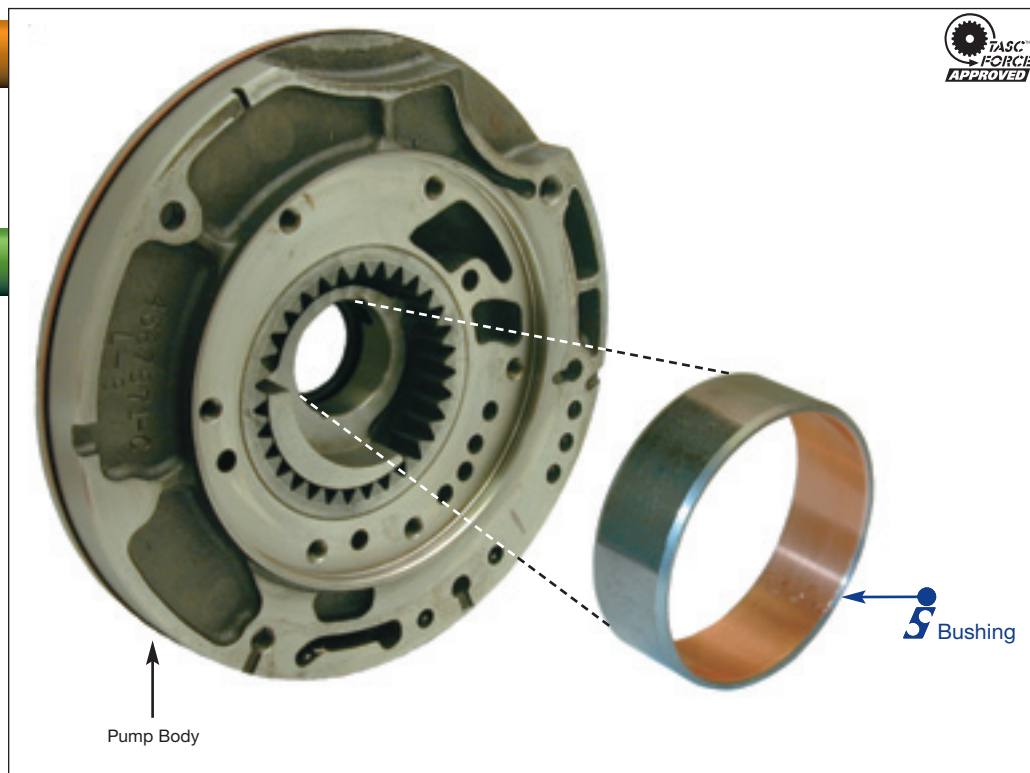
Pump seal leakage, converter slip codes, loss of prime

Pump body bores vary in diameter. Standard replacement bushings often result in excessive hub-to-bushing clearance.

Excessive torque converter hub-to-pump bushing clearance is a root cause of code 38, TCC slip codes, front seal leakage, loss of prime code 35, and pump noise. The OE bushing is machined in place, allowing a wide tolerance on pump housing bore diameters. Bore diameters can vary by more than .003". This wide tolerance is a problem when using standard replacement bushings. Standard replacement bushings will often have .008" or more hub-to-bushing clearance with an average 10 times more oil loss than the Sonnax improved fit bushing. The Sonnax improved fit pump bushing **12502-01** will restore the clearance necessary for proper operation. The Sonnax bushings should be used when the housing diameter is greater than 1.6175", which will be in most cases.

This improved fit replacement bushing restores proper hub-to-bushing clearance.

- Allows precision clearances with wide tolerance pump bushings.
- Does not require machining to restore correct clearance.
