Manual Valve

96201-05

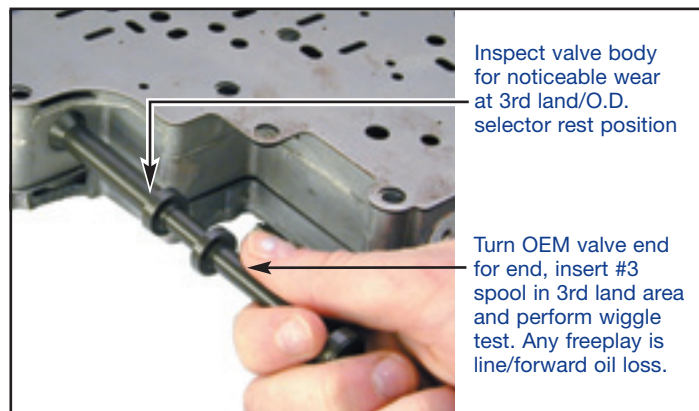
Wiggle & Wet Air Test

This manual valve was designed to reduce loss at the manual valve bore. In some conditions the bore will become severely polished or have step wear from frequent linkage movement. This can be seen visually in badly worn valve bodies. To verify if the bore is worn, a “wiggle test” can be performed as illustrated below. On an assembled unit, or dyno test, the pressure will be erratic and may drop below 50 psi in O.D. range as the unit reaches operating temperature. In order to perform a Wet Air Test of the forward circuit and manual valve, the unit must be completely assembled with fluid filling the valve body, in order to seat the checkballs. With side cover removed, place the selector lever in O.D., and blow air into the forward tap. Fluid leaking out the end of the manual valve bore is leakage past the end spool.
