## TCC Modulator Sleeve & Plunger Valve Kit

**56947J-32K**

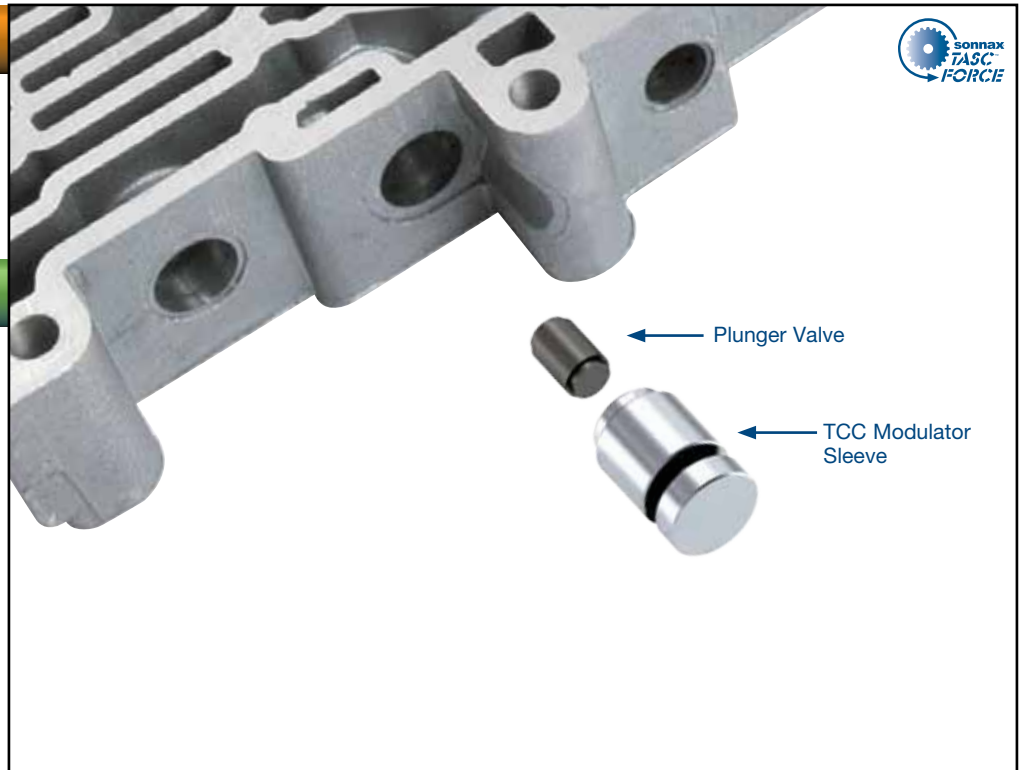
The plunger force is transferred onto the inner modulator valve. When the sleeve wears, the converter apply pressure is reduced and TCC slippage increases.

- Plunger Valve
- TCC Modulator Sleeve

Common complaints with a 5R55N are high TCC slip RPM at increasing load, slip codes, and converter apply or release concerns. These complaints can be caused by wear of the TCC plunger valve and sleeve assembly due to constant oscillation by the pulse width modulated TCC solenoid.

The wear-resistant Sonnax kit prevents future wear and restores proper hydraulic clearances so fluid pressure can position the TCC modulator valve to fully apply lockup.
