4F27E (FN4A-EL) INSTALLATION GUIDE

Ford 4-Speed Automatic Transmission

PRODUCT BULLETIN

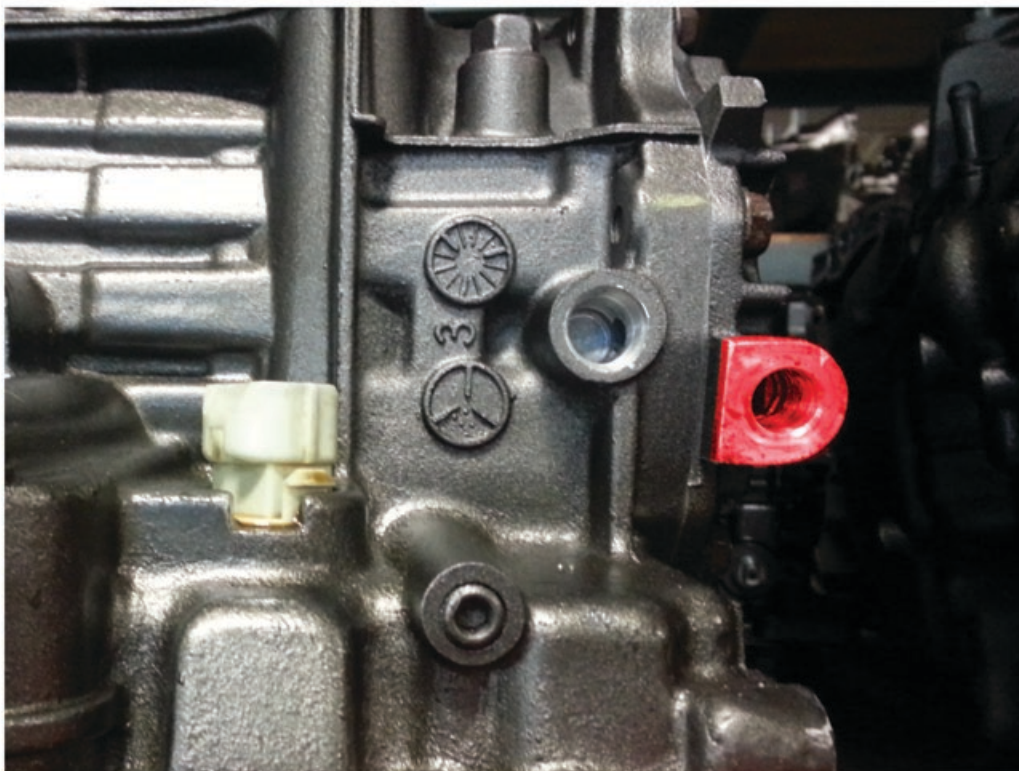
Due to premature rear cover failures in most Mazda applications, all of our remanufactured FN4A-EL (4F27E) transmissions are updated with the improved Ford-designed rear cover.

UPDATED COOLER PORT SHOWN ABOVE IN RED

Note: If you install the return cooler fitting into the original case location there will be no lubrication provided to the rear of the transaxle and immediate failure will result and is **not** covered under your warranty.

For Mazda applications only, the cooler return line **must be** relocated from the case to the end cover. During remanufacturing, the transmission is internally updated and the factory cooler line hole in the case is **permanently** sealed - all Ford applications will remain unmodified. Mazda units are updated to accept Mazda factory cooler line fittings (M14 x 1.50).
