Layer shift because of glass bed shifting

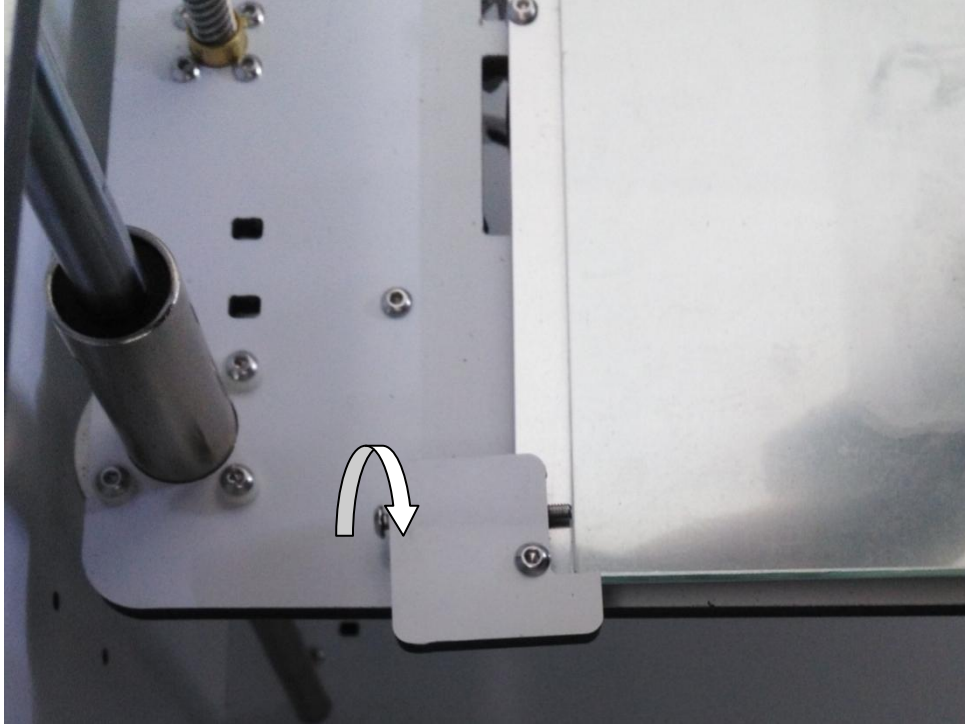
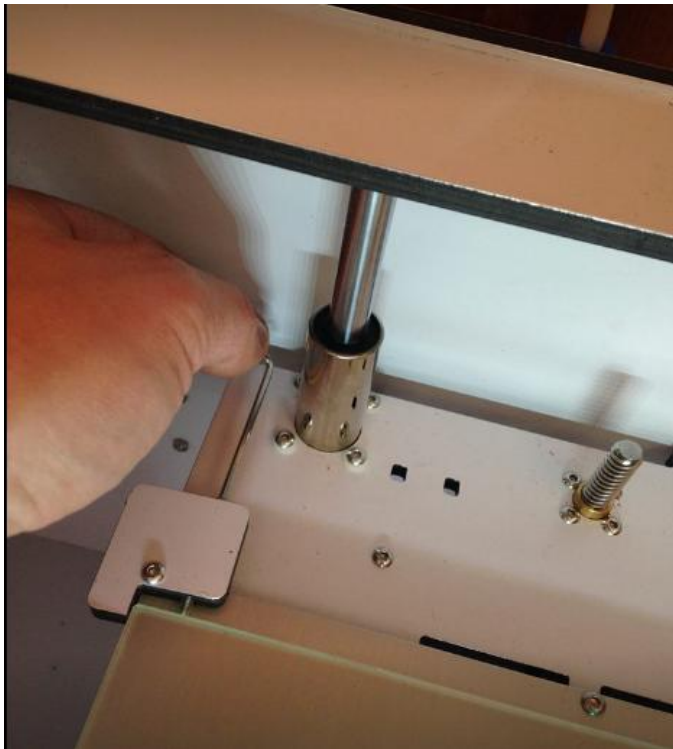
Sometimes the two bolts to fix the glass bed will get loose, and cause the glass bed shifting. So your printing will have shifting lines.

To hold the glass bed, you can screw the bolt to fix the glass, but not too tight, just a little contact with the glass as the photo below.

Meanwhile if the bolt is above the glass, this is usually caused by the aluminum heated bed corner is bent. Please bend it back to be flat, so the bolt can fix the glass bed well.
