By Civil Aviation Administration of Yashiro Commission
And Fountaine Transportation Safety Board

Final Report of IZ-3524 Airbus A300B4 Inazuma Airlines Flight 8361 On May 7th, 2022

Published in June 2025

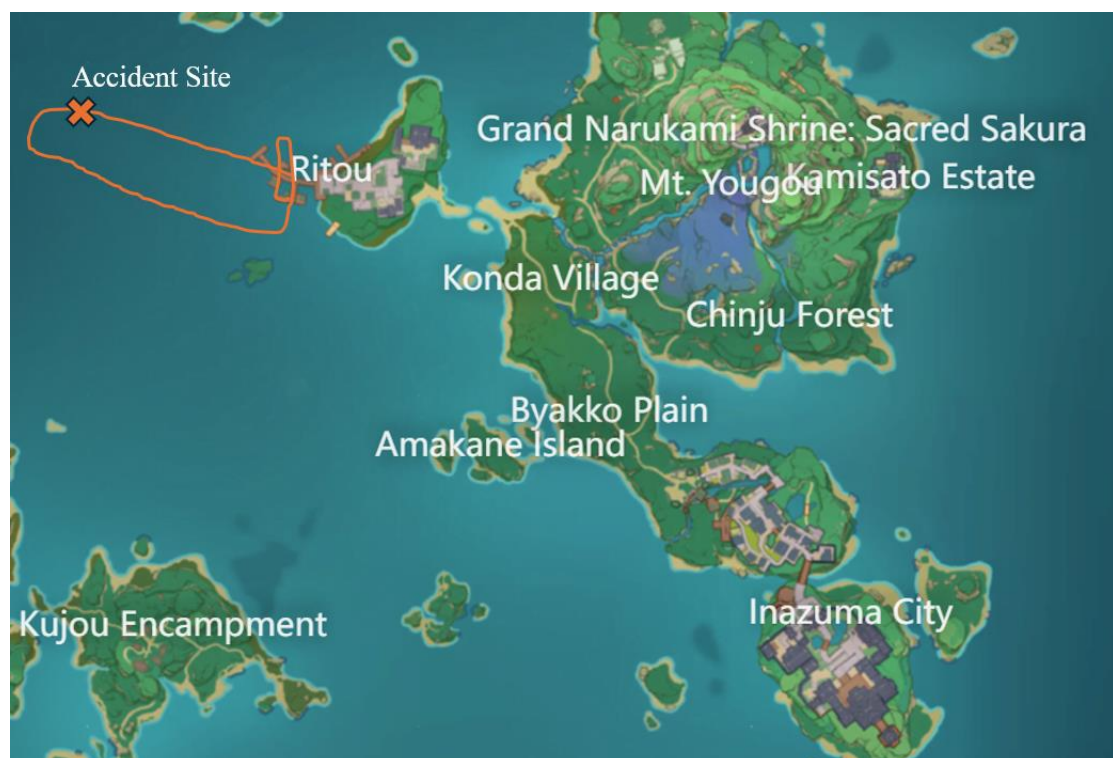
Diagram – Aircraft's Flight Path in This Accident

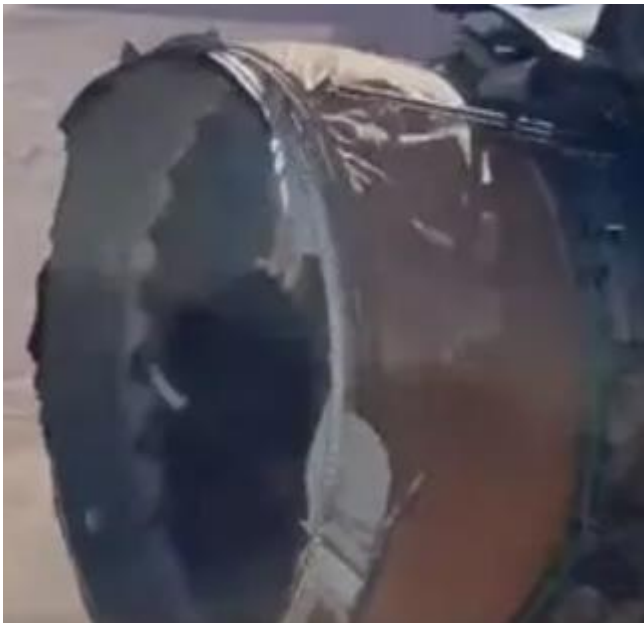
Photograph – The left engine

The left engine suffered an uncontained failure and lost some of its components during the explosion caused by the fire. The general location of the wreckage was determined but due to the depth of the sea in the area, the wreckage were never found.

1. Only the casing of the left engine remained complete, and the inner components had been mixed together;
2. The main engine components had either twisted or melted;
3. The twisted engine components had signs of electric current burning, including tree-like patterns; and
4. These components had diamond-like dents.

The aircraft suffered left engine fire during the flight. Through analysis on wreckage information, investigators determined that the fire was caused by electric current heating metal components and then igniting fuel, starting an uncontrolled flaming.

The aircraft designer is suggested to replace the engine metal components by using high electric resistance materials or conduct electric isolation to prevent eddy current.

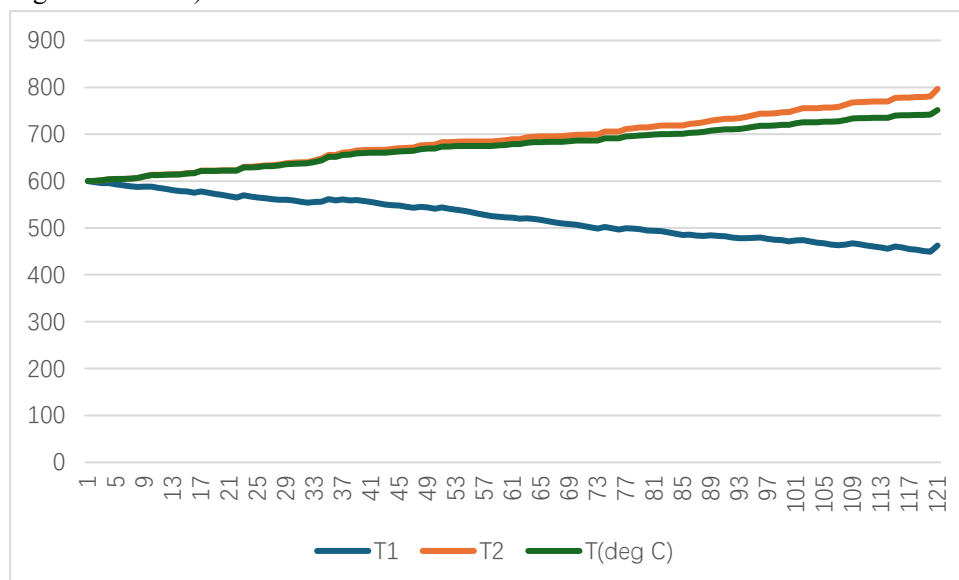
Diagram – T1: Temperature with cooling; T2: Temperature without cooling; T(deg C): Temperature when no cooling is applied

In this diagram, it can be determined that while cooling can reduce the temperature, it increases the temperature of the other part of the metal component by 25% more. Therefore, the fuel in areas where it was supposed to be low temperature was more likely to be ignited and cause fire. More analyses can be done in the same way: When the cooling power reaches 20 W, the highest temperature reaches approximately 900 °C.

Given the fact that the anti-ice components of the left engine were malfunctioning, the Cyro remained in the engine area beyond expectation and normal operation exacerbated the thermal stress of the engine components by increasing the current (especially in cooler areas without fuel burning),

Within 22 seconds, the temperature had risen to a temperature that could ignite the fuel, which then resulted in the uncontained failure.

- Temperature Management: Maintaining higher baseline engine temperatures (e.g., $\geq 700^{\circ}\text{C}$) could reduce thermal gradient-driven current surges;
- Physical Shielding: Consider replacing engine metal components with high electric resistance materials or insulating metal components (especially for the burning area and other areas) to prevent magnetic eddy current;
- Elemental Shielding: Engine components could integrate non-conductive composites (e.g., Geo-infused ceramics) to limit eddy currents; and
- Vision-Assisted Protocols: Trained Vision holders (Electro) could stabilize magnetic fields mid-flight, though long-term regulatory barriers exist.

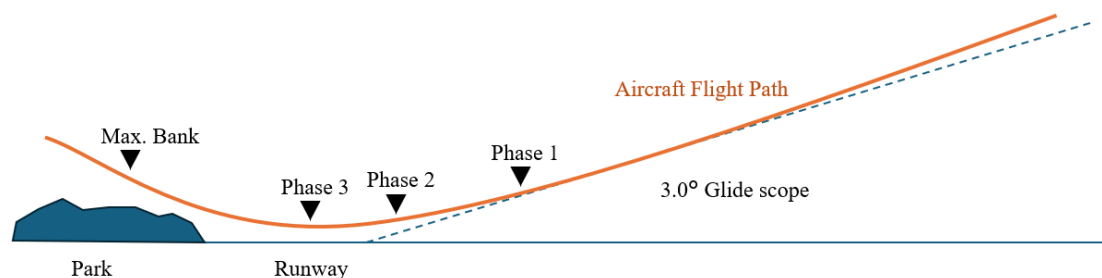
4. Go-around phase 3: At 17:49:30, the aircraft reached its lowest altitude 22 ft, above a beach park 2.08 nm away from the runway threshold.
5. Go-around phase 4: The aircraft regained a positive climbing rate. At 17:49:36, the aircraft reached its maximum bank angle 15.2 deg at 575 ft altitude, which was followed by a commanded thrust reduction to 87.1% and offset.

Diagram – Aircraft Flight Path (Vertical)

Investigators studied the process of the go-around. Throughout the go-around, the airspeed was in acceptable range, without any stall or overspeed. The aircraft was always at least 20 ft above terrains according to radio altimeter data recorded by FDR. The go-around process reflected the proficiency of pilots in approach, compared with flight simulation experiments.
