Doc **WG-R-1452**

# Final Report of Air Regule Aire 8L-LQC Boeing 777-200ER Accident over Lontis On March 13<sup>th</sup>, 415

Released in July 416

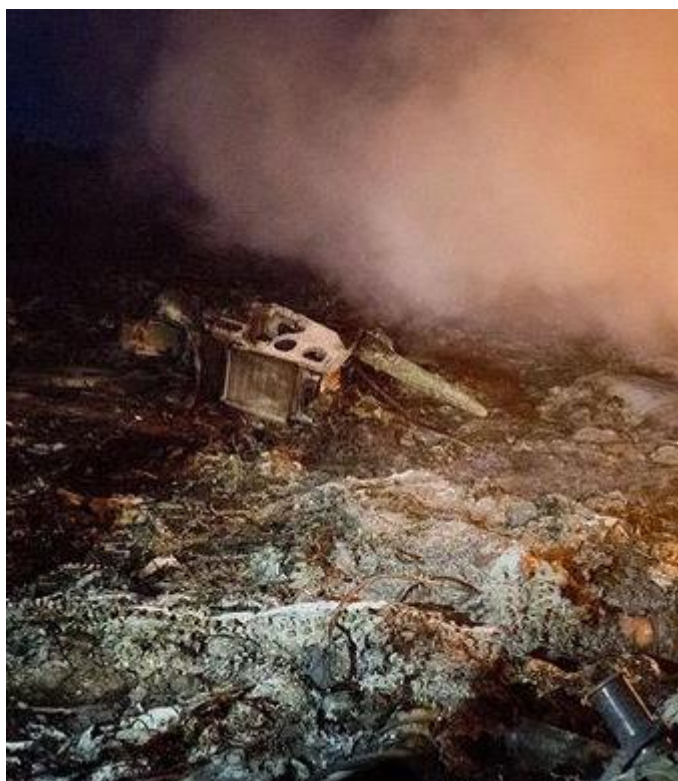
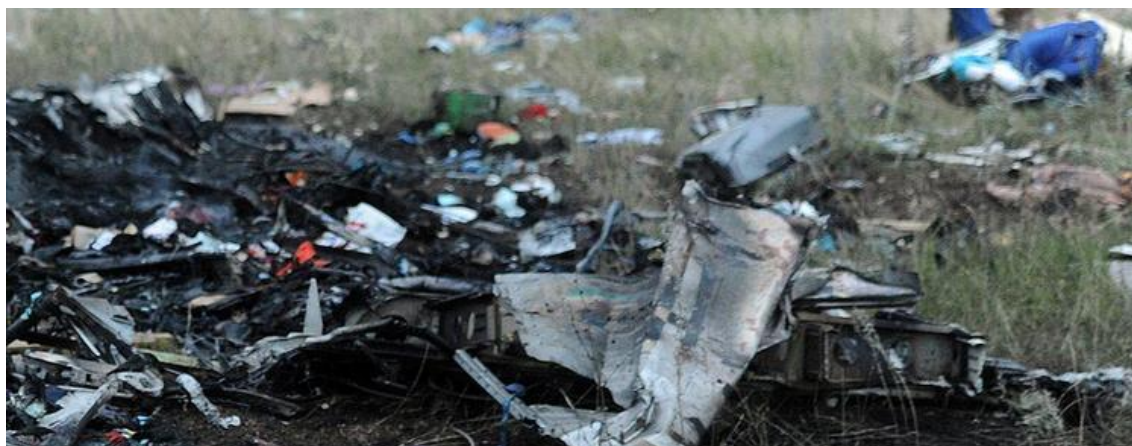
*Figure 1. The wreckages*

The aircraft was completely damaged. The distribution of wreckage is provided in following sections.

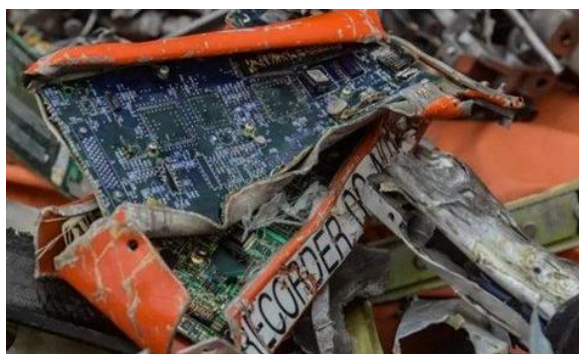
*Figure 2. The FDR and its storage module*

The black boxes, including FDR and CVR, are located at the bottom of the aircraft. Though suffered from impact and fire, the storage module of FDR and CVR remained complete.

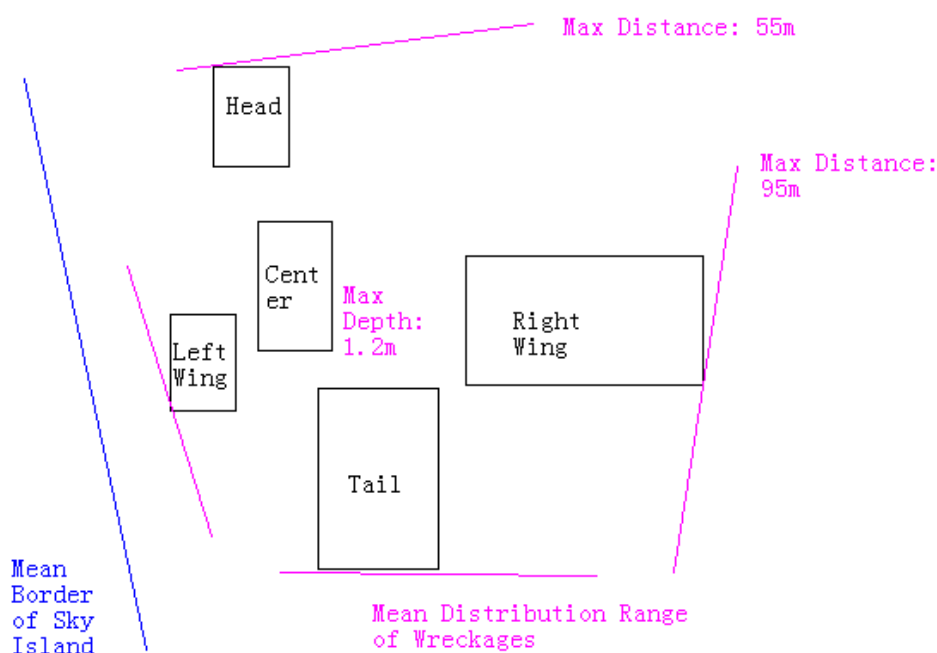
*Figure 3. The approximate distribution of wreckages*

The distribution of the wreckages suggests that the aircraft banked steeply to the left when touching the ground.

It has been found that the only engine, recognized as the right engine (Engine 2), had inhaled soil. This suggests that the engine was still running when the aircraft touched the ground.

The wreckages of the cargo area have the signs of burning, suggesting fire inside, which suits the record of FDR and CVR. The electronic wires of fire extinguisher system were also broken.

The oxygen components were also found. The crew oxygen supplies were all broken from two or more directions, while passenger oxygen devices were either not broken or minor broken.

Burns were also found on almost all hydraulic pipes. The flying surfaces of ailerons and stabilizers remained full-up position.

Cracks whose direction opposes other damages caused by impacts were also found on the left side of the fuselage, near the center area, some of which are large enough to cause cabin decompression.

Besides, parts of the left wing fuselages, including the left engine, winglet, flaps and oil pipes, were found in other places, which is 2.4 miles away from the main crash site on average.

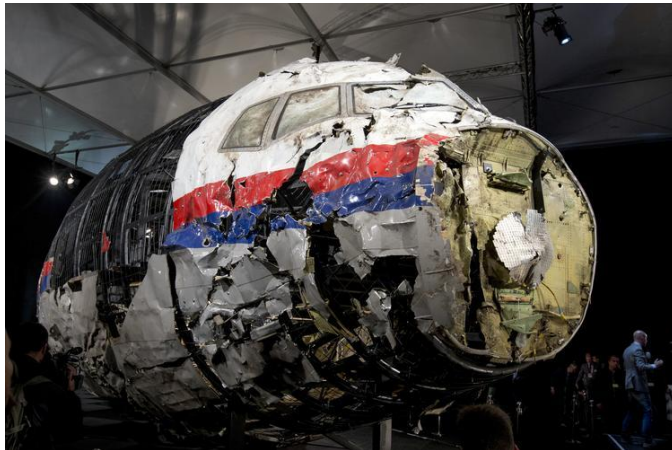
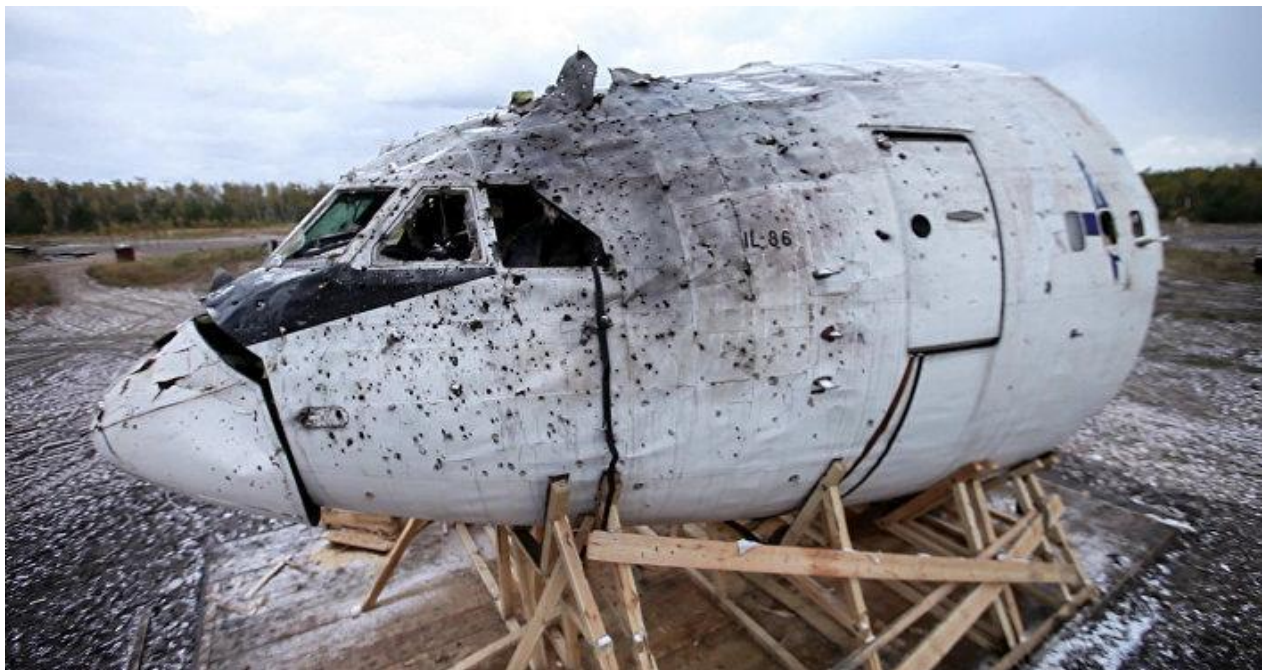
*Figure 4. The result of fuselage attacked in similar way (towards the back side) on the ground*

This suggests that the fuselage parts directly attacked will surely be completely damaged and separate from the aircraft, but other parts will likely remain partially complete. In the air, the attack is less precise and the damage will be less serious.

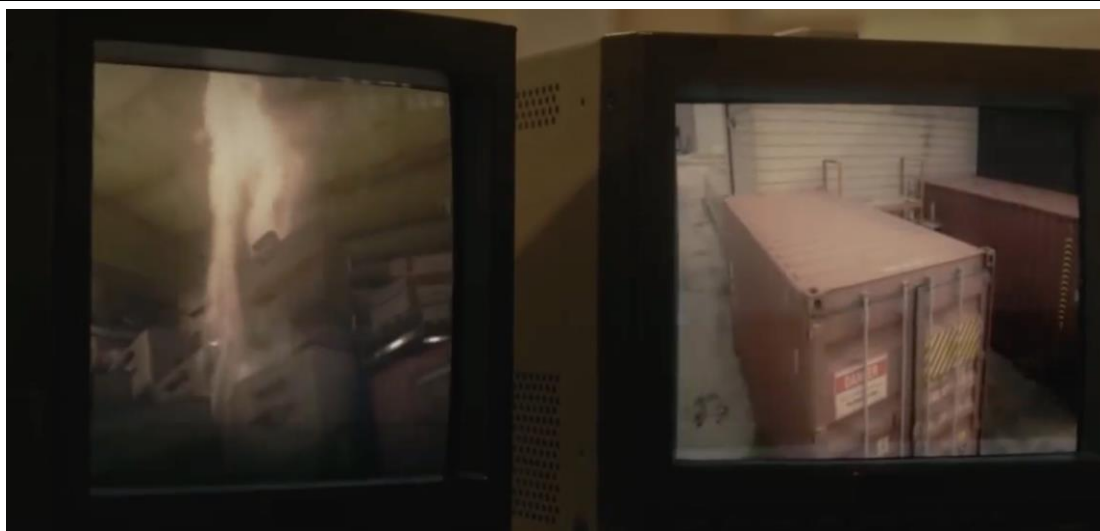
*Figure 5. Inside and outside screen in Test #4*

Test #	The highest temperature after being hit (°C)	Result	The highest temperature after that (°C)
1	32	-	34
2	37	Fire	551
3	45	Fire	782
4	52	Fire	923
5	59	Fire	1,103
6	63	Fire	1,225
7	69	Fire	1,393

Investigators also tested a normal fire extinguisher. It turned out that normal fire extinguisher equipped on the aircraft has been enough to put out the fire.

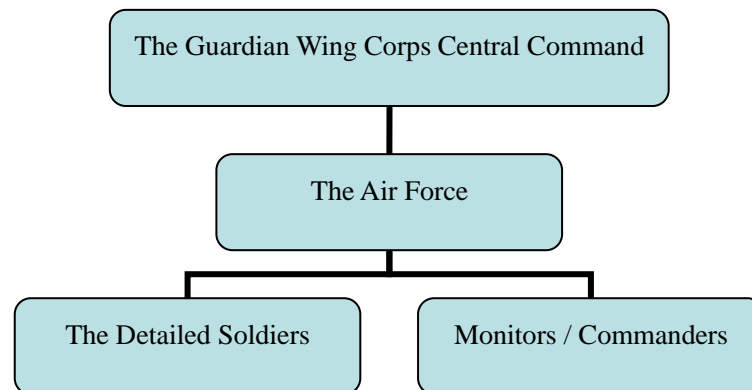
*Figure 6. The structure of the Guardian Wing Corps in the accident*

The structure ensured high response speed during the war, but it didn't provide chances for civil administrations to give advice.

In this way, when the identity of the aircraft can't be confirmed, the mistaking is less likely to take place. Internal workflow and structure of the Guardian Wing Corps are also recommended to be adjusted by inviting officials from civil aviation to prevent damages to civil aviation.

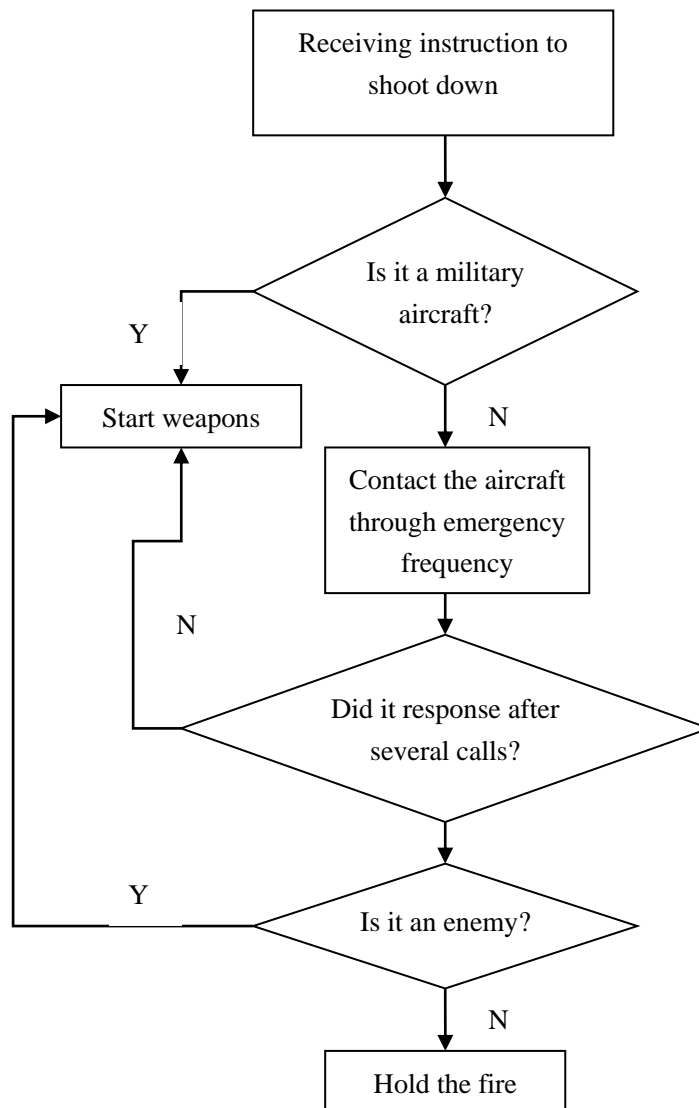
*Figure 7. Procedure of shooting down an aircraft in The Guardian Wing Corps during the accident*

The procedure of the Guardian Wing Corps is likely to cause accident on commercial flights because of the limited communication caused by the inappropriate communication devices used by executive soldiers and the lack of other information.

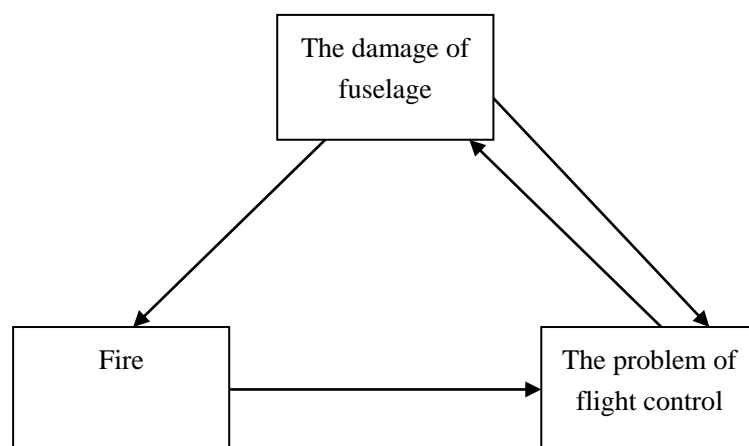
*Figure 8. The mind map representing the relationship between the damages*

Since the engines had separated from the aircraft, the fire must be because of the cargo area. The relationship between them can be described as follows:

In this mind map, only when all of the arrows (factors) worked, the accident could take place.

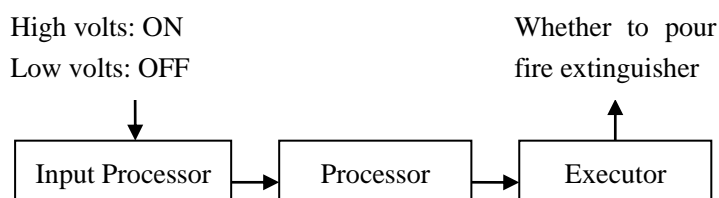
*Figure 9. The graph of the fire extinguisher control system*

In this system, the executor is based on mechanical structures, which won't be influenced by fire or electronic failure. However, the input processor and processor controls the executor based on the electronic input, which will obviously fail if the wire from detector or the button in the

cockpit is broken. When the wire is broken by the fire or other factors, there's no way to turn on the system. Therefore, the system is not fail-safe, not following the safety principle of the man-object relationship and not satisfying the target of extinguishing the fire.

The general strength of the fuselage is qualified and acceptable, but the design of fire extinguisher actually boosted the disaster. The design of the fire extinguisher control system should have been fail-safe, or, in other words, be able to put out the fire without electricity supply, which will be probably cut off during a fire.
