## ARRI TECHNICAL NOTE P-1019

### ARRIMAG 300E “Not Ready” August 1, 2000

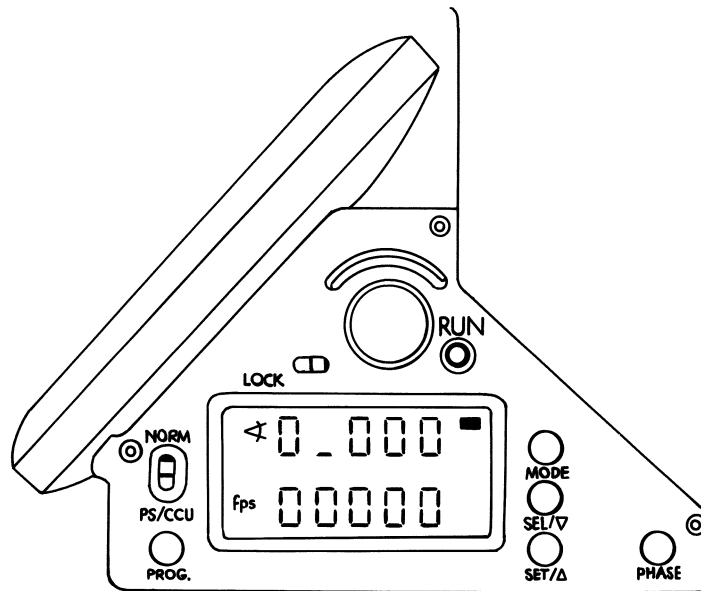
If a problem with the ARRIMAG 300E (the torque motor driven 1000' magazine for the 435) prevents the 435 from running, the camera's RUN LED will glow red, and the second digit on the top line of the display will turn into an underline (see graphic). This is the “ARRIMAGE 300E Not Ready” status, which could be caused by one of the following 5 conditions.
