BIOP Fly Creek Stream Restoration Project

Completion Report

United States Forest Service

December 13, 2010

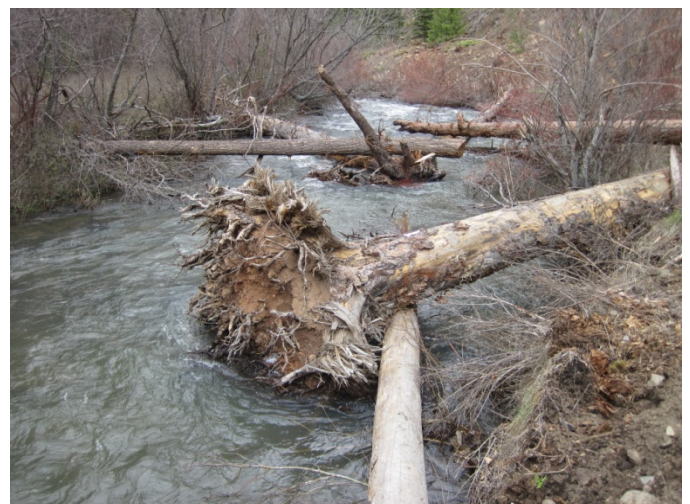
** Fish Structure Site # 29 in 2010 Spring Flows (constructed in 2009)*

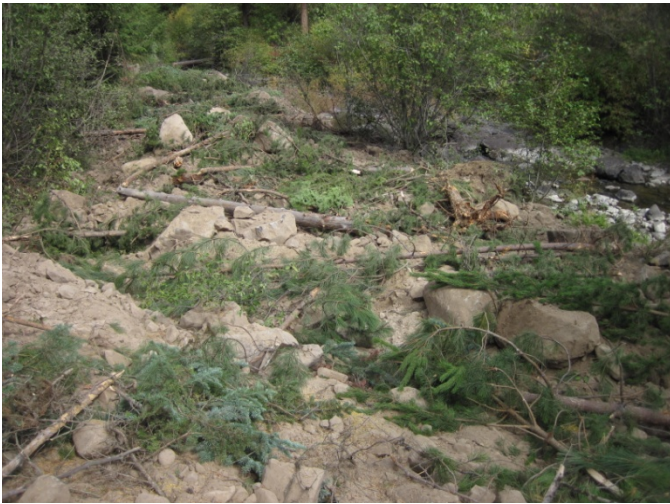
*** 2010 Fly Creek Road Recontour/Floodplain Restoration**

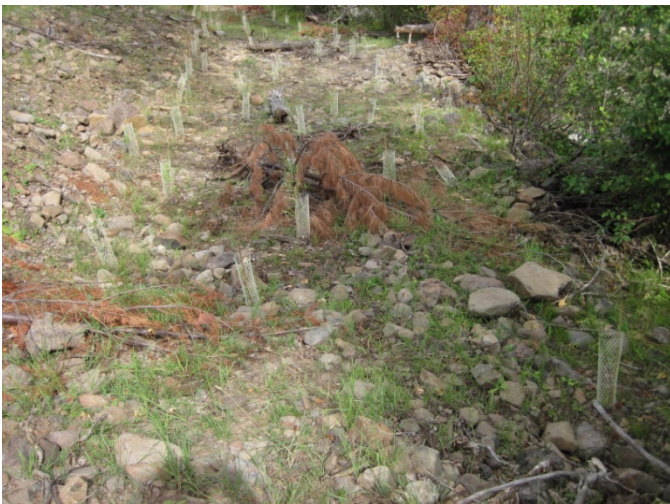
*** 2009 Road Recontour/Floodplain Restoration (seeding occurred in the fall of 2009 and planting occurred in the Spring of 2010)**

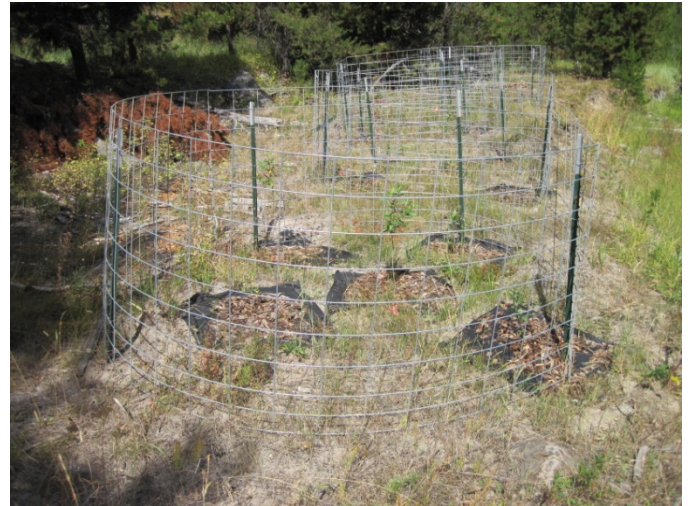
*** Spring 2010 Deciduous Planting**

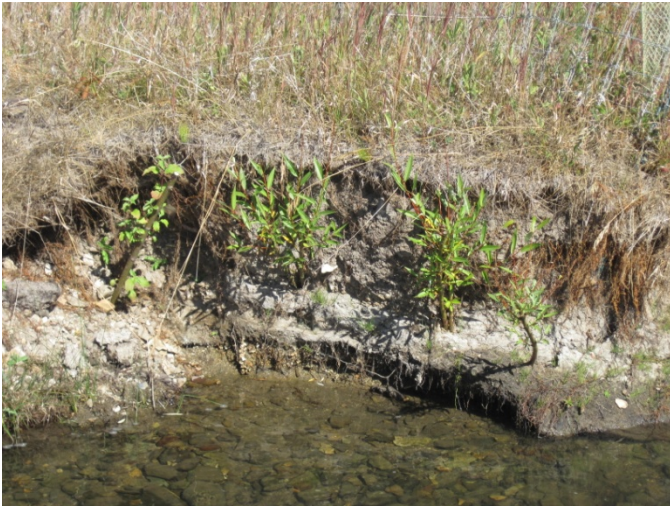
** Spring 2010 Cutting Planting*
