FUJIKURA FIBER OPTICS VIETNAM LTD.			
TECHNICAL REPORT			
Form: 4-Pr-007-4-Fo-005	Version: 08	Page: 1/3

Record No (get by EIC program): 4-PR-007-4-fo-005-9-RC-0071		Date: 22-Mar-22	
Report title: Changing packing method for Acacia products			
Prepared by: ChauVNB	Checked by: HienNTN	Reviewed by Technical Advisor (if any)	Approved by: DucTNM 5-Apr-22

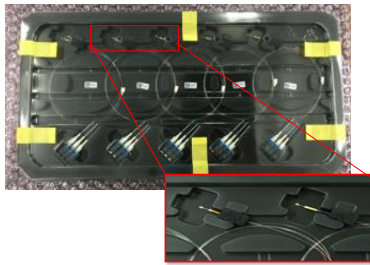
<p>-All product's appearance is OK by microscope follow current Appearance criteria. After testing, we found 1/5pcs have new defect: Delamination near sleeve. Follow current criteria, it is OK & only happened on product which have fiber damaged before testing. And the fiber damaged is still same level, no larger than before testing. So we don't action for this case.</p> <div>

</div> <p>Fiber damage near sleeve Fiber damage near sleeve Delamination : OK</p> <p>-The array No.2 & No.3 is moved. We think that it can be come from removing the SN of sponge after packing so have gap between product & sponge. We decided 2nd testing time to confirm again.</p>

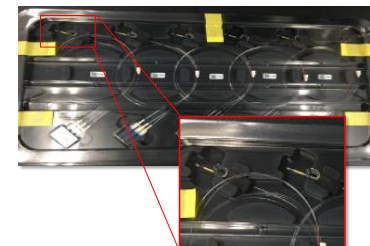
Second drop test

<p>- All product's appearance is OK by microscope follow current appearance criteria. - The fiber of first product jumped out of position as picture beside.</p> <p>=> Investigation: During observe the packing tray, we could see a risk that there's a small gap created between packing tray body and packing tray during droptest. This gap make the space for fiber jump out. We need to make this position fixed better.</p> <p>=>Countermeasure: + Make additional tapes from 6pcs to 8pcs + We fixed 3pcs tape at sponge position No. 1,3,5 to prevent gap between cover & sponge. + We fixed 3pcs tape on the right of LC connector No. 1,3,5. + We fixed 2 pcs tape at stoper of tray. => We decided 3rd time drop test to verify effectiveness of this improvement.</p>
Third drop testing	<div>

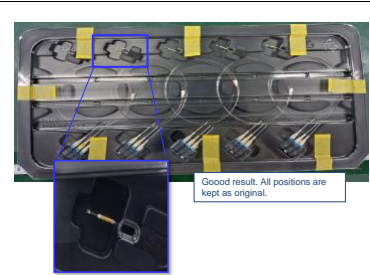
</div> <p>Before improvement After improvement (Countermeasure from 2nd test)</p>

<p>Good result. All positions are kept as original.</p>	<p>-All of part position(fiber, array, sleeve, LC connectors) is fixed and not moving -Because this 3rd drop test confirm the improvement of both 1st drop test & 2nd drop test so we only check the product position is still kept or moved. -We use the result of appearance of product in 2nd testing time to confirm for 3rd time.</p>

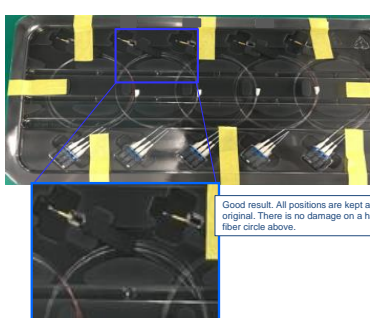
Fourth drop test	<div>

</div> <p>Before improvement After improvement (Change sponge length)</p>

<p>Good result. All positions are kept as original. There is no damage on a half of fiber circle above.</p>	<p>During first drop test for LFF product base on all of improvement SFF product, the fiber of second LFF product still jumped out. So we apply new structure of sponge from 7-DWM-0648 ver.01 to 7-DWM-0648 ver.02, especially change length from 15mm to 29mm for both SFF & LFF product as final actions to keep fiber in this position. => We decided 4th time drop test to verify effectiveness of this improvement.</p> <p>=> Result: -All of part position(fiber, array, sleeve, LC connectors) is fixed and not moving. -Because this 4th drop test confirm additional improvement so we only check the product position is still kept or moved. And inspect the appearance of a half of fiber cycle as beside. The result is OK -We use the result of appearance of product in 2nd testing time to confirm for 4th time.</p>
