Cell No.: - 01		Cell Name: -All WELDING AREA		Machine : - WELDING AREA		Process / Stage : WELDIND AREA		Kaizen No.:	
Kaizen Theme:		Idea: To avoid the welding visual inspection (welding sample stand).							
Process and Product Improvement		COUNTERMEASURE IN PICTORIAL:						Bench Mark	
Present status:		BEFORE						KAIZEN Start

Cell No.: - 01		Cell Name: -9T FF	Machine : -Front Frame assembly	Process / Stage : Part Fixing	Operation :	Part Fixing			
Kaizen Theme:			Idea: To avoid the tube hole position wrong , hole missing and hole incomplete.						
Process and Product Improvement									
Present status:		COUNTERMEASURE IN PICTORIAL:			KAIZEN Start	10.02.18

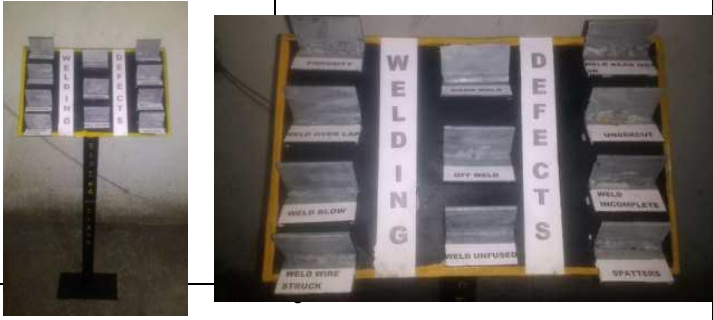
1) New welder to check the welding visual stand .		AFTER						10-01-2018	
2) Welding quality compare the welding stand

KAIZEN Finish	
								12-01-2018	
		Team Members:							
		1-R.Parthiban							
		2-Nilmani							
		Benefits:							
		1-Welding quality improve and visual inspection							
		2-Customer complaints can be avoided							
		KAIZEN SUSTENANCE :							
Why Why Analysis :		Countermeasure & Results:						What to do :	
W1. To Avoid the welding issue		Welding improve and visual inspection .						Irreversible Kaizen	
W2 .To avoid the customer complaint		Result:							
Root Cause :		1-Welding improve and visual inspection improve .						How to do :	
		2-Time of inspection can be reduced						Scope & Plan for Horizontal Deployment	
Registration no. & Date :		12-01-2018		Sr no		Model		Target Date	
Registered by :		Parthiban		1		welding area		12-01-2018	
Manager's Sign :		Sai krishna						Responsibility

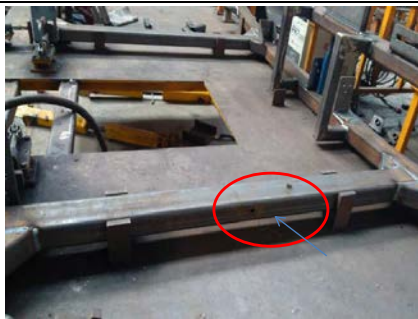
1) Tube hole position is checked by using measurement tape.		<div style="display: flex; justify-content: space-around;"> <div style="text-align: center;"> <p>BEFORE</p>

<p>1) Bracket position is checked by using measurement tape.</p> </div> <div style="text-align: center;"> <p>AFTER</p>   <p>1) Bracket position is checked by using attribute gauge.</p> </div> </div>			KAIZEN Finish	12.02.18

2)Hole missing and hole open condition is ensured visually					Team Members:				
					1-R.Parthiban				
					2-nilmani				
					Benefits:				
					1-Hole position and hole missing can be ensured				
					2-Customer complaints can be avoided				
					3-Hole incomplete can be ensured				
					KAIZEN SUSTENANCE :				
Why Why Analysis :		Countermeasure & Results:			What to do :				
W1. To Avoid the Fitment issue		Time can be reduced and customer complaint can be avoided.			Irreversible Kaizen				
W2 .To avoid the customer complaint		Result:							
Root Cause :		1-Tube hole dimension can be maintained with in limit.			How to do :				
					Scope & Plan for Horizontal Deployment				
		2-Time of inspection can be reduced			Sr no	Model	Target	Responsibility	Status
Registration no. & Date :		12.02.18					Date		
Registered by :		R.Parthiban			1	9T all models	13-02-2018	Nilmani R.Parthiban alaguraja	completed
Manager's Sign :		Sai krishna

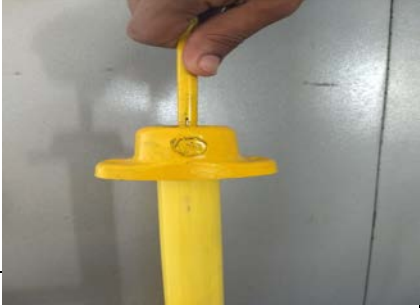
Cell No.: - 01		Cell Name: Final inspection		Machine : -		Process / Stage : Inspection		Kaizen No.:							
Kaizen Theme:		Idea: To avoid the fitment issue and to ensure the coating thickness.													
To ensure the coating thickness		COUNTERMEASURE IN PICTORIAL:				Bench Mark									
Present status:		BEFORE		AFTER		KAIZEN Start		22.12.17

1)Part is inspecting by using vernier.

KAIZEN Finish		22.12.17							
						Team Members:									
						1-R.Parthiban									
						2-Alaguraja									
						3-Nilmani									
						Benefits:									
						1-Insection time can be reduced and fitment can be ensured									
						2-Customer complaits can be avoided									
						KAIZEN SUSTENANCE :									
Why Why Analysis :		Countermeasure & Results:				What to do :									
W1. To Avoid the Fitment issue		Time can be reduced and customer complaint can be avoided.				Irreversible Kaizen									
W2 .To avoid the customer complaint		Result:													
Root Cause :		1-Part can be ensured in terms of fitment.				How to do :									
		2-Time of inspection can be reduced				Scope & Plan for Horizontal Deployment									
Registration no. & Date :		26.12.17				Sr no		Model		Target Date		Responsibility		Status	
Registered by :		Parthiban				1		Driver Partitions		25.12.17		Parthiban		Completed
