Important :

In this document, I describe my personal approach to disassembling the Apple Pencil (2nd generation) in order to access and remove the battery. I have performed this disassembly myself and encountered several issues along the way. I am sharing these observations so that others are aware of potential problems they may face if they choose to attempt a similar repair.

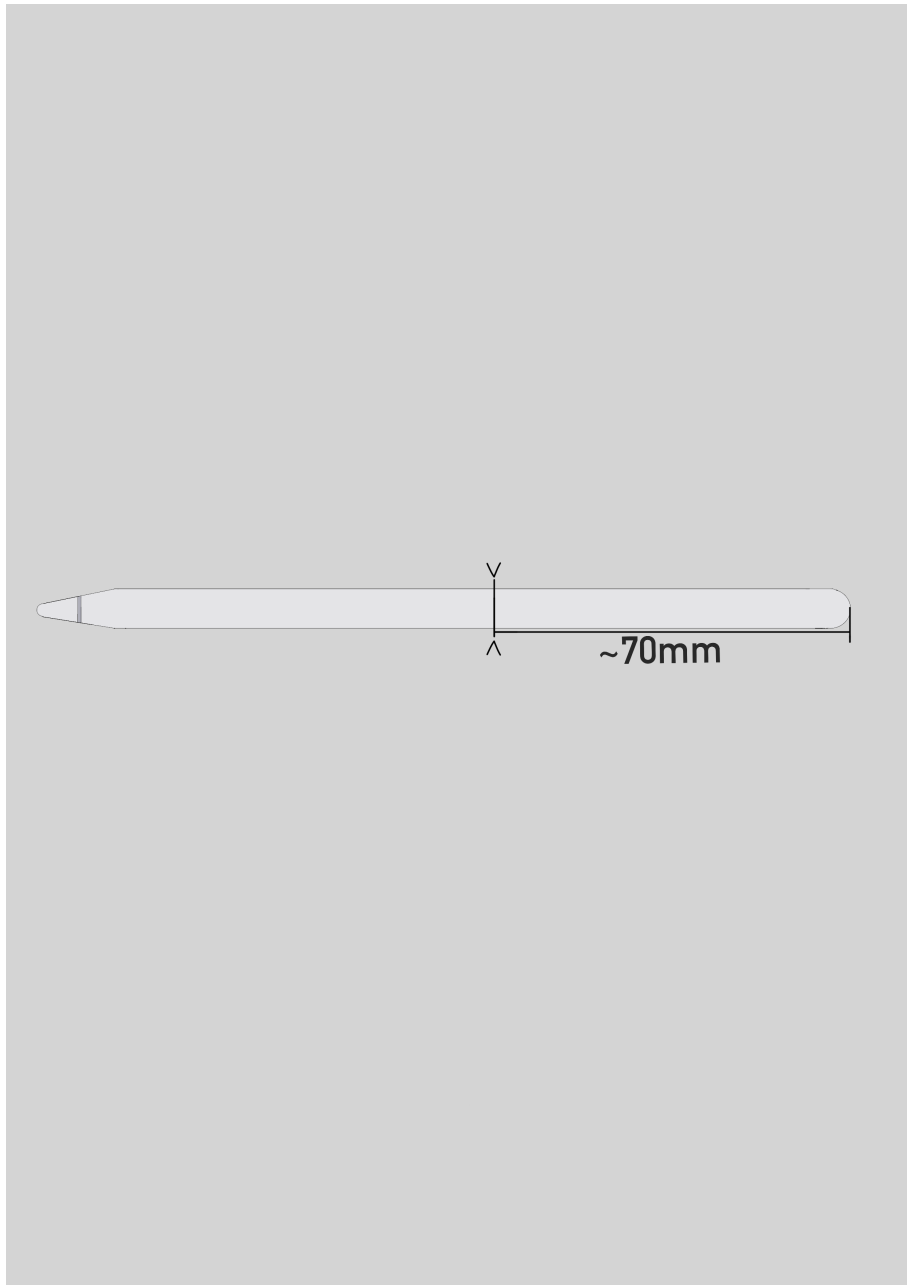
1. First, unscrew the tip to avoid damaging it.
2. Based on my personal experience, the enclosure separation occurred around the mid-section of the pencil. In this area, the adhesive securing the outer shell appears to end, which made it the least resistant point during disassembly.

I attempted to create a controlled separation along this section while trying to minimize cosmetic damage to the metal shell. This observation is shared only to describe where structural changes were encountered, not as a recommended method.

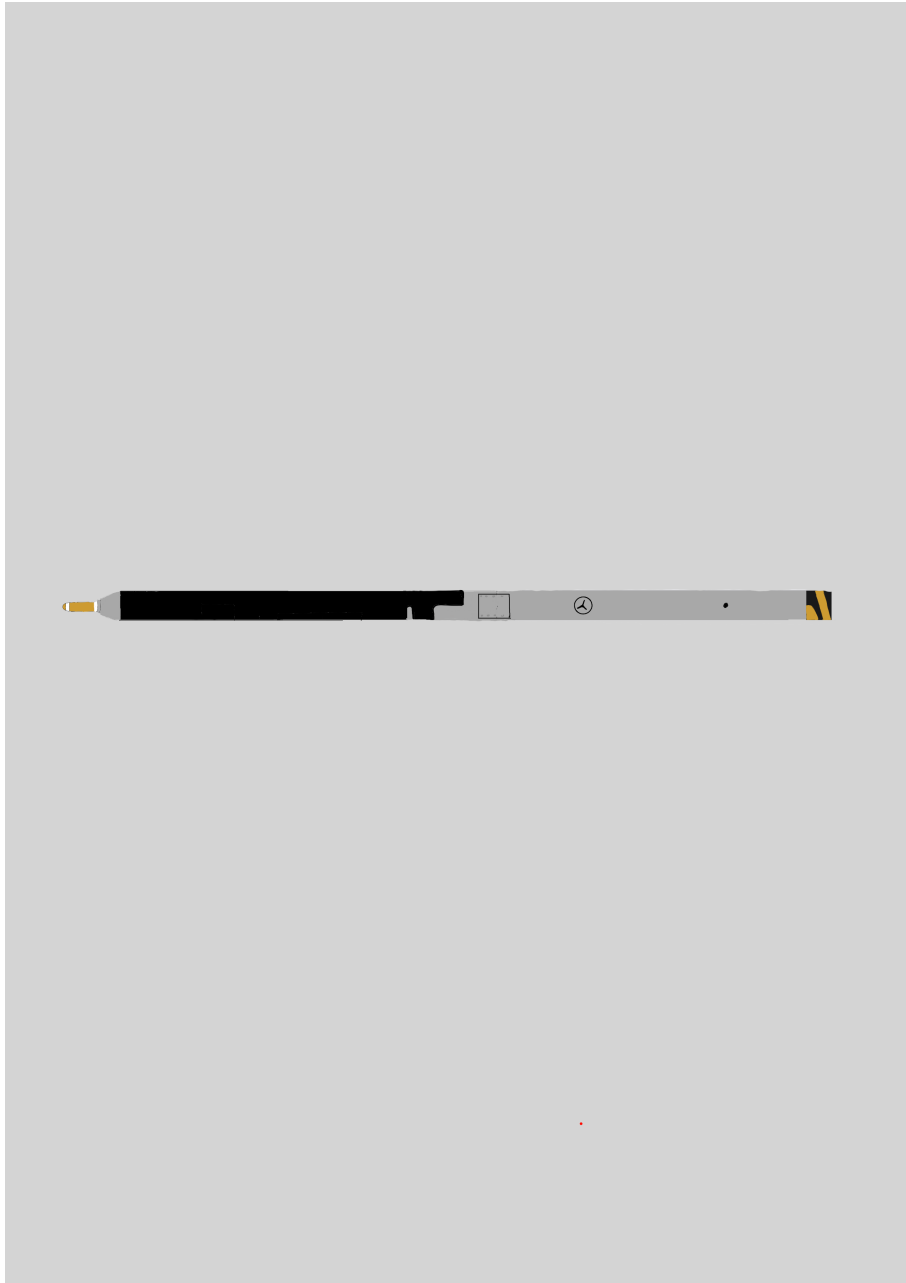
3. After this stage, the lower section of the enclosure became detached during my attempt.
4. At this stage, I observed further separation points on both sides of the enclosure, as illustrated. In my case, the adhesive in this area appeared to soften when exposed to moderate heat, which affected how the plastic component detached.
5. In my experience, the next stage involved examining the internal components as shown in the illustration. I observed a screw securing the battery and a small square cover that appeared to be

spot-welded. This cover was the most challenging part to separate, and I noticed that sharp tools could easily damage internal components if not handled carefully.

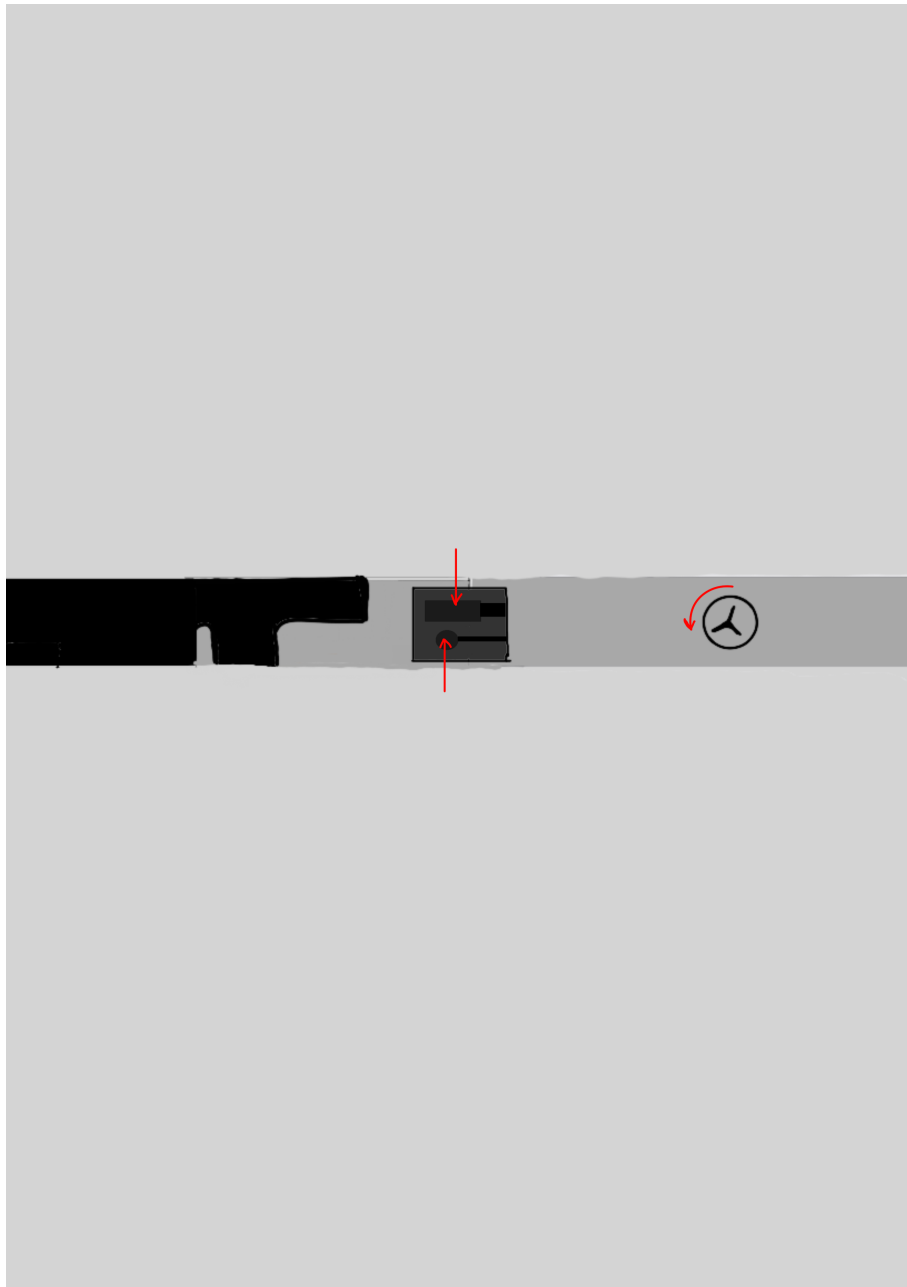
After the plastic section was separated, residual adhesive remained and required additional attention before any further examination

and disconnect both convectors, before doing this, remove the small

glue spots

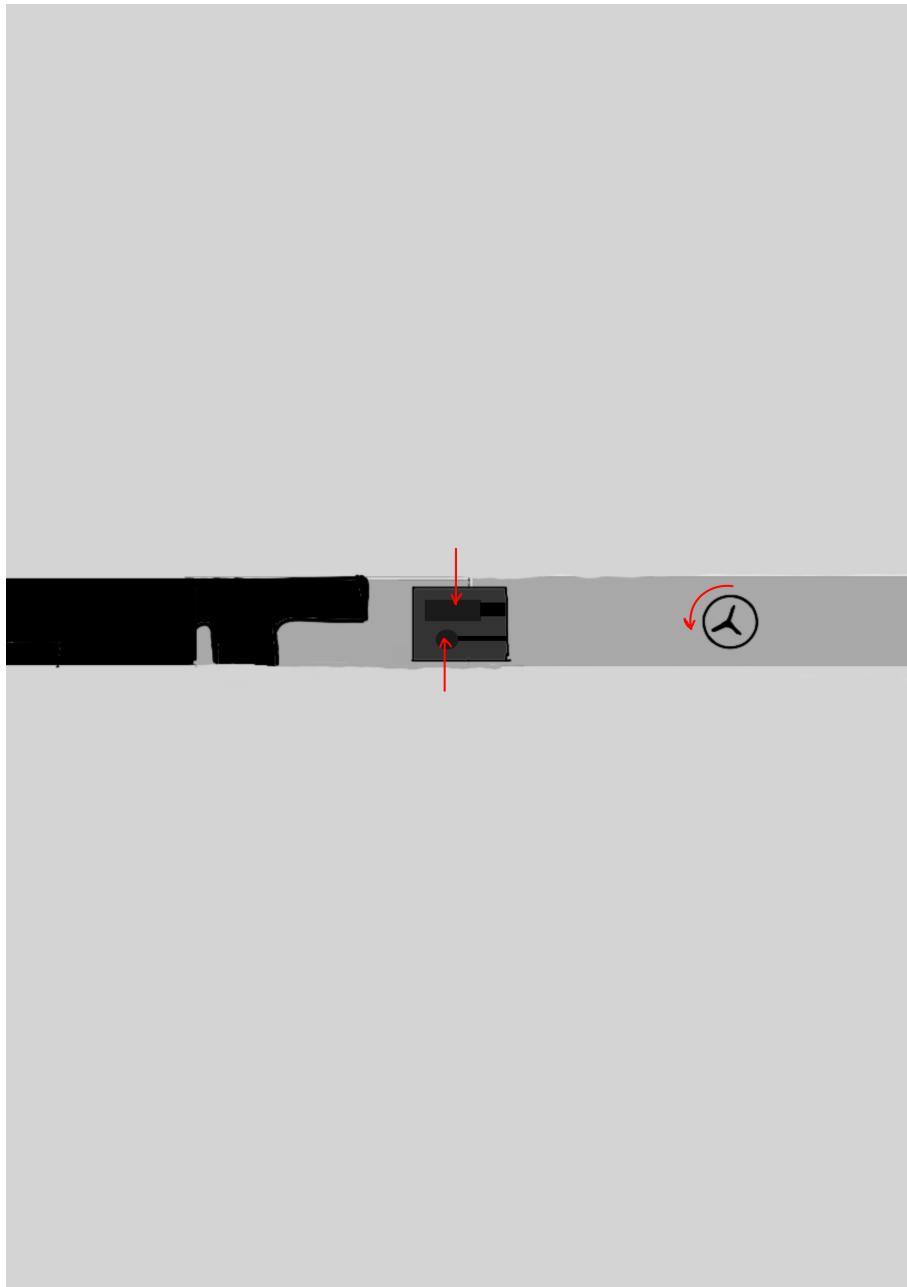
6. In my experience, when examining the end of the pencil, I observed areas where spot welds were present along the edges. These welds appeared to require careful attention to inspect and assess the structure. I found that fine tools, such as a file, could be used to examine these areas more closely.

7. In my experience, at this stage, the antenna became detached. I observed that the wire leading to the antenna is very fragile, and any bending or movement could easily damage it, making repair extremely difficult. This note is provided purely to describe what I encountered and is not a recommendation for performing repairs.
