Engineering Ethics

CHARLES B. FLEDDERMANN

THE SPACE SHUTTLE *CHALLENGER* AND *COLUMBIA* ACCIDENTS

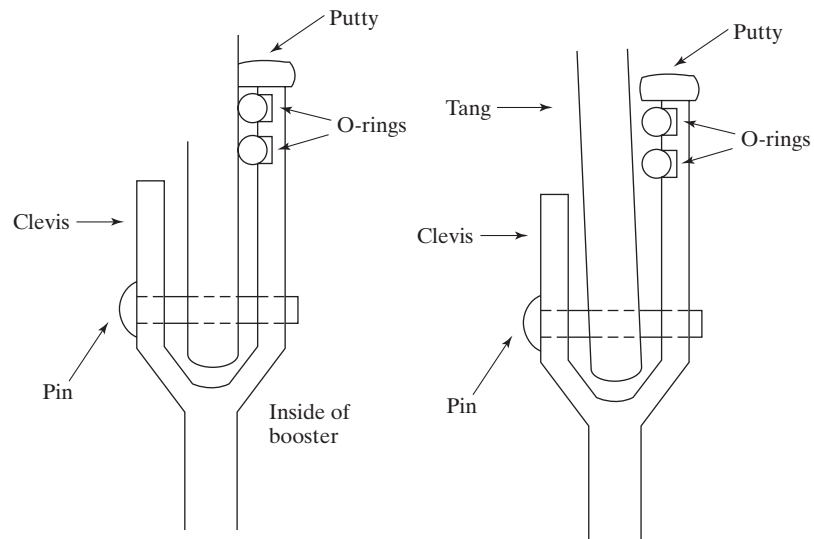
Figure 1.1

Problems with the field-joint design had been recognized long before the launch of the *Challenger*. When the rocket is ignited, the internal pressure causes the booster wall to expand outward, putting pressure on the field joint. This pressure causes the joint to open slightly, a process called “joint rotation,” illustrated in Figure 1.1b. The joint was designed so that the internal pressure pushes on the putty, displacing the primary O-ring into this gap, helping to seal it. During testing of the boosters in 1977, Thiokol became aware that this joint-rotation problem was more severe than on the Titan and discussed it with NASA. Design changes were made, including an increase in the thickness of the O-ring, to try to control this problem.

(a) A schematic drawing of a tang and clevis joint like the one on the *Challenger* solid rocket boosters.

(b) The same joint as in Figure 1.1a, but with the effects of joint rotation exaggerated.

Note that the O-rings no longer seal the joint.

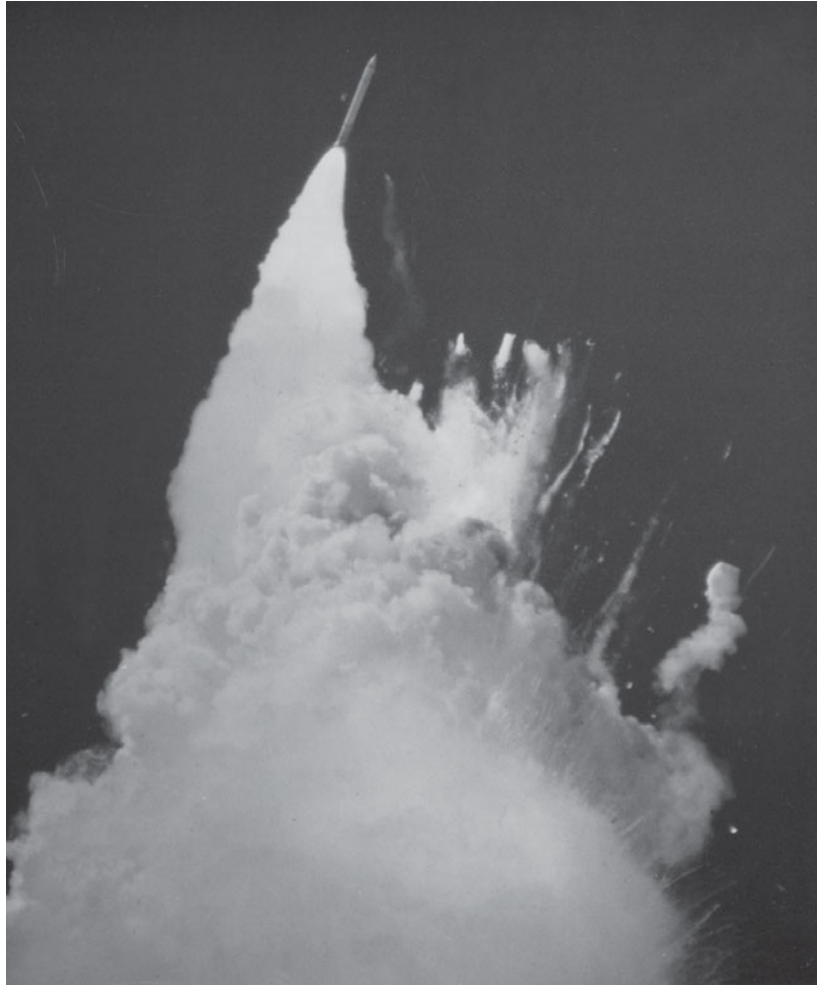
NASA routinely documents as many aspects of launches as possible. One part of this monitoring is the extensive use of cameras focused on critical areas of the launch vehicle. One of these cameras, looking at the right booster, recorded puffs of smoke coming from the aft field joint immediately after the boosters were ignited. This smoke is thought to have been caused by the steel cylinder of this segment of the booster expanding outward and causing the field joint to rotate. But, due to the extremely cold temperature, the O-ring didn't seat properly. The heat-resistant putty was also so cold that it didn't protect the O-rings, and hot gases burned past both O-rings. It was later determined that this blow-by occurred over 70° of arc around the O-rings.

formation might have averted the disaster had it not been for a very strong wind shear that the shuttle encountered almost one minute into the flight. The oxides that were temporarily sealing the field joint were shattered by the stresses caused by the wind shear. The joint was now opened again, and hot gases escaped from the solid booster. Since the booster was attached to the large liquid-fuel booster, the flames from the solid-fuel booster blow-by quickly burned through the external tank. The liquid propellant was ignited and the shuttle exploded.

Explosion of the space shuttle *Challenger* soon after liftoff in January 1986. NASA/Johnson Space Center
