# Embedded Hardware Designer Challenge:

## Sensor Interface & Debug

This report documents the design, implementation, and debugging process of a temperature-sensing system using an **ESP32 microcontroller** interfaced with an **LM75A temperature sensor** over **I2C**. The collected temperature data is transmitted via **UART**.

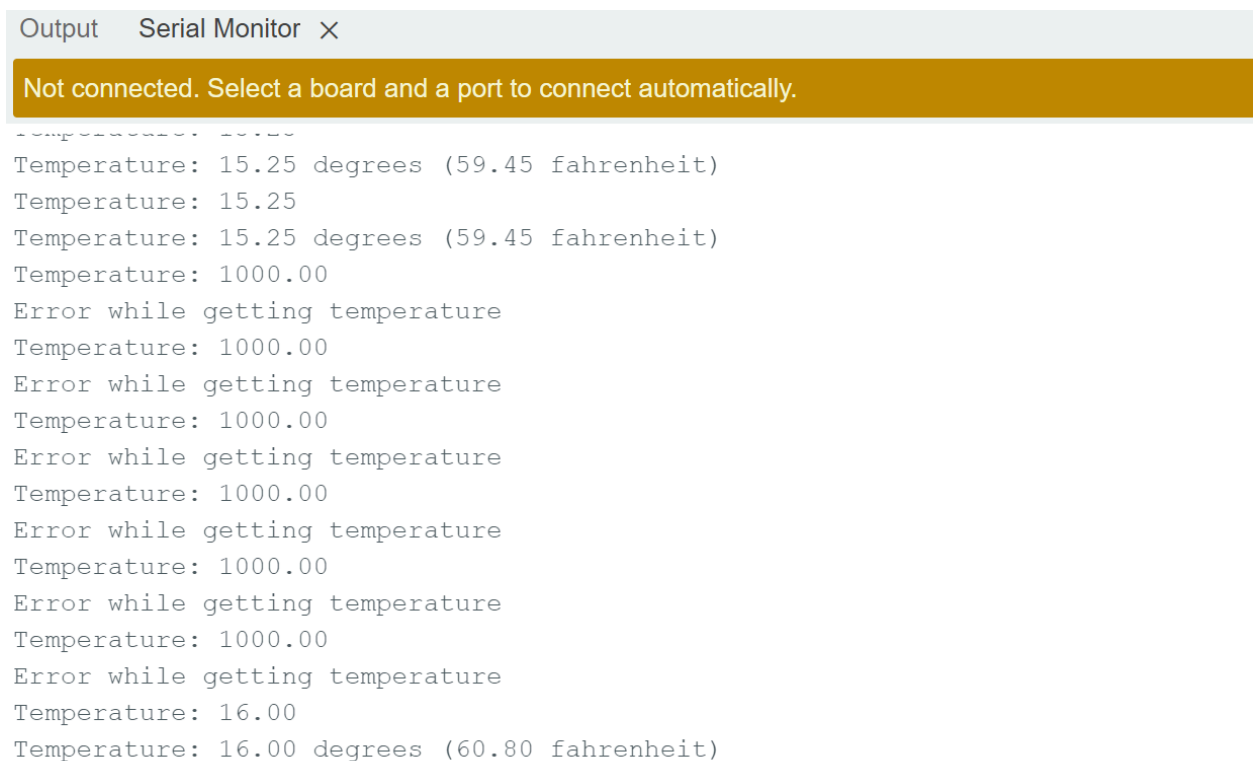
Figure 9: Incorrect Temperature Reading

After programming the **ESP32** to read temperature data from the **LM75** sensor via the **I2C** protocol and transmitting it to a PC using the **UART** protocol, the **Serial Monitor** sometimes displays invalid values or error messages like:

```
Temperature: 15.25
Temperature: 15.25 degrees (59.45 fahrenheit)
Temperature: 15.25
Temperature: 15.25 degrees (59.45 fahrenheit)
Temperature: 1000.00
Error while getting temperature
Temperature: 1000.00
Error while getting temperature
Temperature: 1000.00
Error while getting temperature
Temperature: 1000.00
Error while getting temperature
Temperature: 1000.00
Error while getting temperature
Temperature: 1000.00
Error while getting temperature
Temperature: 16.00
Temperature: 16.00 degrees (60.80 fahrenheit)
```

### Final Fix:

- **Added 4.7k $\Omega$  pull-up resistors** to I2C lines.
- **Introduced a small delay (10ms)** after each I2C sampling data from the sensor.
- **Ensured stable power supply** by adding a **100nF capacitor** near the LM75.
- **Grounded Pin A0,A1,A2.**

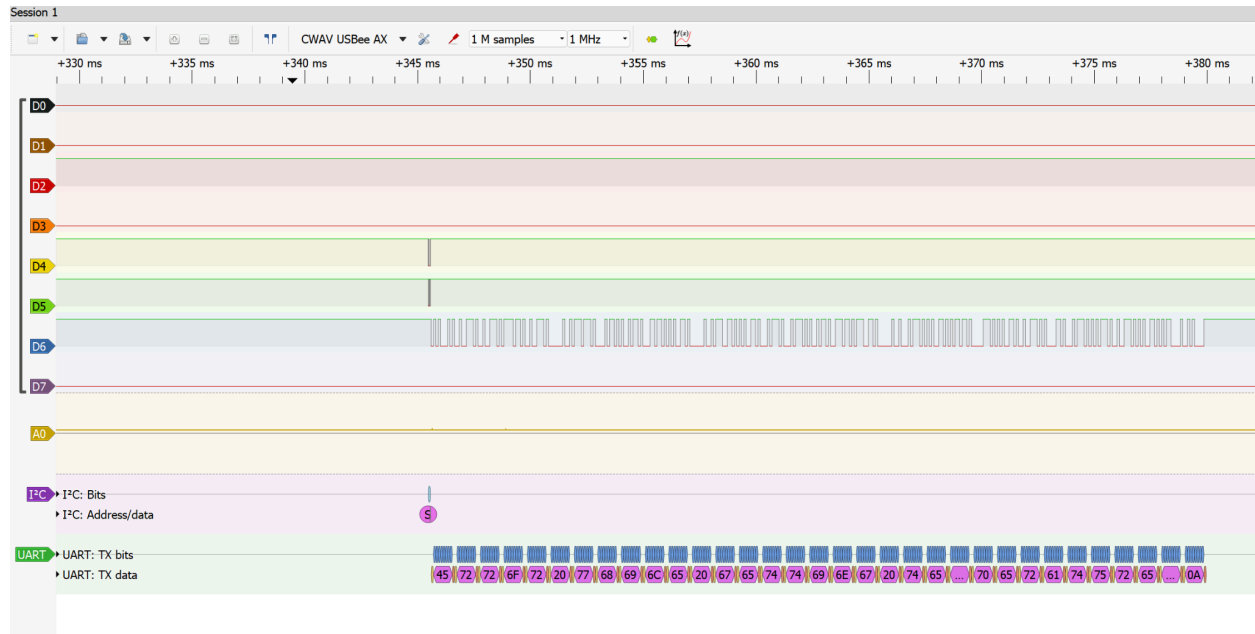
I used the LHT00SU1 logic analyzer for debugging, with PulseView software to analyze the signals. This logic analyzer was utilized throughout the project and has the capability to function as both an oscilloscope and a digital signal analyzer. Prior to adding the pull-up resistors and grounding the A0, A1, and A2 address pins of the LM75 sensor, I observed the output on the logic analyzer as shown below:

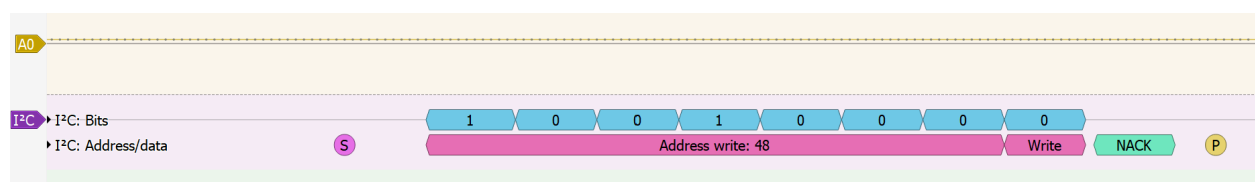
When I zoom in on the I2C signal, I observe that the master (ESP32) initiates communication with a start condition, followed by sending the 7-bit address of the LM75 sensor (48 in decimal). Data is written to the sensor, and the master receives a NACK (Not Acknowledge) signal before concluding the transaction with a stop condition. This process is intended for reading sensor data. However, I noticed that the data is not being read correctly. In the next step, I will add a pull-up resistor to see if this resolves the issue.

After adding pull-up resistors to the SCL and SDA lines, I observed no change. Next, I grounded the A0, A1, and A2 address pins of the LM75 sensor. This action resolved the I2C communication issue with the LM75 temperature sensor, indicating that grounding the address pins fixed the problem.

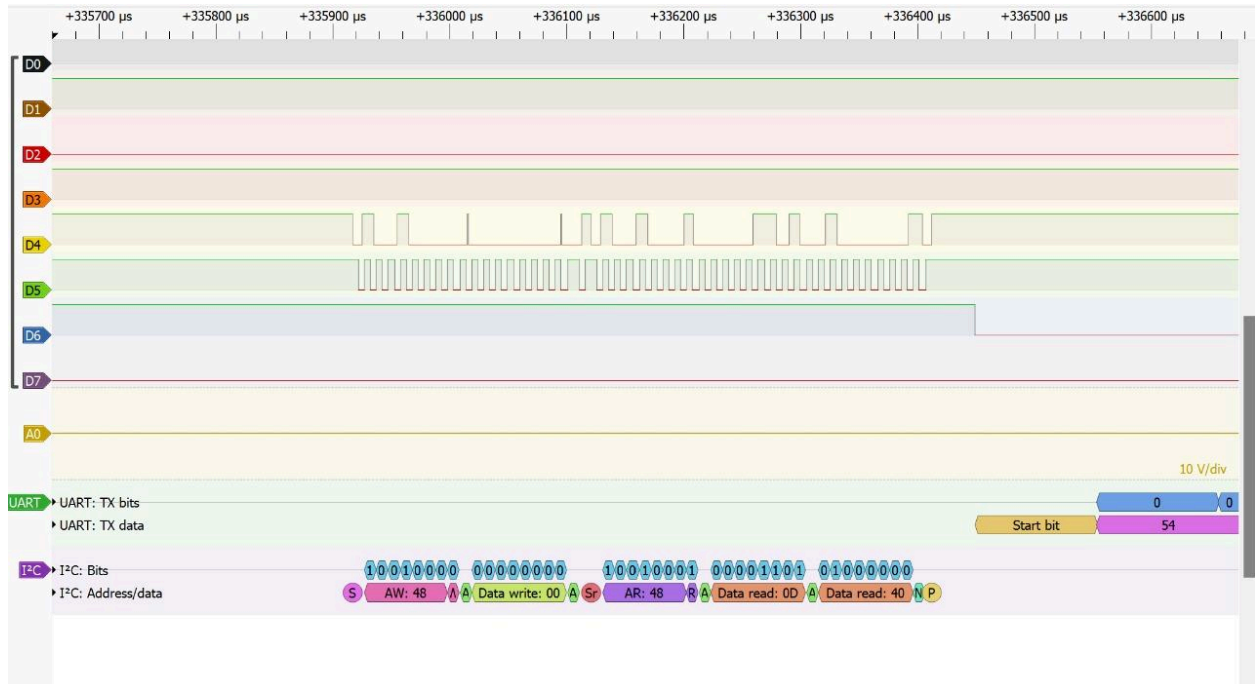
What I expect is that the ESP32 writes to and reads from the sensor at address 0x48. After making the necessary adjustments, I observe that the actual temperature reading is now displayed correctly.

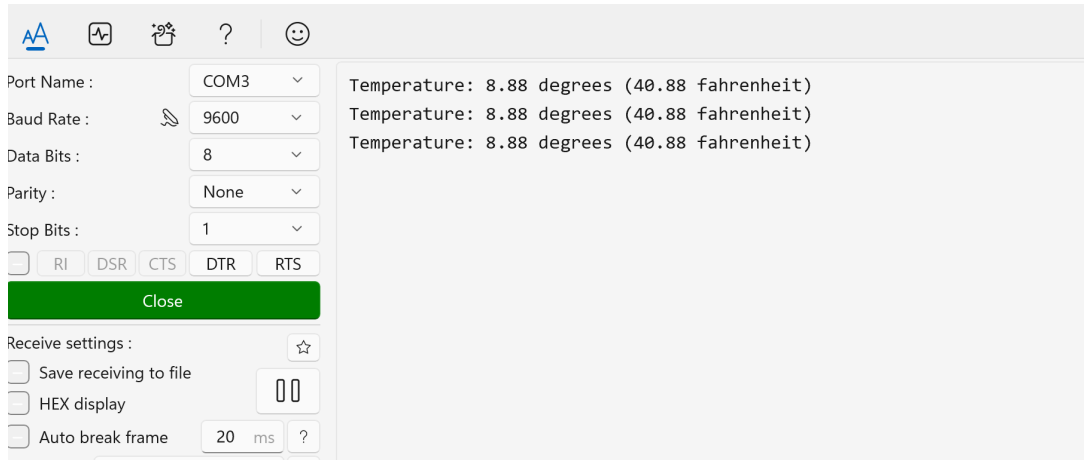
The temperature displayed in the serial output is 8.88°C, which corresponds to 40.88°F. Let's break down how I can convert this actual output to the raw data I'm receiving:

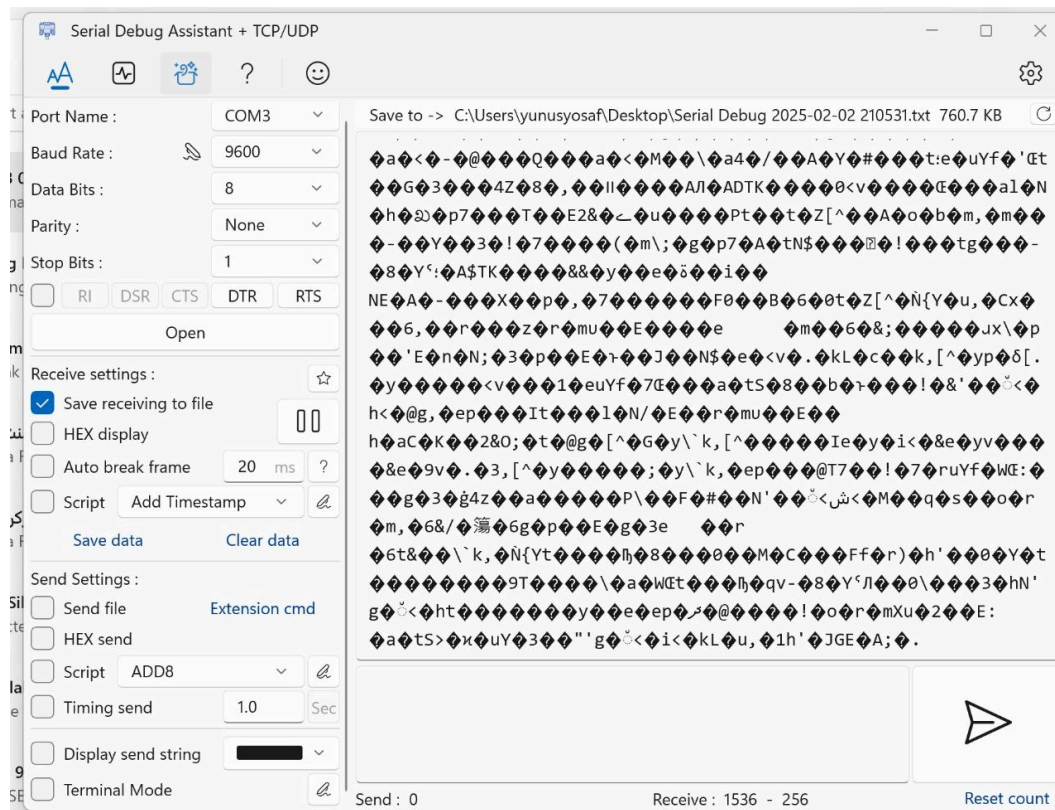
Figure 13: Gibberish reading through PC from UART interface

The ESP32 reads temperature data from the LM75 sensor at address 0x48 via the I2C interface and transmits it over UART. The blinking LED serves as a confirmation that the ESP32 is successfully reading data from the LM75 sensor. However, the output in the Serial Debug Assistant (a Windows application available on the Microsoft Store)

appears as gibberish, suggesting an issue with UART transmission. The following figure illustrates the output of our code:

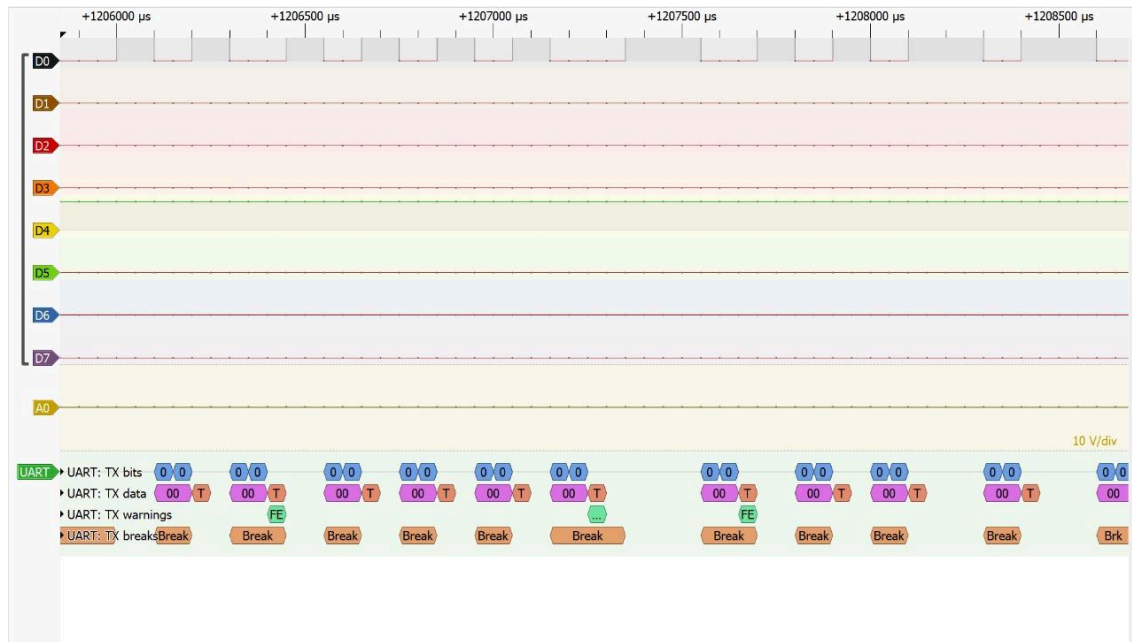
The data I was receiving on the logic analyzer through the UART transmission lines was corrupted. This could be caused by noise or invalid transmission between the PC and the ESP32. To start troubleshooting, I first checked the baud rate in both PulseView software and on the ESP32.

After confirming that the baud rate was the same on both ends, I suspected that the issue could be related to the sampling frequency. Initially, I had set the sampling frequency in PulseView to 100kHz, which is the minimum frequency required for debugging UART signals. However, I realized that the recommended sampling frequency for more accurate analysis is 1MHz.

To address this, I increased the sampling frequency in PulseView to 1MHz and planned to analyze the data again with this setting.

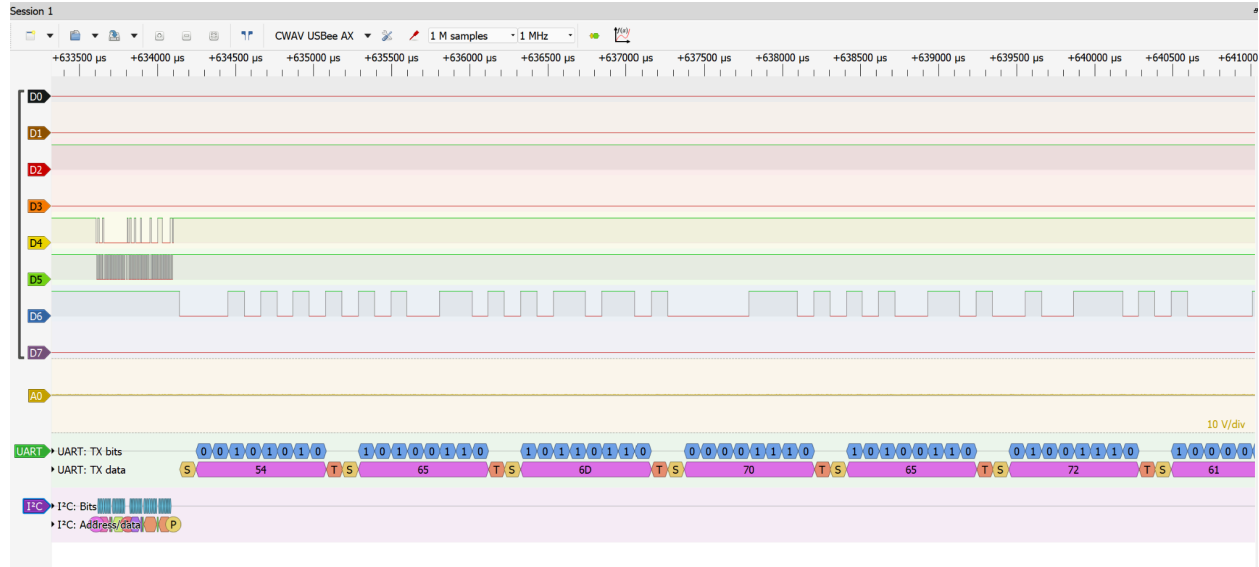
At a 100 kHz sampling frequency, Pulseview logic analyzer showed a data frame error. However, it displayed the correct data frames at a 1 MHz sampling frequency.

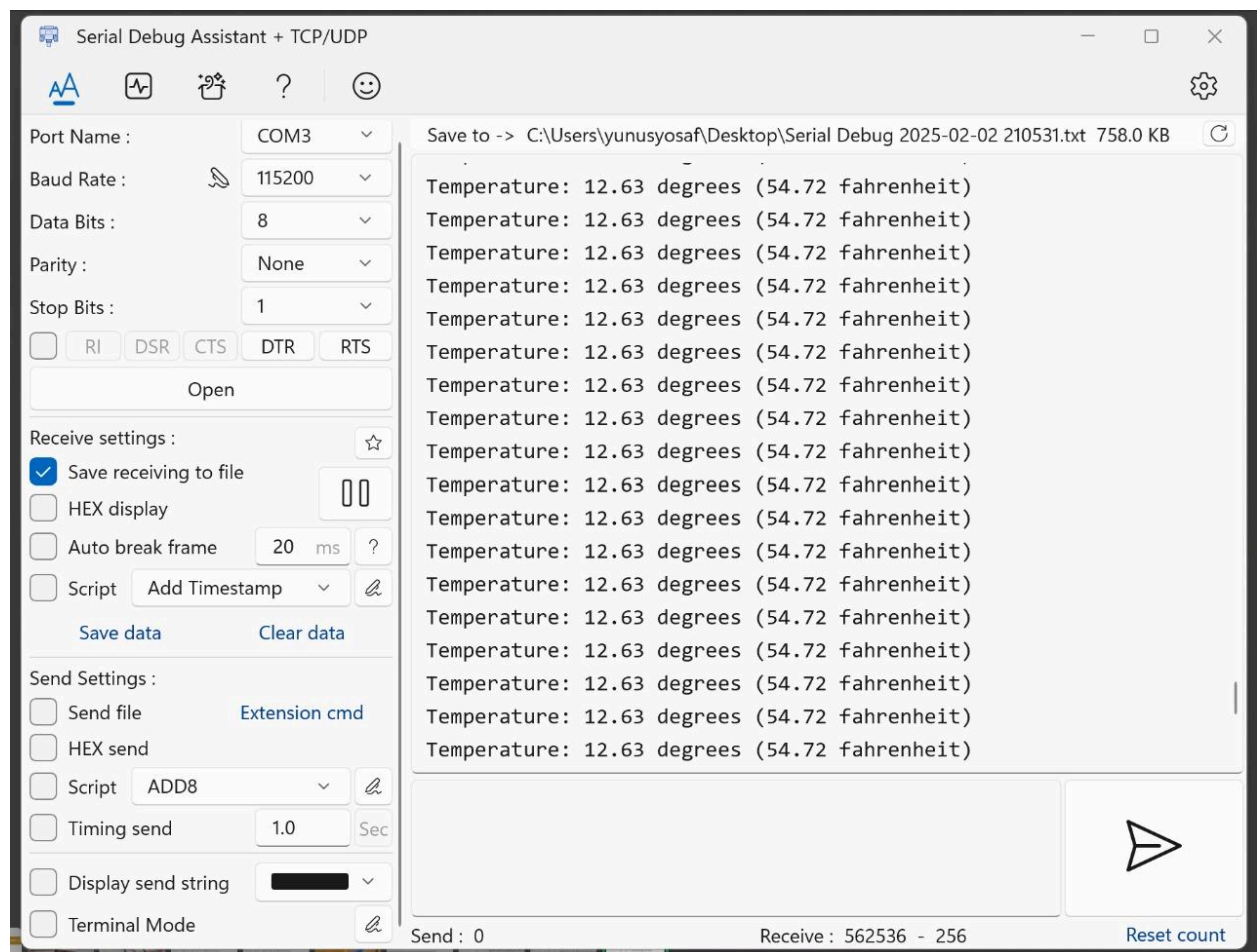
Figure 14: Correct reading after baud rate fixes

For accurate readings in the serial monitor, the UART baud rate must match on both ends. In the code, I set the baud rate to 115200 bps, but in the Serial Debug Assistant, it was set to 9600 bps. After synchronizing the baud rate in both the Serial Debug Assistant and Pulseview software to 115200 bps (the same as the ESP32 microcontroller), the data was displayed correctly, as shown in the figure below:
