HAZARDOUS MATERIALS ASSESSMENT REPORT

Job details: Owner/s: Mr. J. & Mrs. K. Lamesa
Location: 7 Annette Street, Oatley NSW

Date of assessment: 3rd March 2015

Our reference: HM03750315

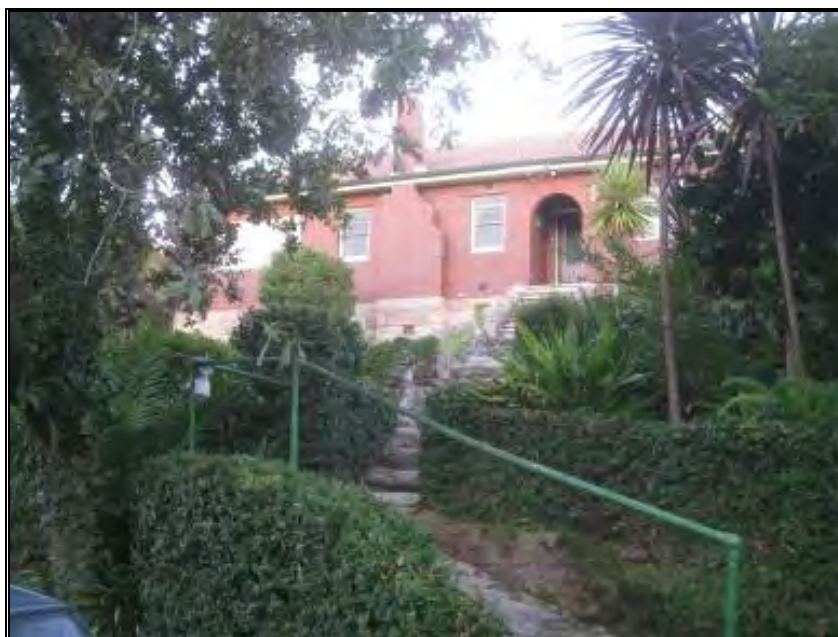
Front south east elevation of the residence
