标题: 【原创】Z-turn Board 的SD卡启动问题 [\[打印本页\]](#)

作者: dastan 时间: 2016-8-12 09:51

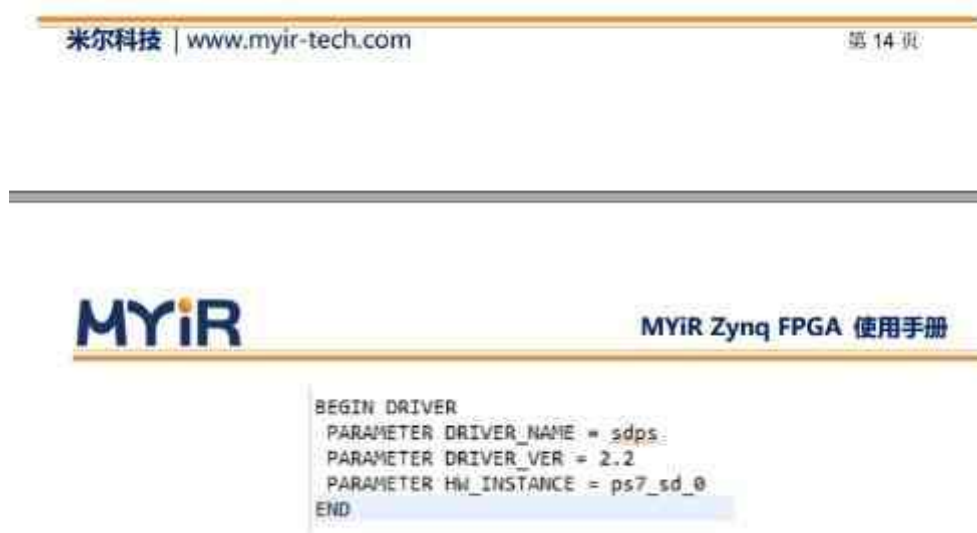
图 1-19

FSBL的SD驱动2.3版本有问题，降回2.2版本就能正常使用。这么草率的解决方法，太不喜欢了。如果说驱动真有问题，Debug一下不行吗？而且在vivado 2016.2，SD驱动版本已经到2.8了，不可能再倒回2.2版本。而且2.8版本的驱动依然无法用SD卡启动板子，我想如果驱动有Bug，也早该修复了才对。

发现 SD V2.3 驱动有问题，将其退为 2.2。在 HelloWorld_bsp 工程下打开 system.mss 文件，点击左下角的 source，修改 sd 驱动版本为 2.2，按键 ctrl+s 保存。

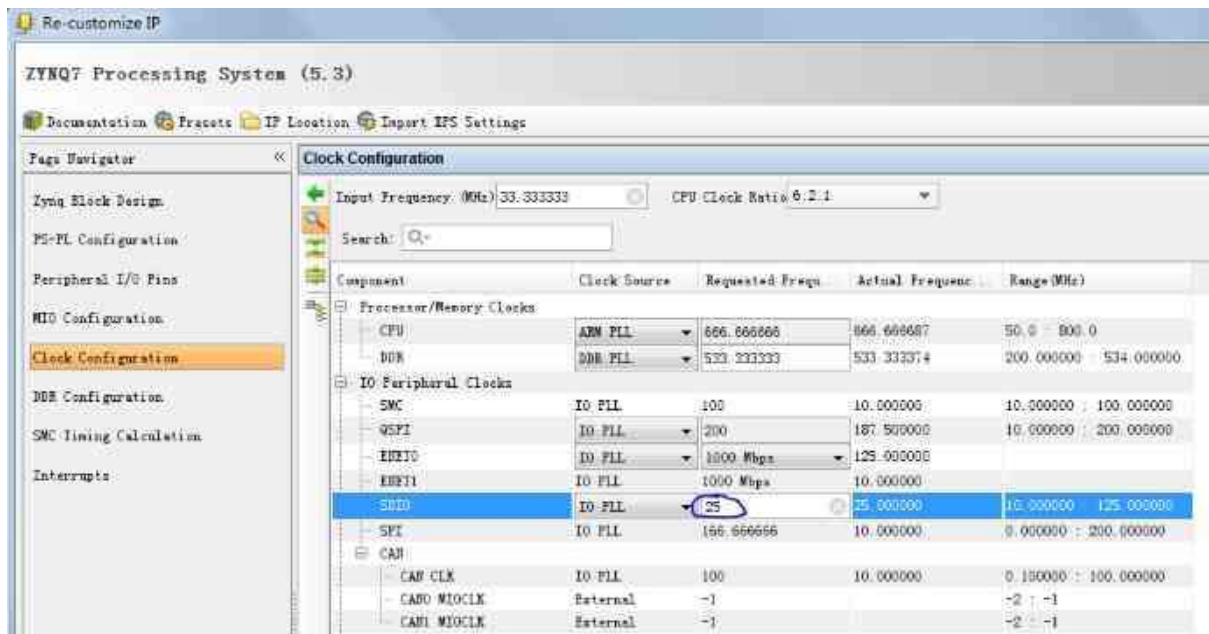
I revised SDIO Clock Configuration:50MHz == > 25MHz.

国外几个Xilinx论坛上都有这个问题，上面有一个提到修改驱动软件代码，我试了没什么作用，而且我觉得软件方面不会有问题，后来几个帖子提到了SD相关IO和时钟的硬件配置，他们SDIO时钟用的25M，而我看了一下我的板子：125M，频率好高啊，按照上面两张图配置SD IO和时钟，问题解决了。
