Wayne Wright, W5XD
Directional Coupler

Rev 1.0
10/15/2023

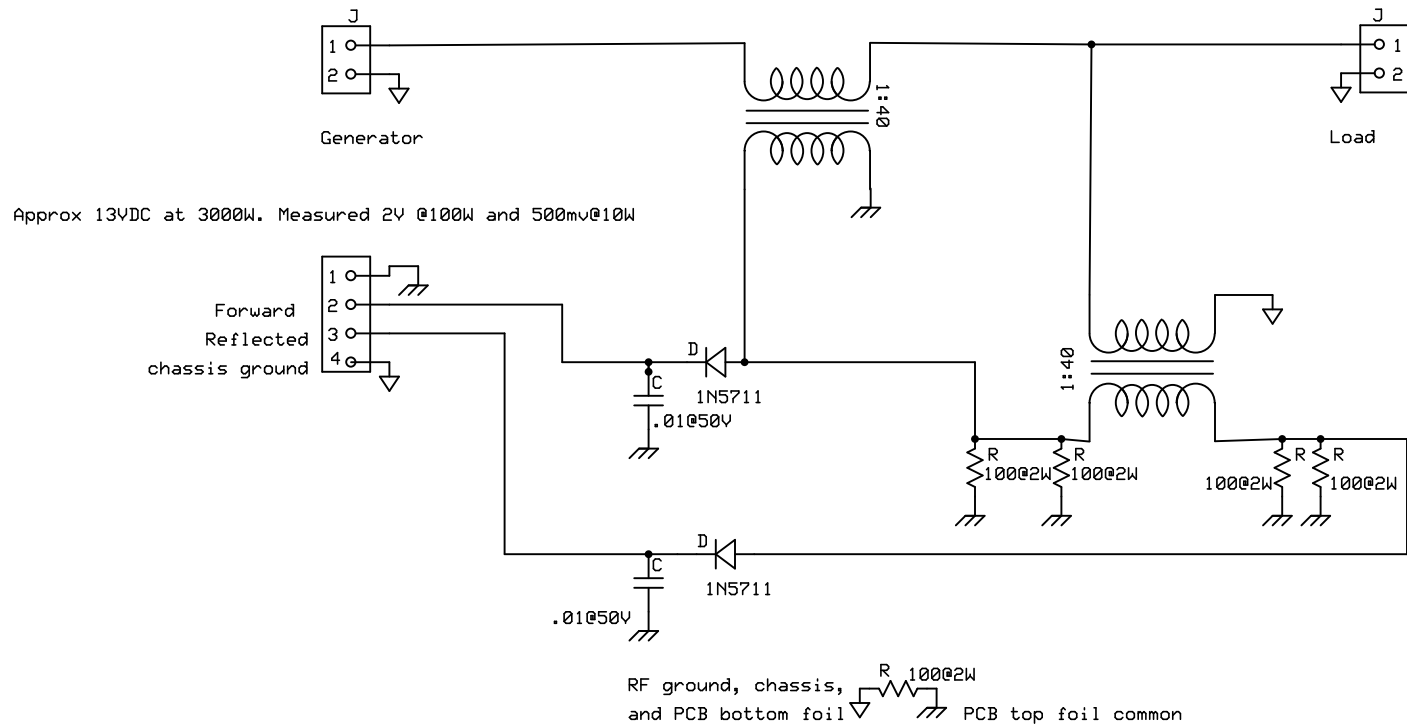
both transformers are 40 turns AWG 24 on 3 stacked T80-2 and threaded over a 1.5" piece of RG-213

The transformers must be identically wound.

Exception: REV01 of the PCB has the 40T holes placed such that Forward and Reflected are reversed at the output

Fix this either by:

- a) reverse one of the transformer's wires to their opposite holes on the PCB OR
- b) wind the second transformer in the opposite direction when you construct it.
