Wayne Wright, W5XD  
Directional Coupler

Rev 1.0  
10/15/2023

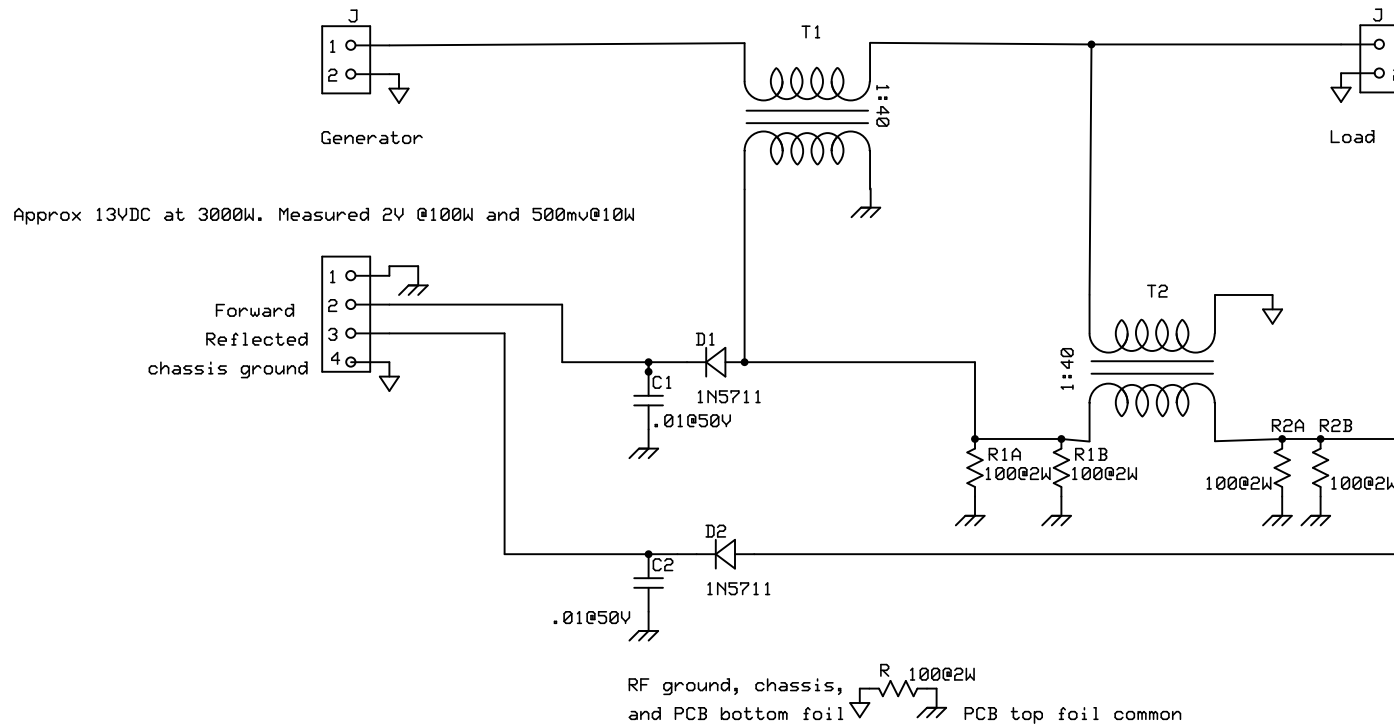
both transformers are 40 turns AWG 24 on 3 stacked T80-2 and threaded over a 1.5" piece of RG-213

The transformers must be identically wound.

Exception: REV01 of the PCB has the 40T holes placed such that Forward and Reflected are reversed at the output

Fix this either by:

- a) reverse one of the transformer's wires to their opposite holes on the PCB OR
- b) wind the second transformer in the opposite direction when you construct it.
