VESSELS AND PIPING

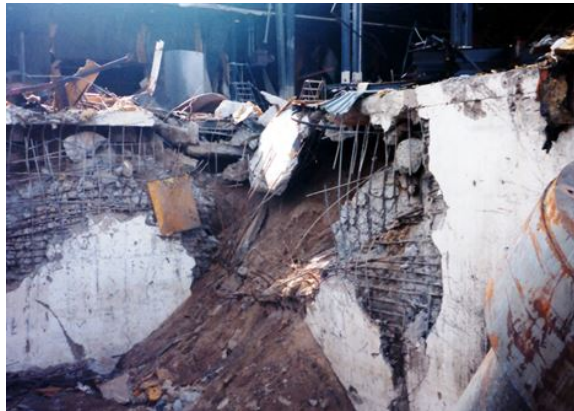
The photographs below show the potential collateral damage from the failure of a vessel at pressure (Figure 1) and under vacuum (Figure 2).

Fig. 1. Collateral damage following catastrophic failure of a hot isostatic press

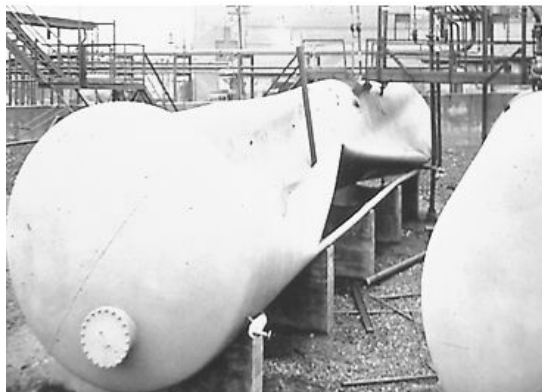
Fig. 2. Imploded tank caused by inadequate design

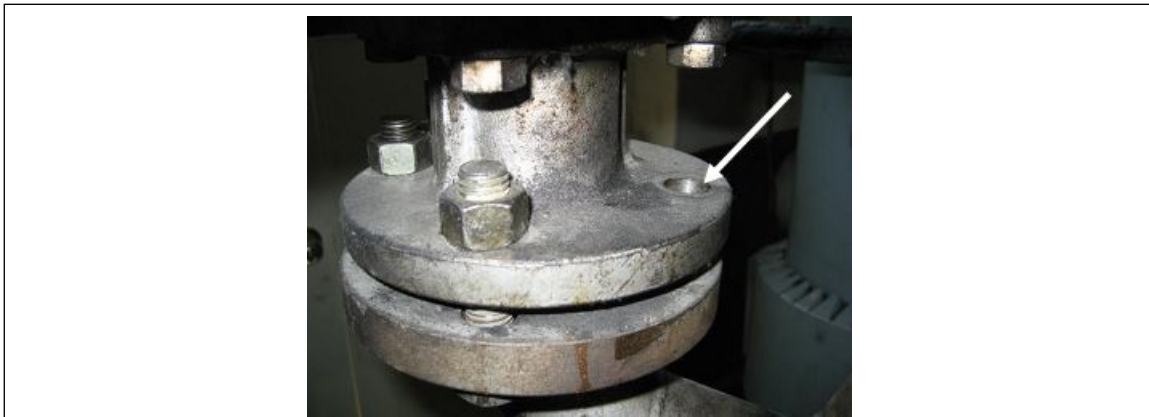
Common deficiencies in bolted flange joint assemblies include misalignment of the joint, not tightening the bolts in the proper sequence to evenly distribute the clamping force, using incorrect torque specifications leading to increased stress in the bolts or inadequate pressure retaining capability, and not providing full thread engagement of the nut-bolt assembly, otherwise known as short bolting. A photograph of a bolted flange with missing bolts is provided below in Figure 3.

Fig. 3. Bolted connection on pressure vessel pressure boundary showing missing bolt

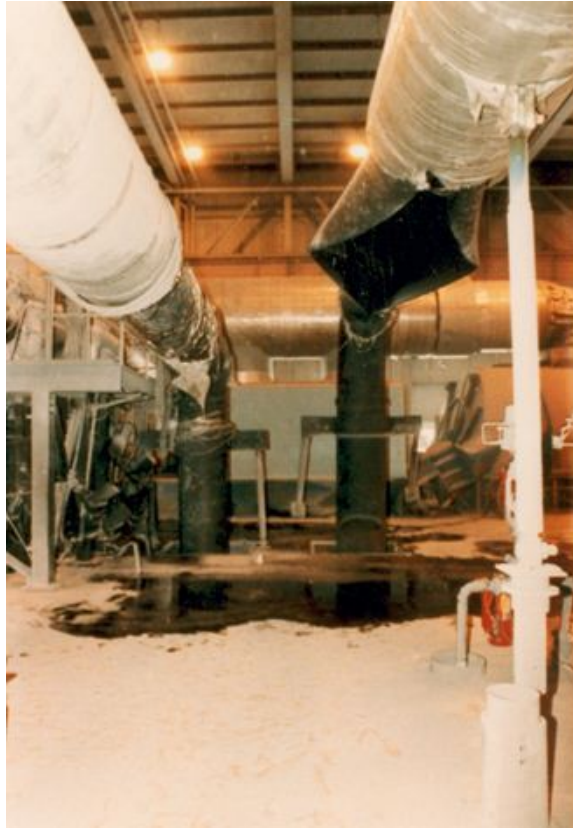
Fig. 5. Utility reheat steam line failure along a pipe spool seam weld joint; timely inspection could have provided opportunity for corrective action

Effective inspection of in-service systems, with appropriate repair or replacement of damaged components, can mitigate critical system failures. This is a lesson some electric generating companies learned the hard way, after suffering catastrophic failures of seam-welded hot reheat piping in 1985 and 1986. A photograph of a seam-welded pipe after failure is provided in Figure 5. Subsequent investigations revealed that in some plants, seam-welded pipe had been substituted for the specified seamless pipe, and experience demonstrated seam-welded pipe was likely to develop cracking conditions associated with the seam-weld. Inspection programs for seam-welded pipe were initiated and reliable examination techniques have been developed. Many electric generating companies have replaced extensive seam-welded piping systems to avoid disastrous failures due to creep. Additionally, some design codes (ASME B31.1, B31.3) have introduced factors to account for the reduction in long-term creep strength as a result of having a seam weld.

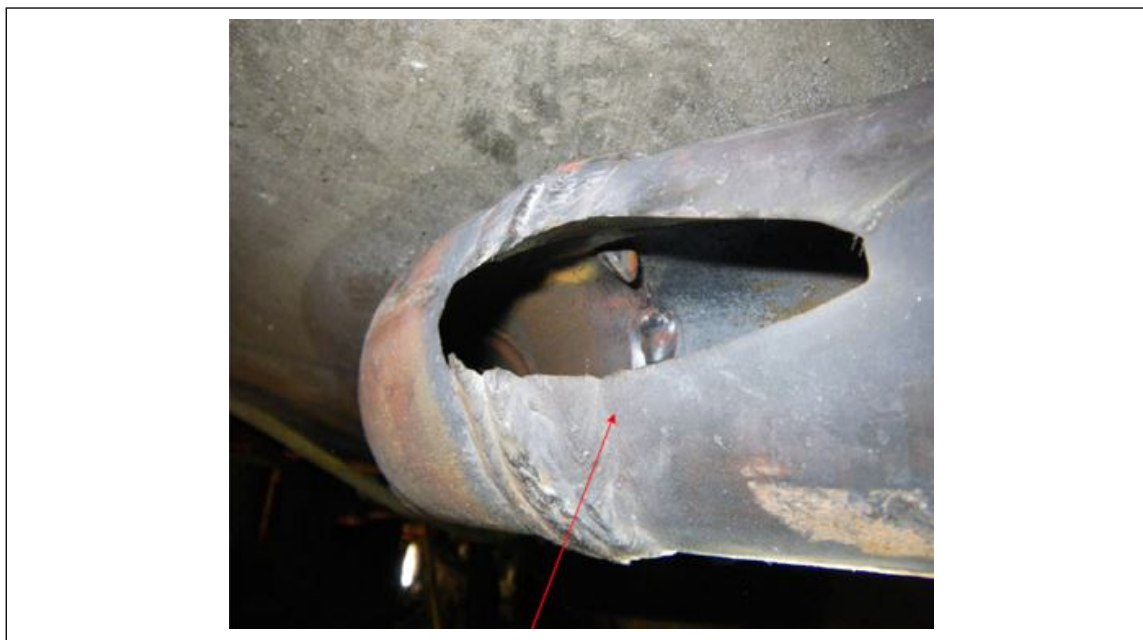
Erosion is a mechanical process. Typically, solid particles have an abrasive effect when they impact the metal surface. This abrasiveness can break the protective film on the material or scrape away material. The simultaneous combination of both the chemical corrosion process and the mechanical erosion process is known as erosion-corrosion and is often called flow-accelerated corrosion (FAC) in steels. A photograph showing the condition of a pipe after failure from solid particle erosion is provided as Figure 6.

Fig. 6. Solid particle erosion at a change in direction led to the failure of this pipe at a power generating station

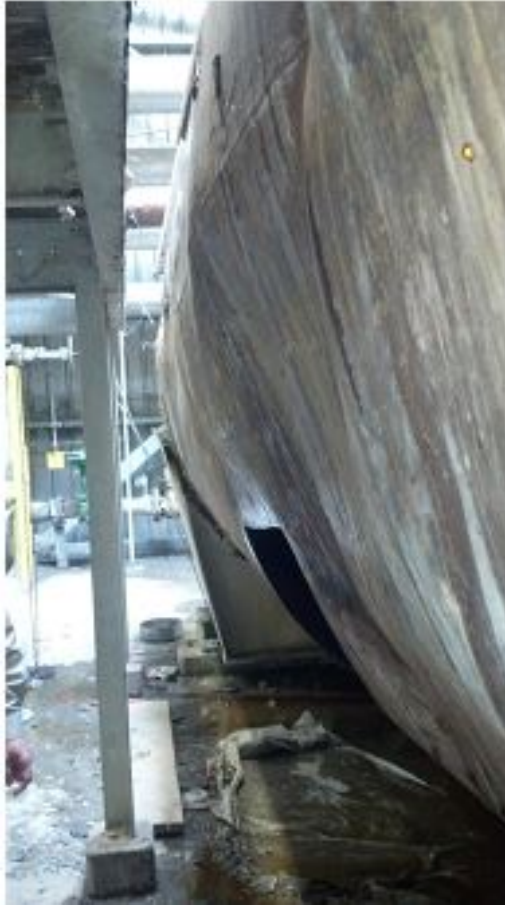
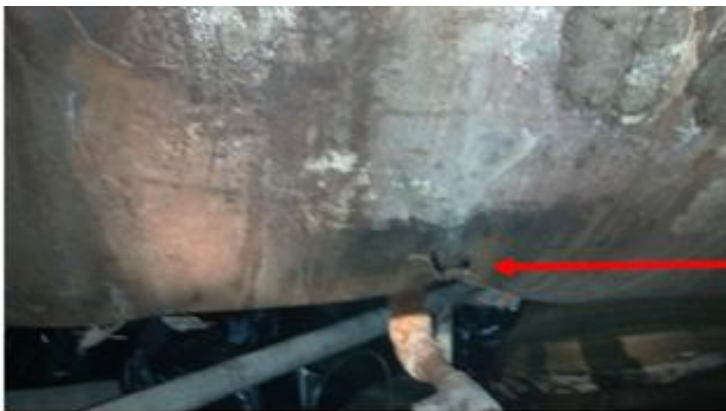
While operators worked to lower the deaerator storage tank level, a vacuum was produced. This vacuum imploded the lower half of the deaerator storage tank, which disabled the tank. The deaerator storage tank appeared distorted on its lower half and showed signs of vacuum collapse. There were six holes of various

sizes appearing to fish mouth inwardly. All adjacent piping and instrumentation were damaged. Photographs of the damage to the deaerator are provided in Figures 7 through 9.

Fig. 7. Photograph of failure location at center of tank

**Hole at Bottom
Center of Tank**

Fig. 8. Photograph of failure location at center of tank

Improper operation of the deaerator unit (the bypass of the high-level dump valve and manual control of the water feed rate and water level allowing the deaerator storage tank water level to fill into the No. 1 Deaerator Head) led to the scenario that produced the vacuum on the vessel. The adequacy of the vacuum protection on the equipment will be considered.

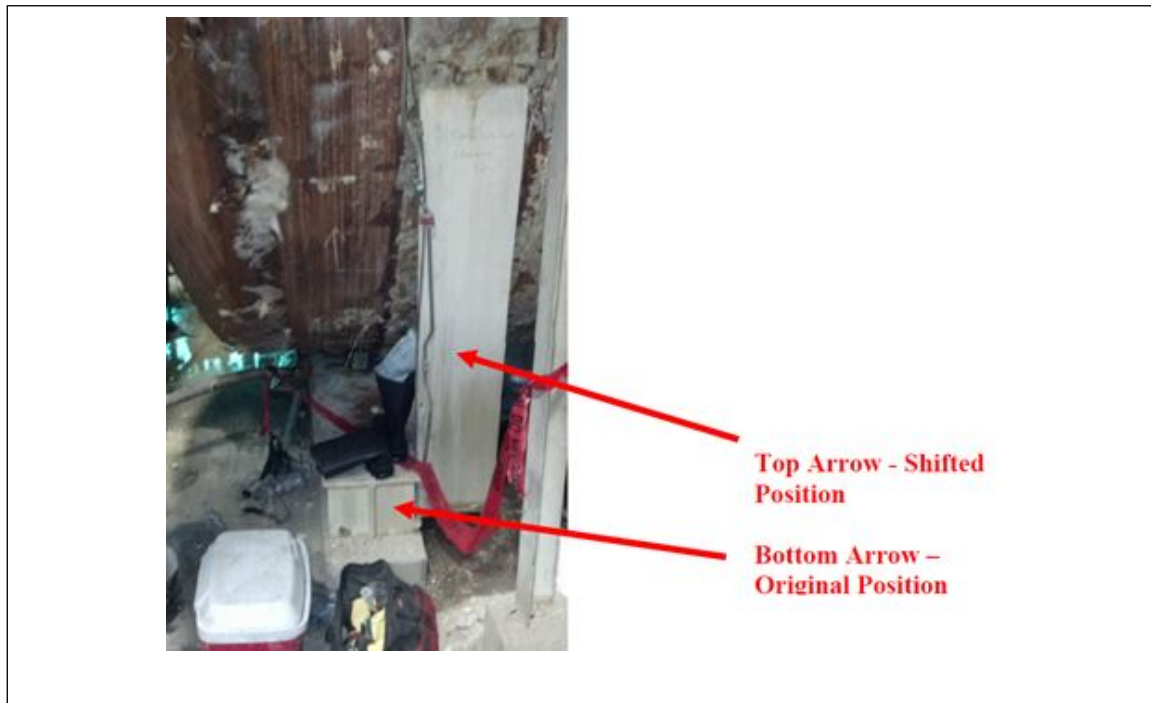
Fig. 9. Photograph of shifted support

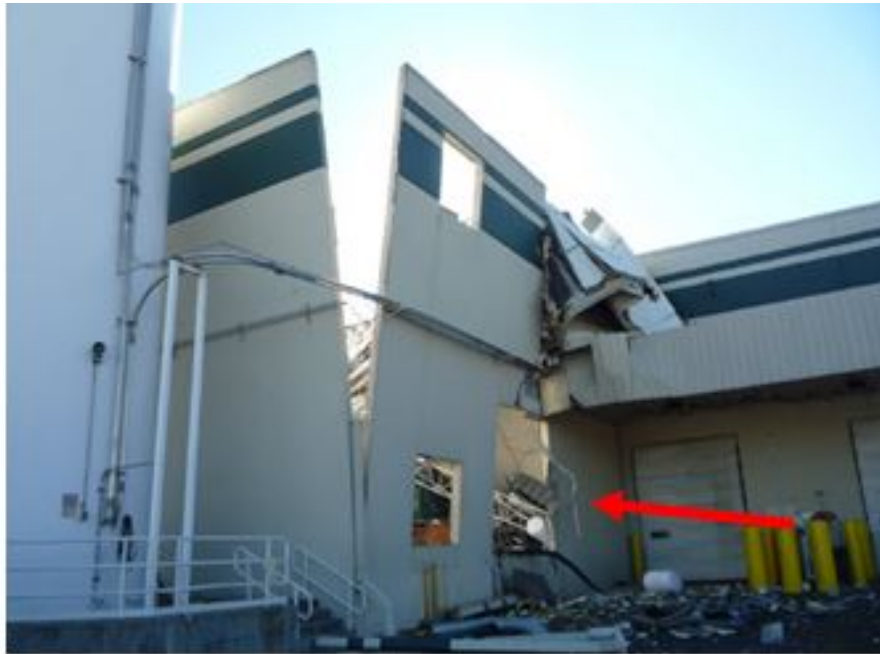
The deaerator had not been inspected and the weldments suffered from cracking and wall loss that routine inspection, testing, and maintenance would have been able to identify. Additionally, it was revealed that the original welding of the vessel did not achieve complete penetration of the weld joints. It was unsure if there was complete joint penetration in the location of the failure.

Fig. 10. The boiler building showing the rear walls; the red arrow shows the area where the deaerator exited the building

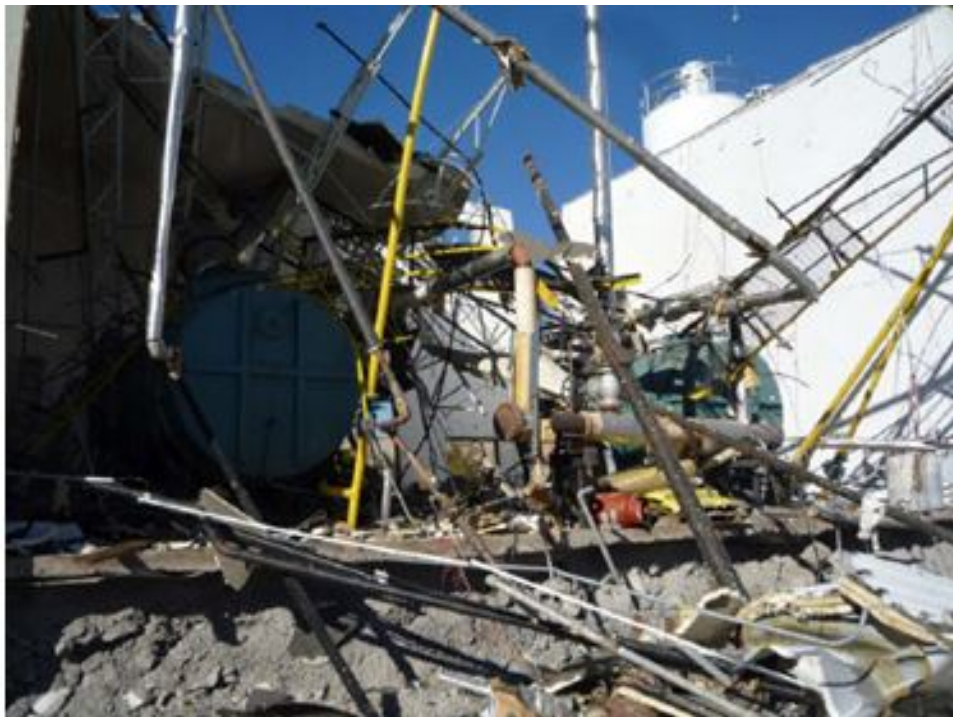
Fig. 11. The boiler room, showing the two front walls completely blown to the ground

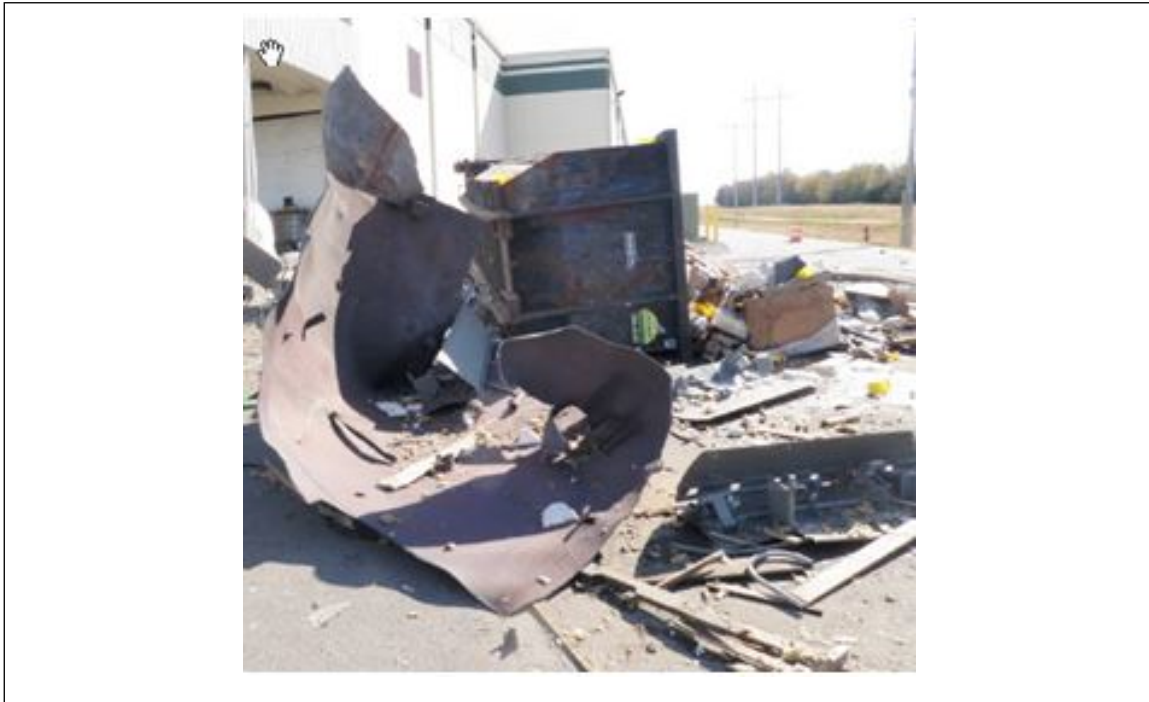
Fig. 12. The deaerator after colliding with the dumpster; part of one head is attached to the shell (the other head went out the front of the boiler room)

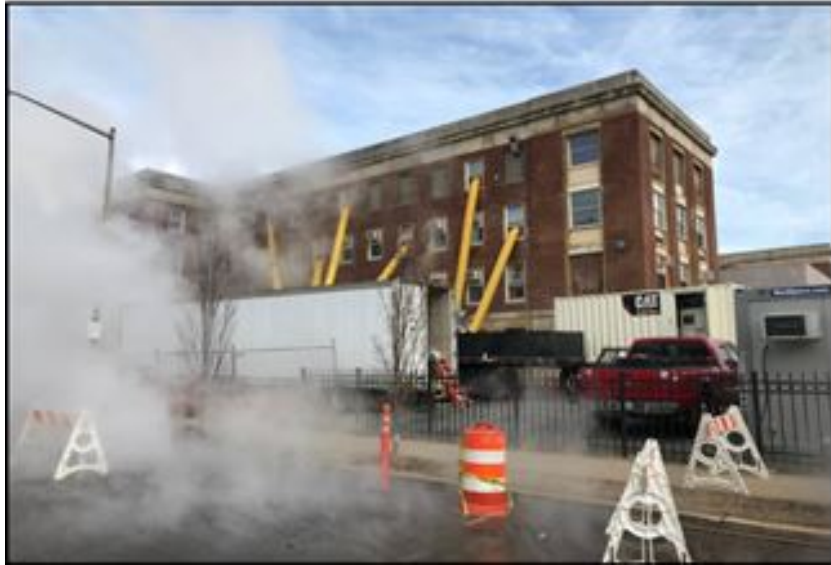
Insufficient maintenance and haphazard repairs of an already deteriorated steam and condensate system led to the severe failures. The poor quality of the steam only added to the ongoing corrosion and subsequent leaks within the piping installed in the underground tunnels. Several buildings sustained steam releases from corroded steam piping into the buildings from openings from the tunnels, resulting in extensive damage to interior finishes and contents. Some buildings lost adequate heat resulting in frozen sprinkler or domestic water piping and subsequent leaks. Photographs of the dehumidification process and interior damage to the buildings are provided in Figs. 13 and 14.

Fig. 13 Dehumidification efforts

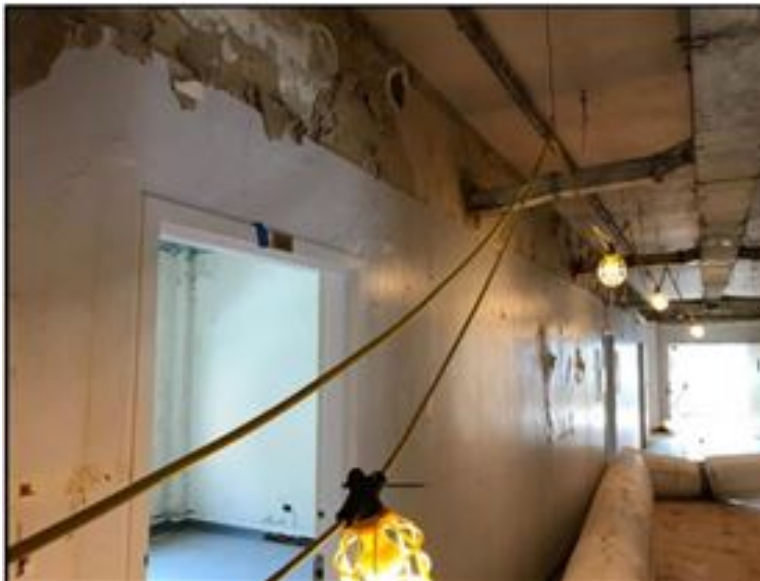
Fig. 14. Interior building damage

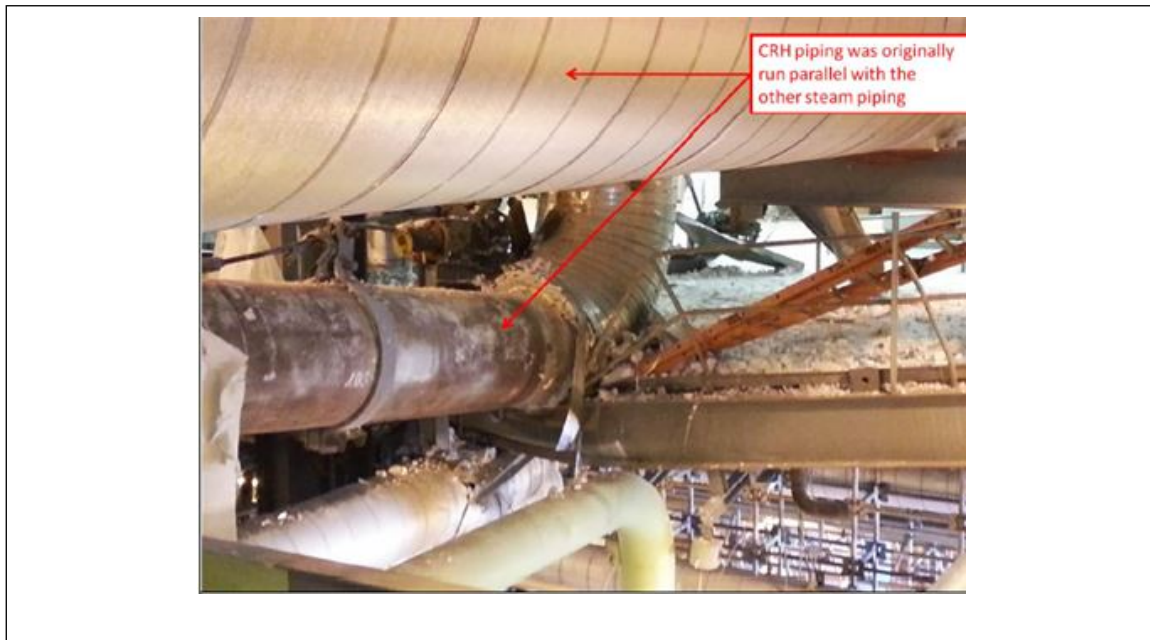
The addition of the check valve in the CRH line allowed water that had leaked past the attemperator spray valves to collect on top of the valve. When the RSV was opened, steam was introduced into the system causing a "hammer" event.

Fig. 15. Unsupported CRH pipe

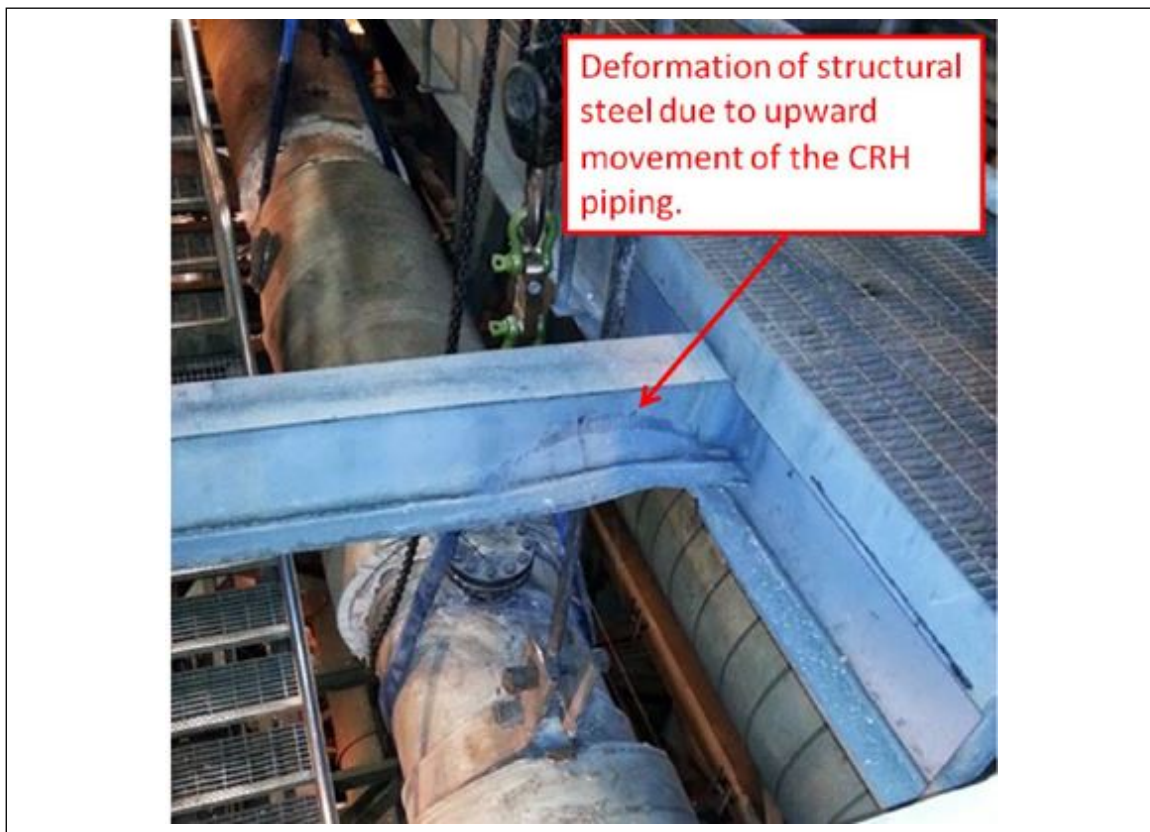
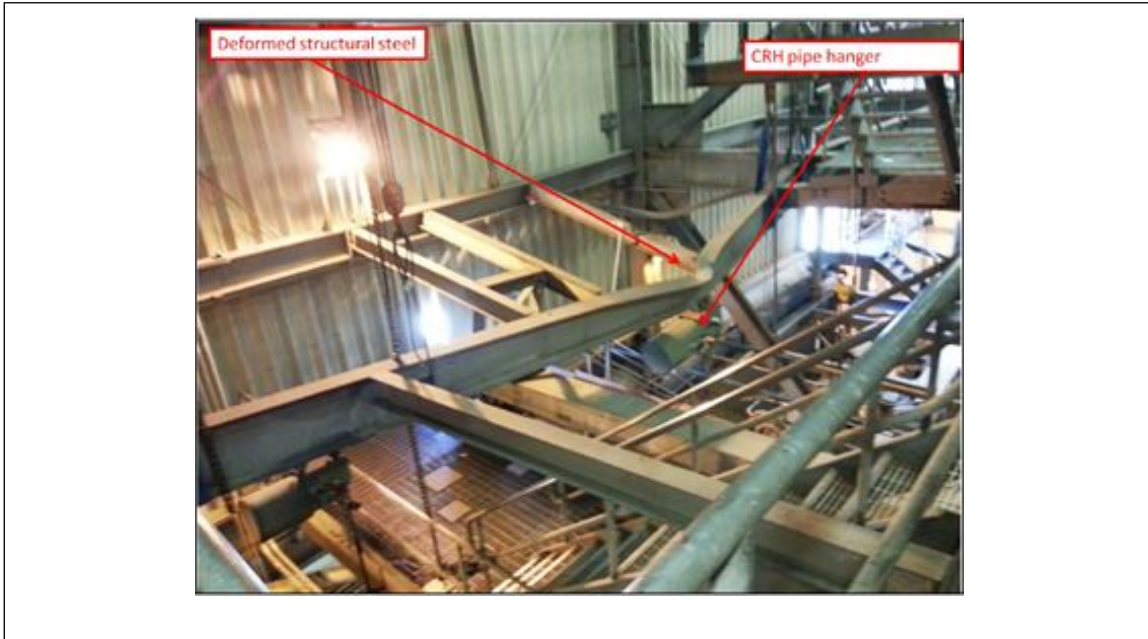
Approximately 280 ft (85 m) of CRH piping moved in this incident. Based upon the deformation of the structural steel, the vertical section of the CRH pipe moved significantly vertically, resulting in all of the pipe hangers and supports for the CRH piping being bent or broken. No piping ruptured due to overpressure.

Fig. 16. Damage to the structural steel due to pipe movement

Fig. 17. Damage to the structural steel due to pipe movement

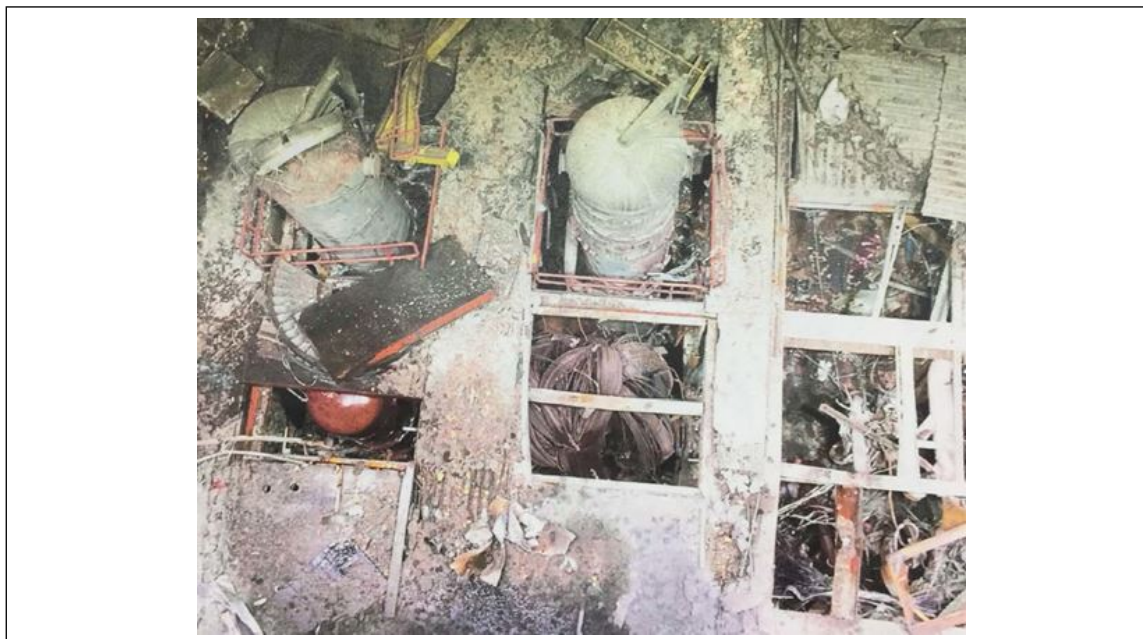
The water/steam flash damaged the turbine deck and mezzanine as well as major structural beams, adjacent feedwater heaters, various metal wall panels (~60,000 sq. ft [5,574 m²]), brick walls (~20,000 sq. ft [1,858

m²)), doors, motor control centers, piping, switchgear, etc. Temporary bracing was required to allow personnel in for clean up/repairs. A photograph of the damage is provided in Fig. 18.

Fig. 18. Damage due to heat exchanger failure

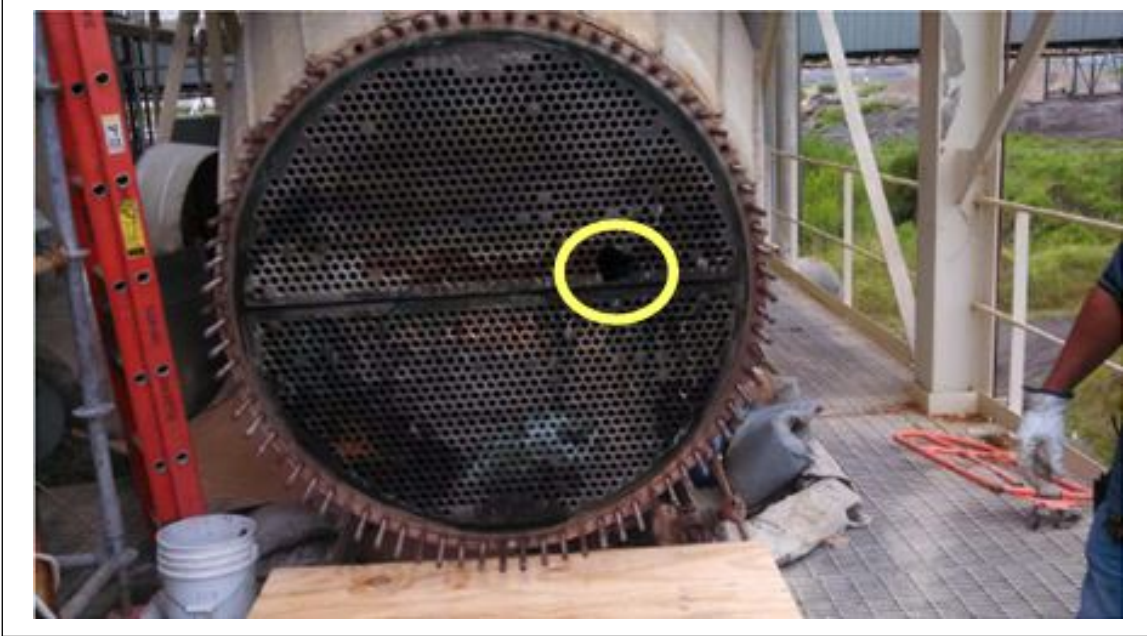
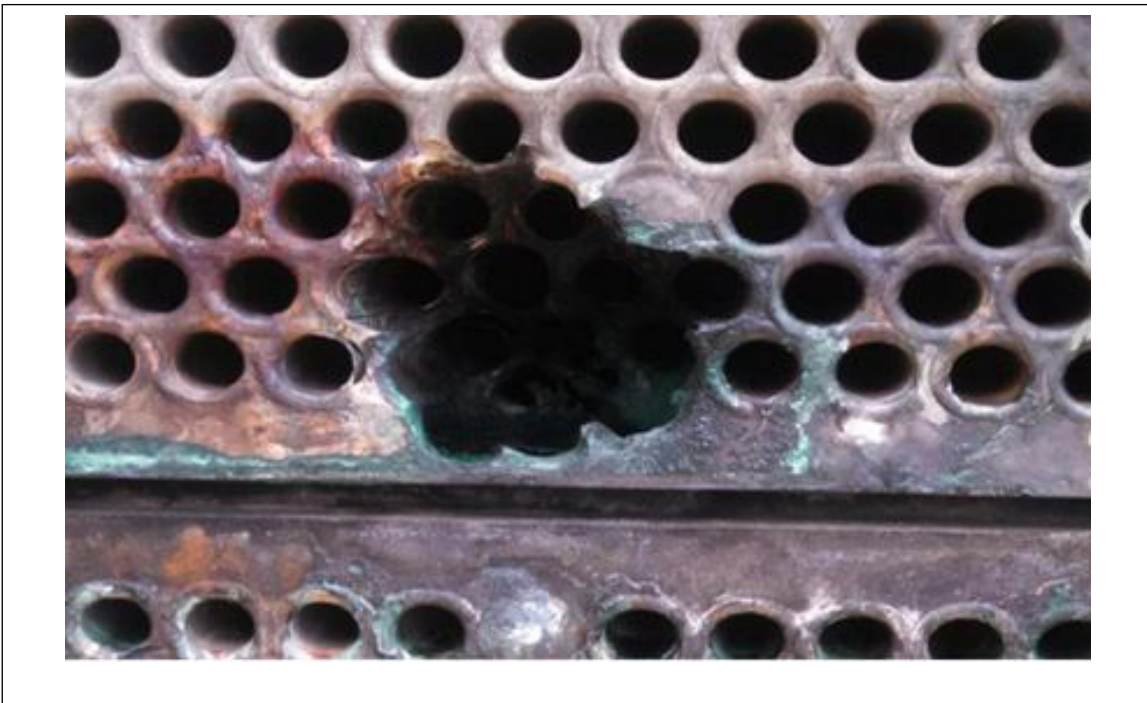
The damage was a result in failure of a seal weld of a previously plugged tube on the heat exchanger. These were not part of the yearly heat exchanger testing being performed. Photographs of the damage are provided below in Fig 19 and 20.

Fig. 19. Tube bundle; damage is circled in yellow

Fig. 20. Closeup of damage to the tube bundle

Replacement of the tube bundle was necessary since the damage was not repairable. Cleaning and inspection of the plant vessels was performed. Damage was revealed on the acid circulation pump and heat recovery system tower boot. Acid had also entered the gas side of the plant and damaged brick work, mist eliminators, ducting, and the heat recovery system tower distribution equipment. The plant was able to resume operation at a reduced rate (88% of normal). A total of 23 days of acid and steam production were lost.

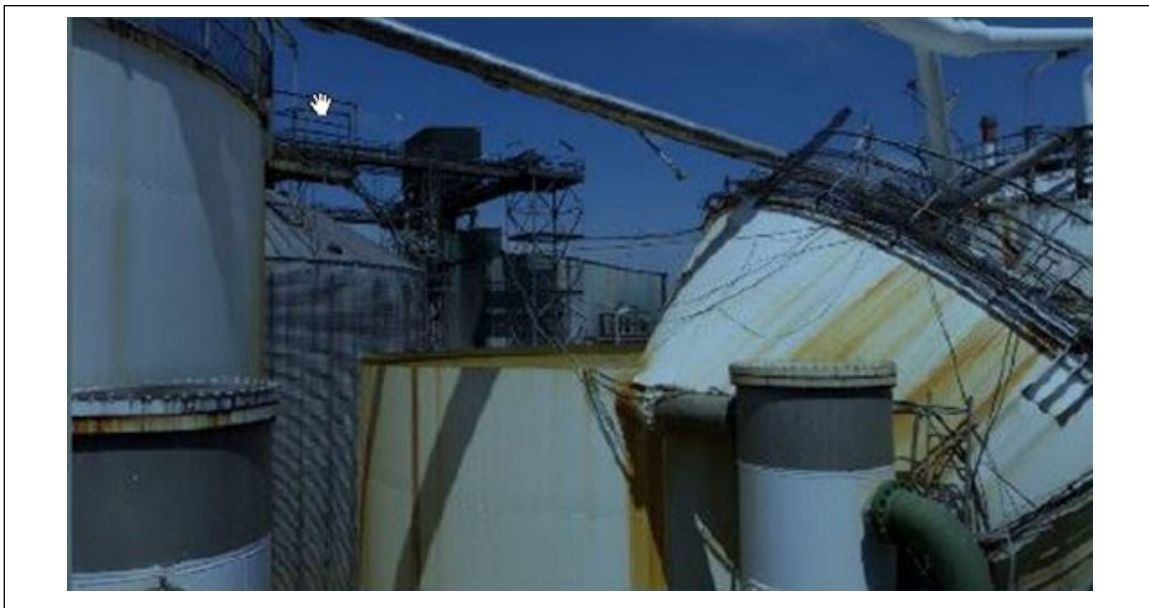
The cause of the failure was likely a combination of significant corrosion that was not detected and increased pressure from the fermentation process.

Fig. 22. Upper portion of fermenter after failure

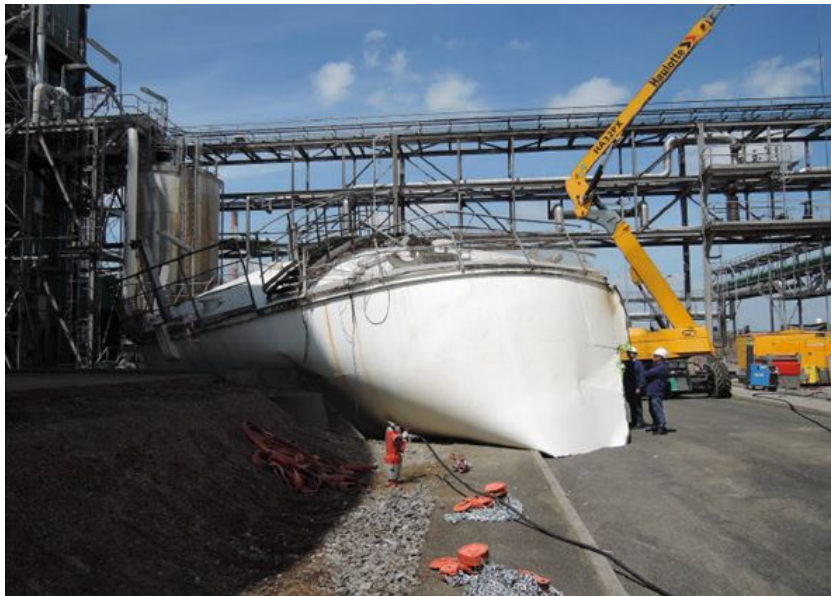
Fig. 23. The roof of the fermenter after failure

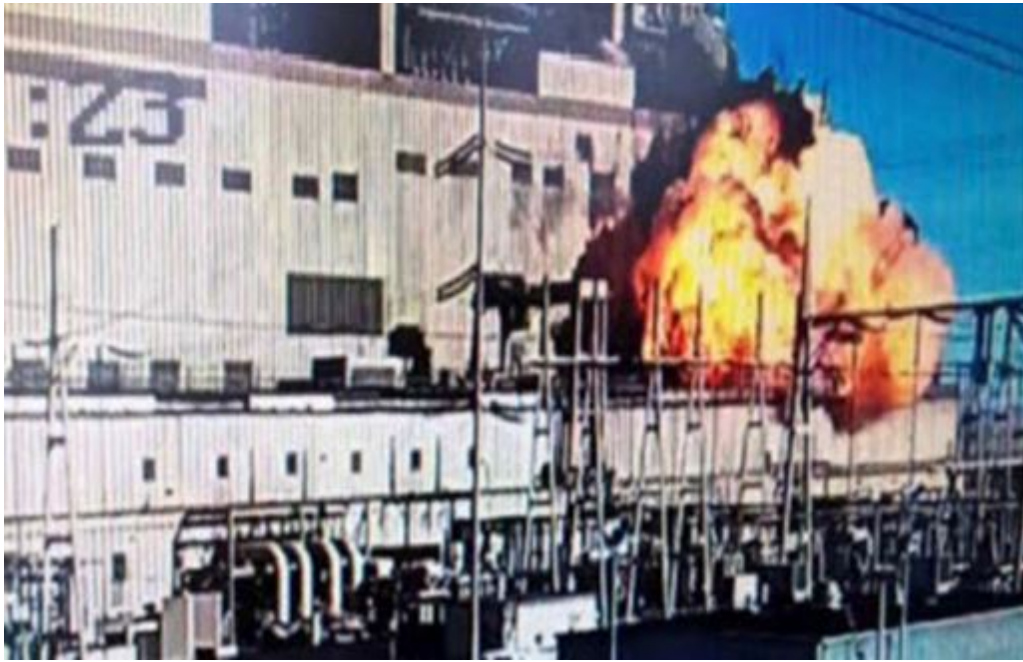
Immediately following the collapse, a coal dust deflagration occurred and blew off the metal wall panels and roof vents of the building. A fire did not follow. The building panels that were blown off hit the Unit 1 start up transformer deluge sprinkler piping and broke the piping fittings. Photographs of the deflagration and subsequent damage are provided in Figs. 24-26.

Fig. 24. Deflagration fireball erupting from the silo enclosure collapsed feeder deck

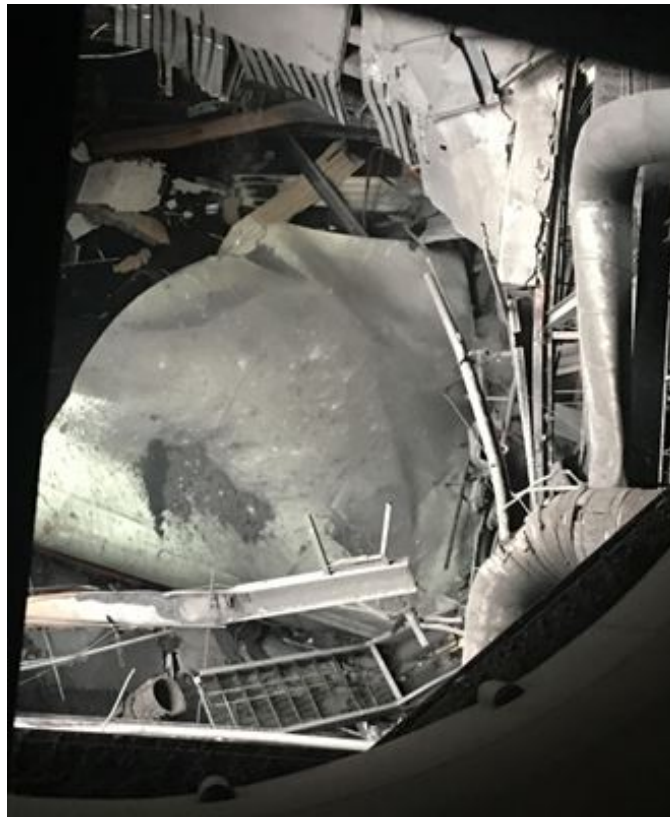
Fig. 25. Collapsed feeder deck

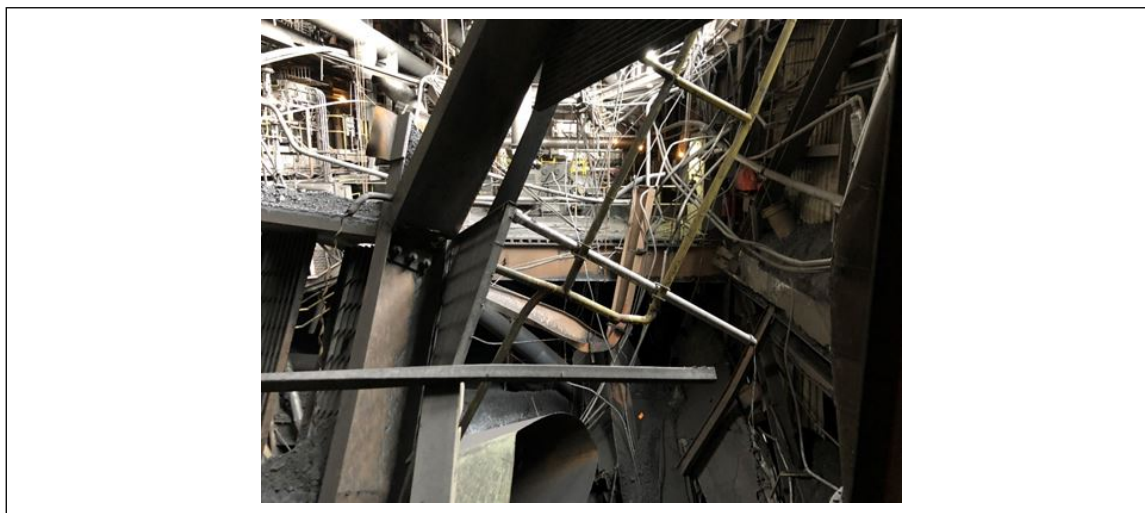
Unit No 4 was able to stay in operation. Significant wall thinning, and weld cracking were revealed on the failed silo.

Fig. 26. Structural damage as a result of the silo failure

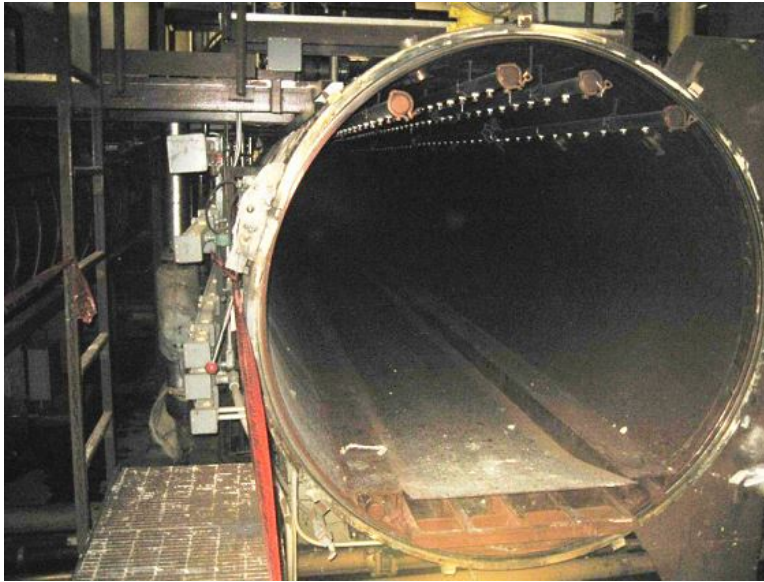
The root of the failure was the quick-actuating closure not being in a condition which was able to withstand design pressure. Regular inspection of the quick-actuating closure was not included in the autoclave maintenance program. This allowed the condition of the quick-actuating closure to deteriorate over time unknown to the operators. Photographs of the damage to the autoclave are provided as Figs. 27 and 28.

Fig. 27. Autoclave front seal area with remains of locking rings

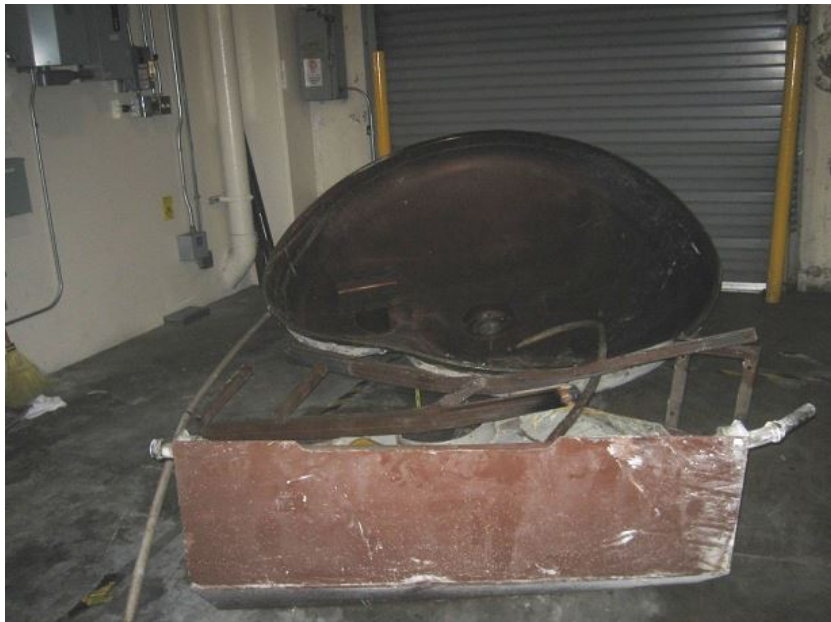
Fig. 28. Autoclave door that failed and separated from the autoclave

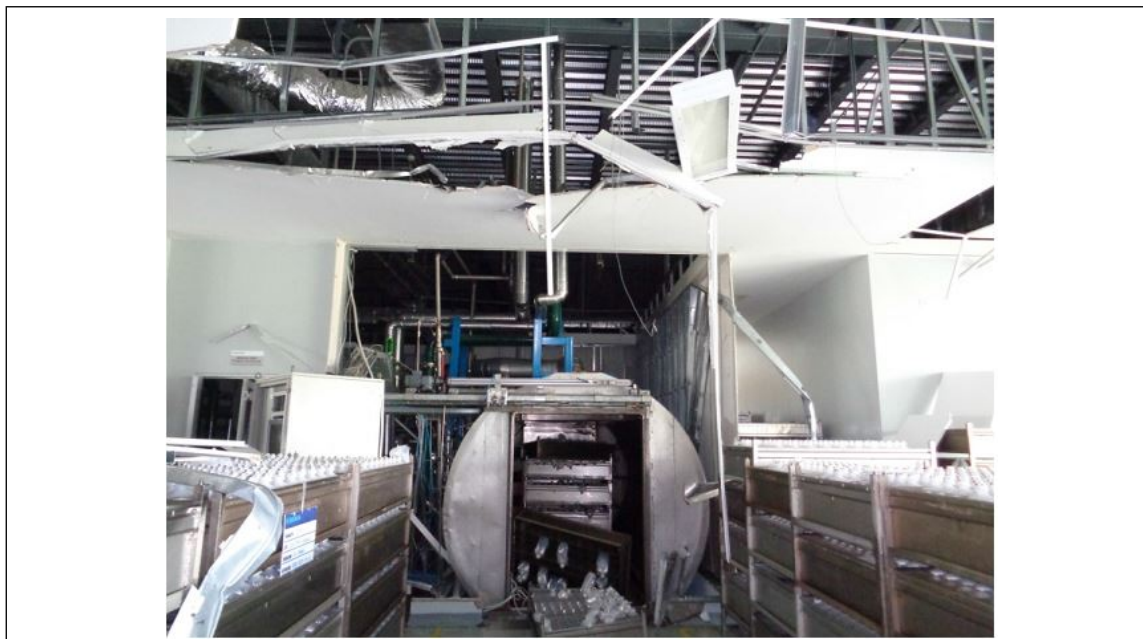
The autoclave operates at 44 psig (0.33 MPa) and 292°F (144°C). During the heating portion of the cycle, approximately 57 minutes after the autoclave started operating, a failure occurred that caused leakage of the contained water. Leakage leading to a rapid cascade of events led to the complete failure of the autoclave door. The failure of the door led to a steam explosion (rapid vaporization of the hot water in the vessel). The steam and shockwave liberated from the explosion sent the 1,320 lb. (600 kg) door approximately 50 ft (15.2 m) across the room and landed in an office area. The autoclave was displaced 6 in. (154 mm) back from its original position and rotated slightly counterclockwise. The welds and bolts were torn apart at the base of the autoclave. The door was projected horizontally and caused damage to in-process containers to be sterilized, gypsum walls, ceiling tiles and the epoxy floor. Fortunately, it did not damage other critical equipment. The autoclave required full replacement. The facility was completely shut down for six days. Partial operations started four weeks later (50% of the Parenteral Fluids line), and it took 12 months to restore the facility to full production. Photographs of the damage to the Autoclave are provided as Figs. 29 and 30.

The autoclave manufacturer had previously reported an issue with a position limit switch used to serve as an interlock to prevent pressurizing of the vessel unless the closing mechanism was fully engaged. This was found at another installation (not specified), where the position switch did not properly detect that the closing mechanism was not fully engaged. The manufacturer sent two bulletins regarding this issue and recommended to install a second position switch to ensure the autoclave doors closed completely, and the sides engaged adequately in the side rail. These had not been installed prior to the explosion and may have prevented this loss from happening. Secondly, NDE should have been done on the horizontal lower and upper edges of the sliding door of the autoclave to identify any cracks.

Fig. 29. Autoclave after the steam explosion

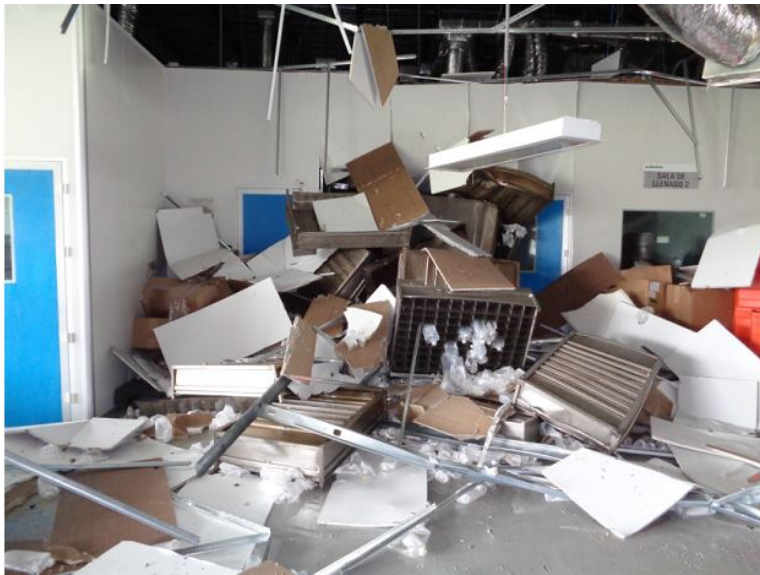
Fig. 30. Autoclave door and internal trays that were propelled 50 ft (15.2 m) across the room
