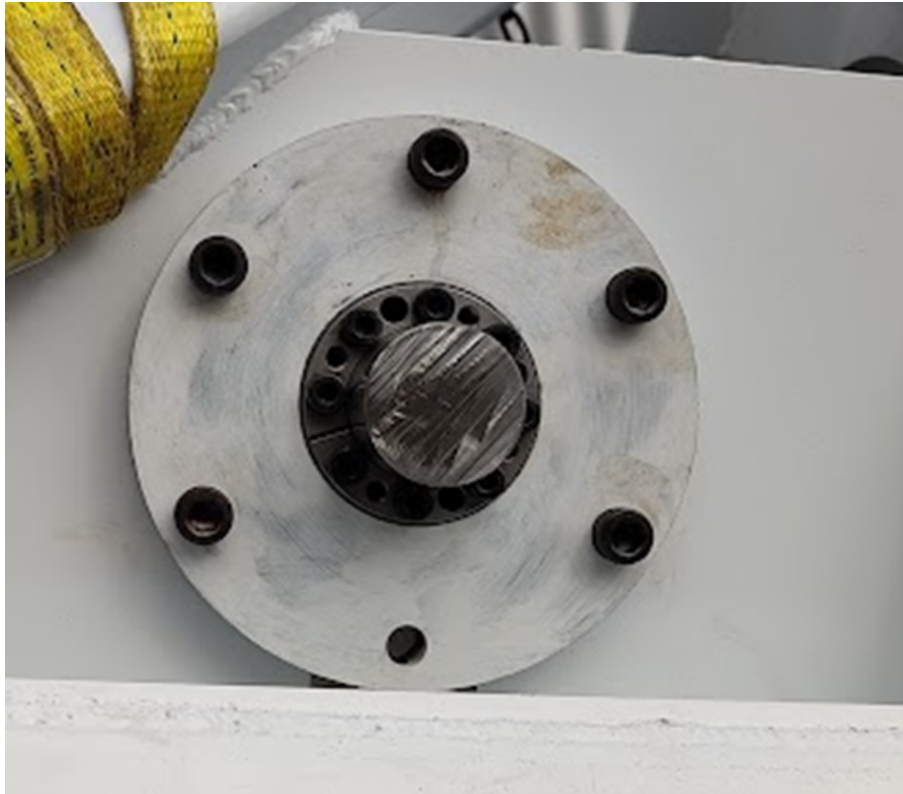
To do: Know how these clamps work - Fenner drives b121050

Unsure if side to counterbalance matters but fenner drive to metal flange does. They are currently taped together with the cover.
