TAVI Case Complicated with Valve Infold and Dislodgement

Oleg Polonetsky, MD

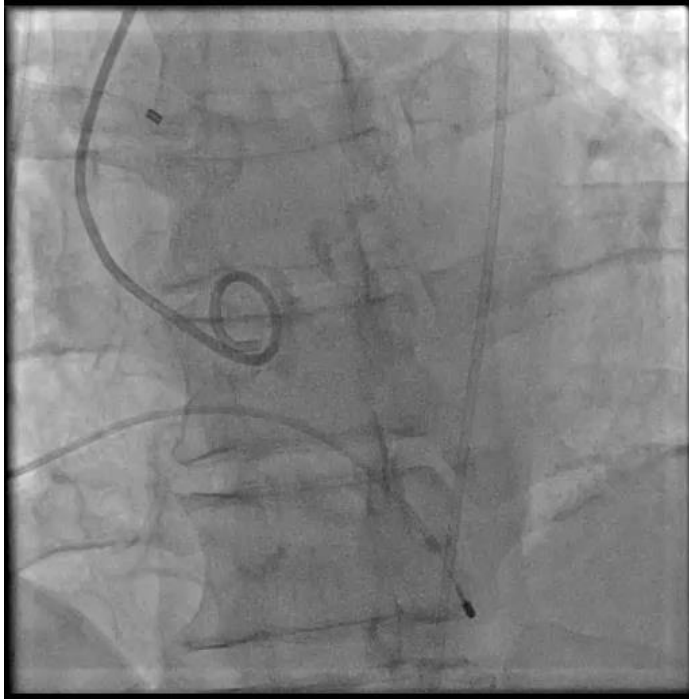
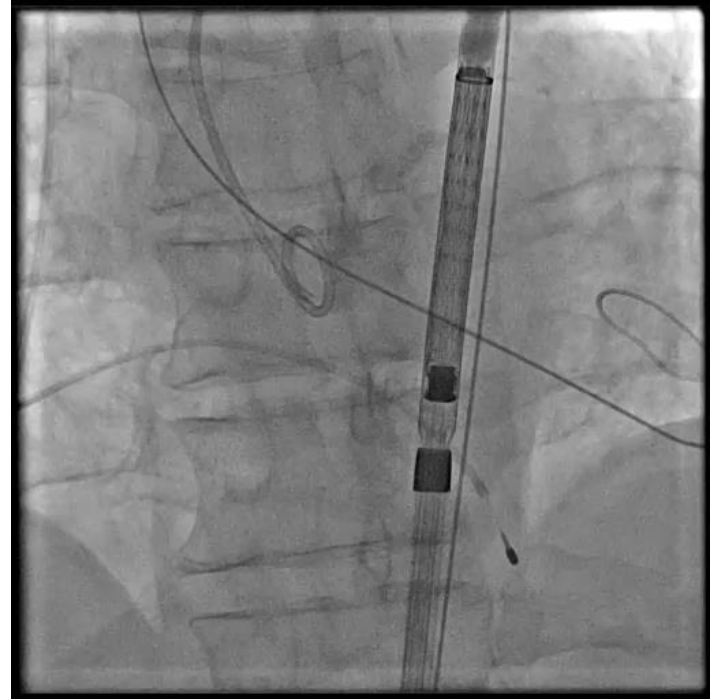
1st mistake: very formal inspection of the loaded valve

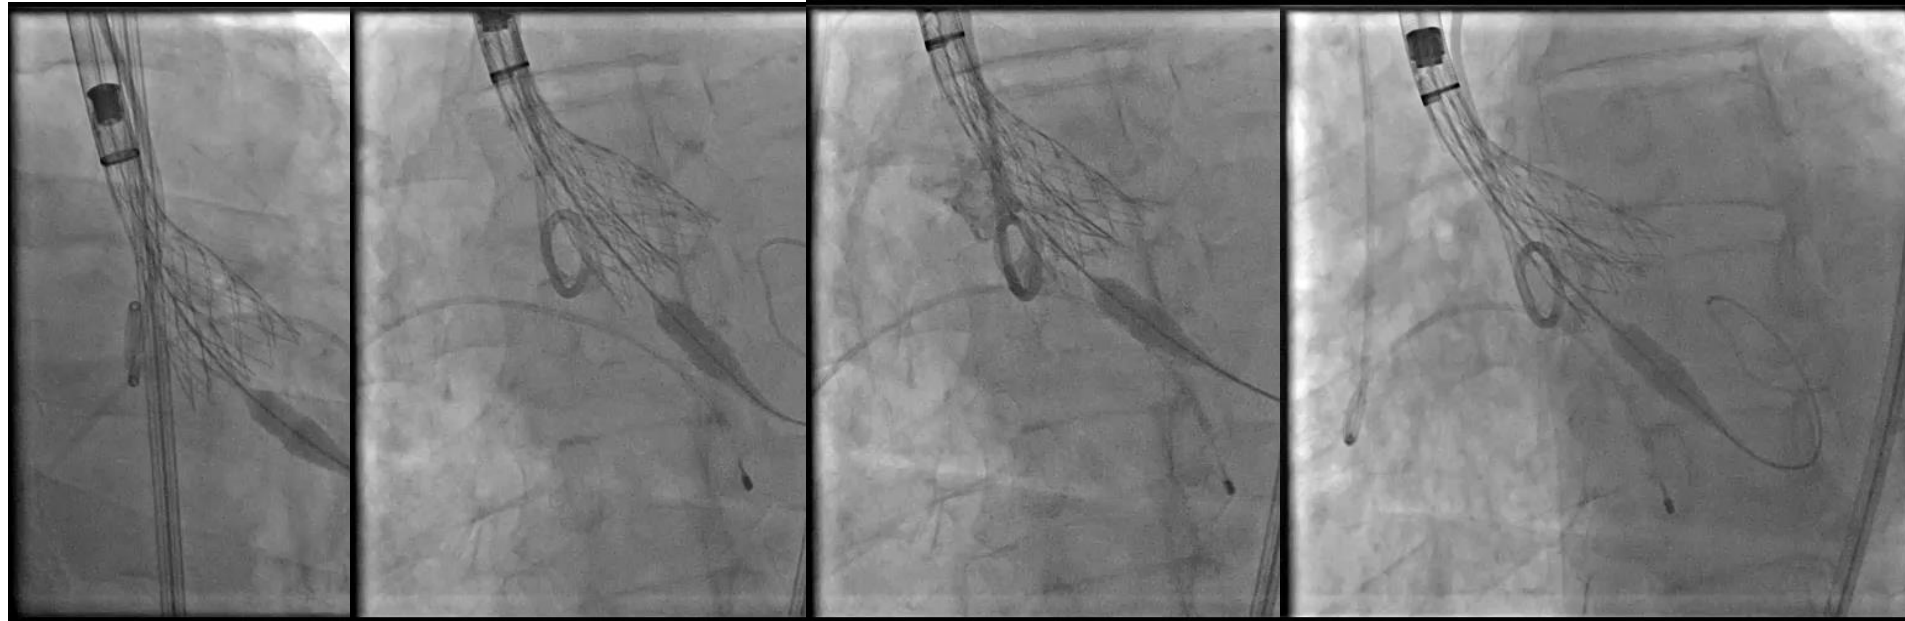
2nd mistake: concentration on the height and ignoring of other important signs and parameters

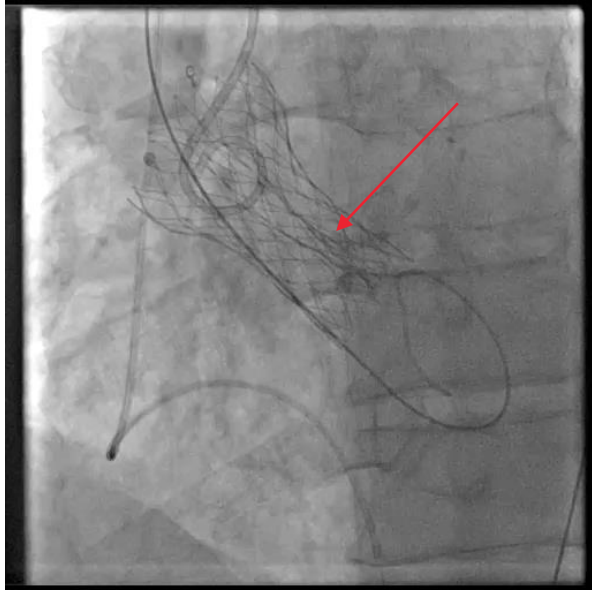
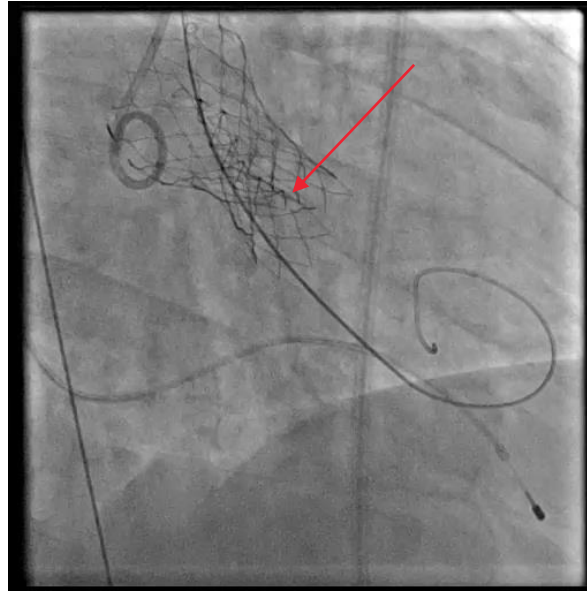
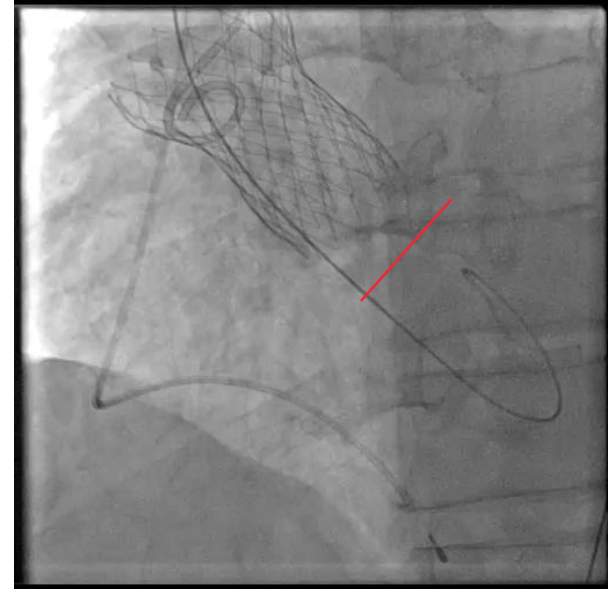
3rd mistake: infold wasn't recognized and TAV was released

4th mistake (?): attempt to fix infold with the postdilatation, which led to the popping out of the entire TAV to the aorta

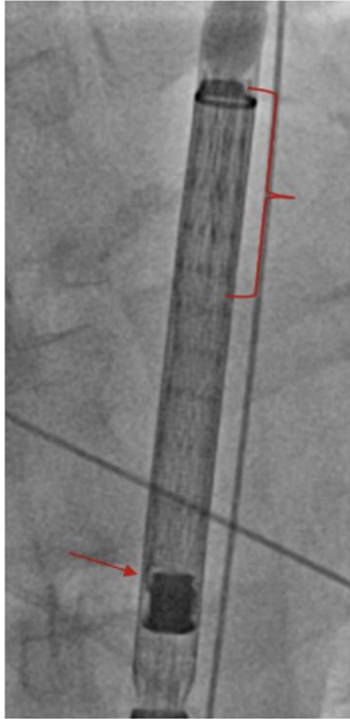
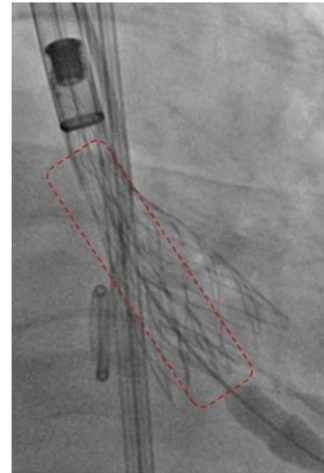
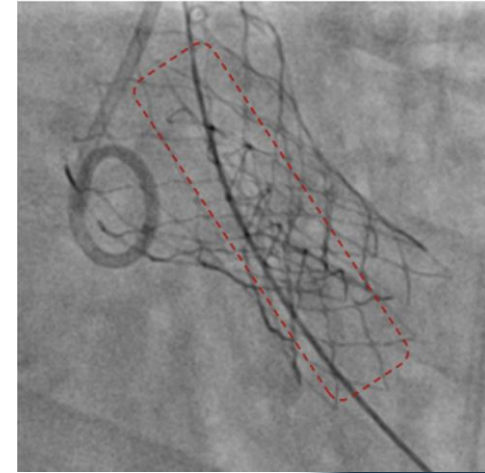
Signs of the misloaded TAV:

- Inflow crown overlap seeing as non-uniform shadow starting at inflow edge and not ended before the fourth node;
- Outflow crown misalignment and/or not parallel to the paddle attachment
- Curved or bent capsule
