Group-8

Bug-1 Report

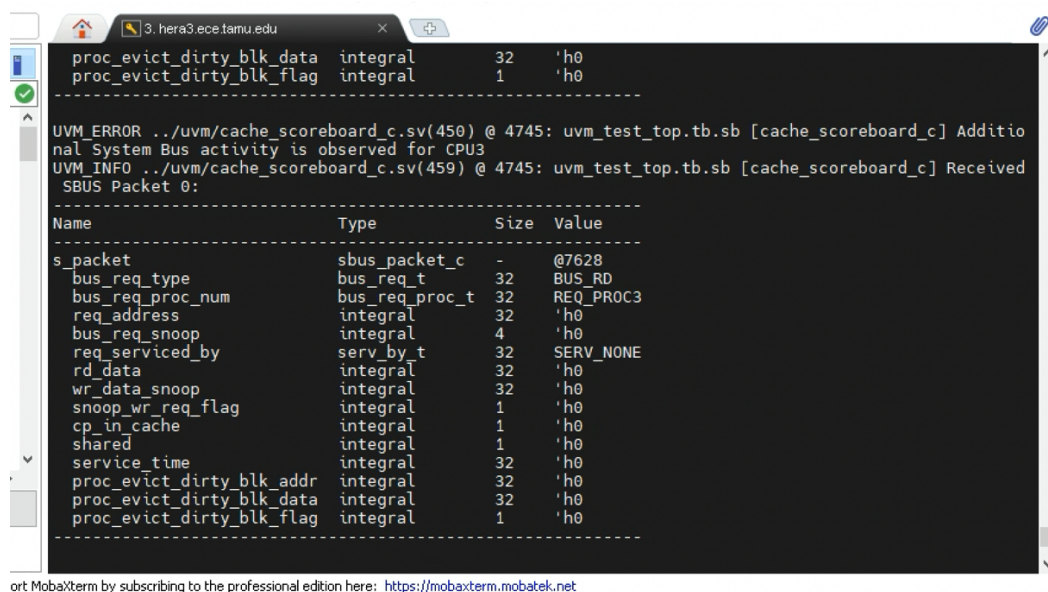
Error message:

```
proc_evict_dirty_blk_data integral 32 'h0
proc_evict_dirty_blk_flag integral 1 'h0
-----
UVM_ERROR ../uvm/cache_scoreboard_c.sv(459) @ 4745: uvm_test_top.tb.sb [cache_scoreboard_c] Additional System Bus activity is observed for CPU3
UVM_INFO ../uvm/cache_scoreboard_c.sv(459) @ 4745: uvm_test_top.tb.sb [cache_scoreboard_c] Received SBUS Packet 0:
-----
Name                               Type             Size  Value
-----
s_packet                           sbus_packet_c    -      @7628
bus_req_type                       bus_req_t        32     BUS_RD
bus_req_proc_num                   bus_req_proc_t   32     REQ_PROC3
req_address                        integral         32     'h0
bus_req_snoop                      integral         4       'h0
req_served_by                      serv_by_t        32     SERV_NONE
rd_data                           integral         32     'h0
wr_data_snoop                     integral         32     'h0

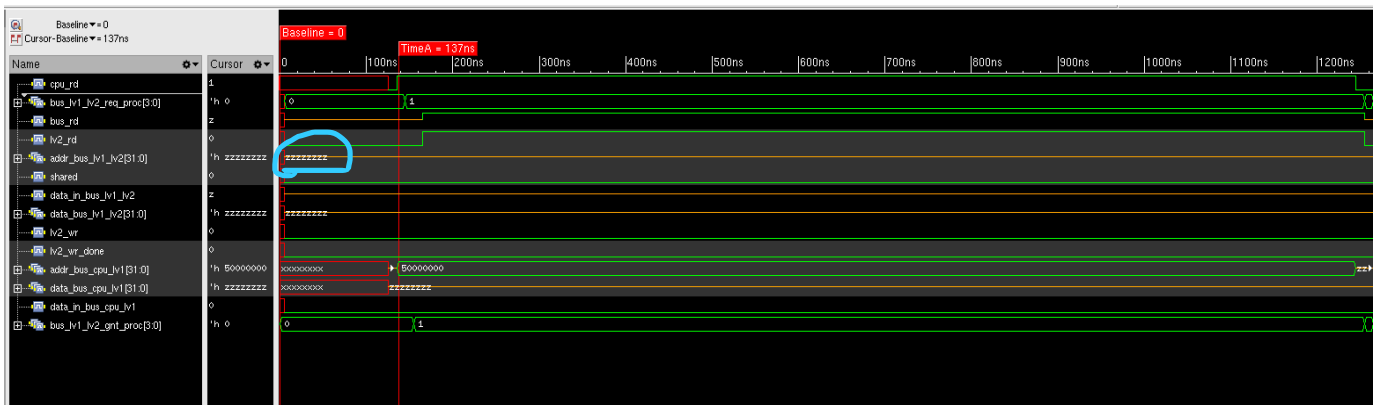
4. **Failing assertion that helped you identify the bug** - Verified outputs from the waveform by simulating the test (read_miss_dcachc.sv) and by following processor read miss steps from HAS document.

Waveform was observed, and it was found that addr_bus_lv1_lv2 has high impedance with no assigned value. So, the design files were checked for address bus assignments.

5. **Erroneous RTL file name** - main_func_lv1_dl.sv
6. **Lines of RTL file responsible for the bug (mention the line numbers and lines of the bug)**
Line no – 104, assign addr_bus_lv1_lv2 = data_bus_lv1_lv2_reg;
7. **Corrected RTL code (only mention the corrections)**- Line no - 104. assign addr_bus_lv1_lv2 = addr_bus_lv1_lv2_reg;
