City of Hampton, Virginia Shoreline Inventory Report Methods and Guidelines

Special report in Applied Marine Science and Ocean Engineering No. 428 of the Virginia Institute of Marine Science

City of Hampton - Shoreline Inventory Report

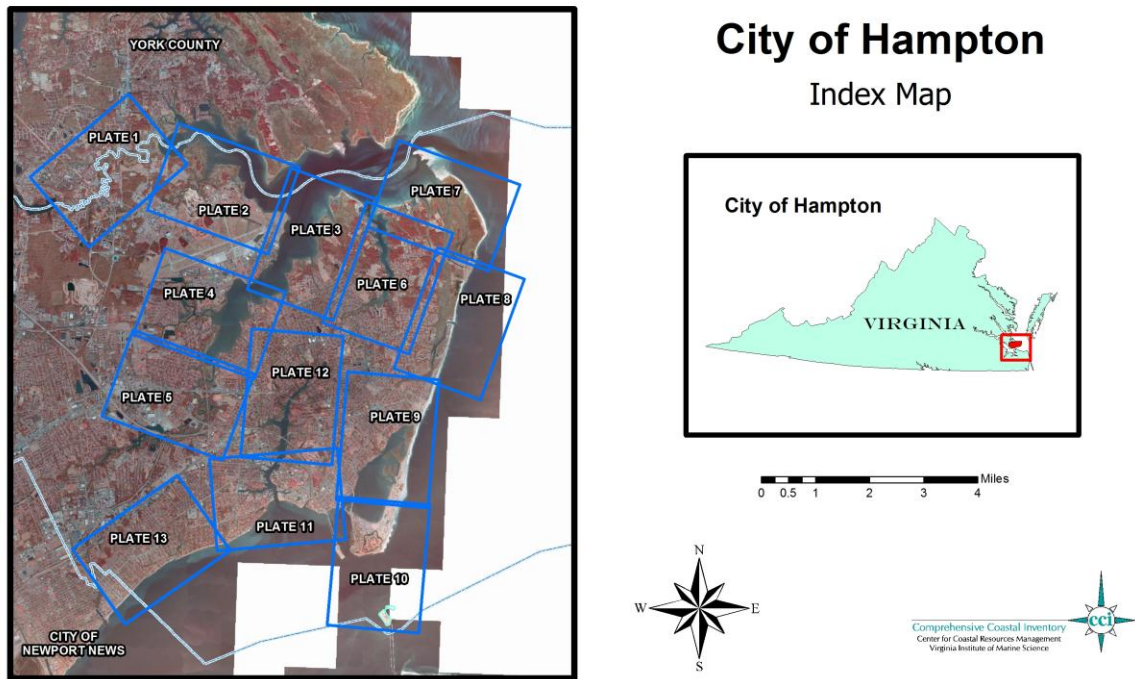
Figure 2. Map index for the City of Hampton

website (Figure 1), an index is provided to help users locate the area of interest and view the orientation of the maps to each other (Figure 2). Each plate can be individually selected and viewed from the plate list along the left hand column of the index page.

For publication purposes the City is divided into a series of maps. Maps are scaled at 1:12,000 for publication at 11x17. Scale will vary if printed at a different size. There are 13 maps for the City of Hampton determined by the City’s geographic size and shape. For each map there are four plates (plate 1a, 1b, 1c, 1d, etc.), for a total of 52 map compositions. On the

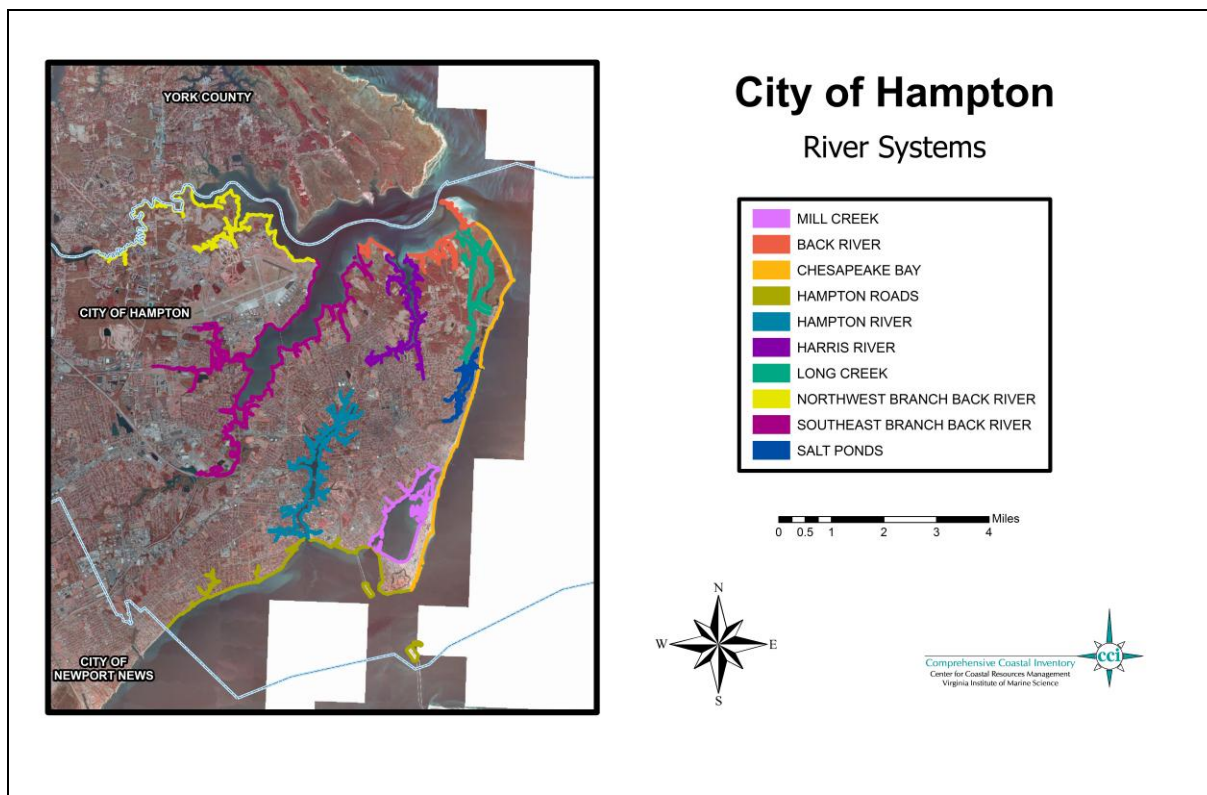
Figure 3. Delineation of City river systems used for data reporting

Tables 4, 5, 6 and 7 quantify features and conditions mapped along the rivers using frequency analysis techniques in ArcInfo. The values quantify features by river systems (Figure 3). For linear features, values are reported in actual miles surveyed. Point features are enumerated. The total miles of shoreline surveyed for each tributary is reported. For the City, a total of 157.54 miles were surveyed in the field. Approximately 47.88 miles of shoreline were surveyed using remote sensing techniques. Figure 4 illustrates where field surveys were conducted and where remote sensing techniques were applied. Remote techniques were used in places where navigation was restricted. Table 6 reports the survey dates, miles surveyed, and miles surveyed remotely.

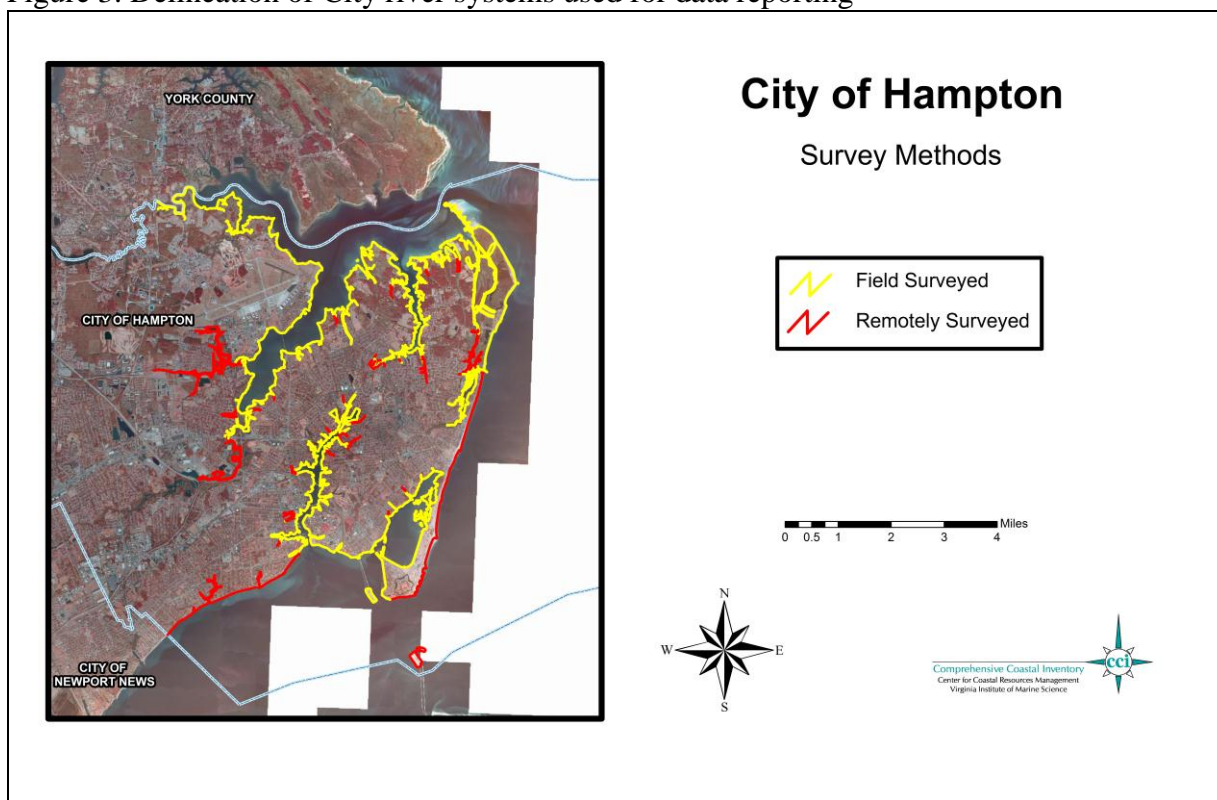
Figure 4. Location of field surveys and remotely sensed data collection.

Shoreline condition is described for City of Hampton along primary and secondary shoreline. Characteristics are described for all navigable tidal waterways contiguous to these shorelines. A total of 157.54 miles of the total 168.88 miles of shoreline are described. Less than 48 miles (47.88 miles) were using remote sensing techniques because water depths restricted access by boat.

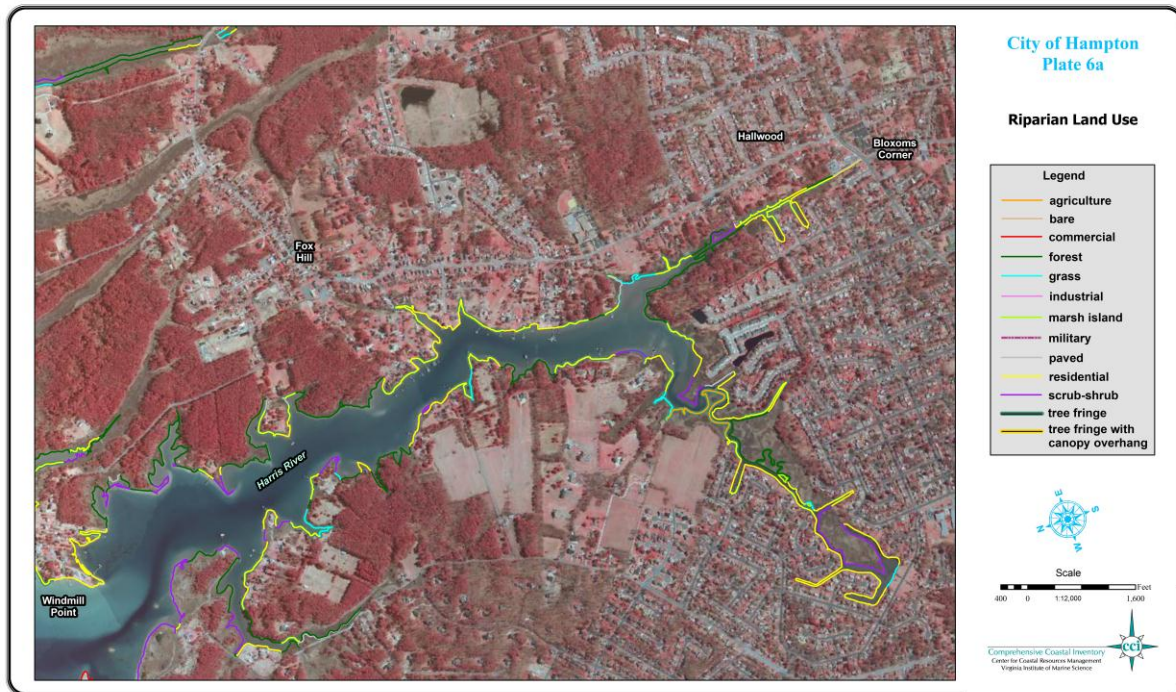
Figure 6. Sample riparian land use map for the City of Hampton

Plate A describes the riparian land use as color-coded bars along the shore. If the line is highlighted underneath with green, there is tree fringe on site. Tree fringe suggests a spattering of trees along the shoreline but not at a density sufficient to classify the lot as being forested. If the line is highlighted underneath with yellow, there is tree fringe with canopy overhang. Canopy overhang is captured because of its attribute value in developing management strategies. The background imagery is infrared color VBMP imagery at a publication scale of 1:12,000.

For example, land use, to some extent, directs the type of management practices one can expect to find along the shoreline. The land use data, illustrated in plate “a” of the map series illustrates current land use at the time of survey that may be an indicator of shoreline management practices existing or expected in the future. Residential and commercial areas are frequently altered to counter act shoreline erosion problems or to enhance private access to the waterway. In contrast forested or agricultural uses are frequently unmanaged even if chronic erosion problems exist. Small forest tracks nestled among residential lots have a high

Once you determine which plate you want, the scroll down menu on the left has links to the four part series for each plate (Figure 5). At the top of the scroll bar Riparian Land Use (plate a) is first. You can scroll down to see links to maps illustrating Bank Conditions (plate b), Shoreline Features (plate c), and Natural Buffers (plate d). The content and details of the four part plate series was described in detail in Chapter 2. The actual map will come up when you click on the plate number. For example, Figure 6 is the riparian land use map for plate 6. Figure 7 is the map illustrating bank conditions for plate 6. Figure 8 shows all the shoreline features for that same area, and Figure 9 the natural buffers associated with that section.

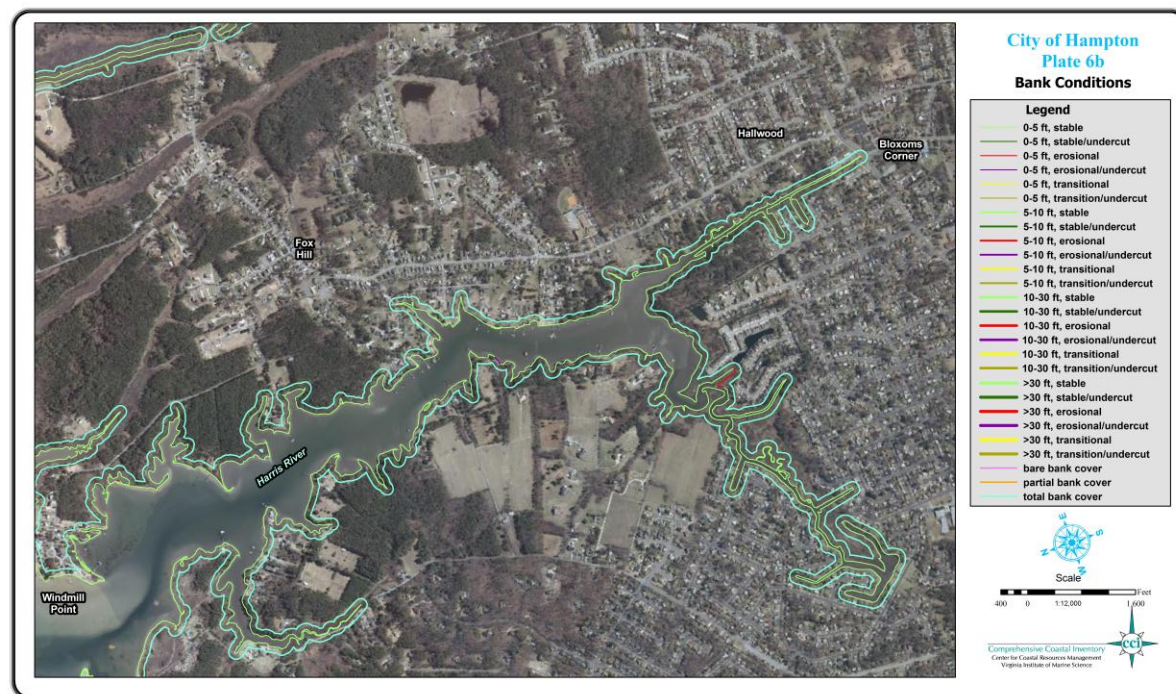
Figure 7. Map illustrating bank conditions for plate 6 in the City of Hampton

Plate B depicts stability and height and cover of the bank. The shoreline is color-coded light green, red and yellow to report if the bank is stable, erosional, or transitional, respectively. If each of these conditions occurs with undercutting at the base of the bank, the colors become, dark green, purple, and olive green, respectively. The thickness of the line reflects the bank height; where the thickest lines designate the highest banks (> 30 feet). Plate B uses natural color VBMP imagery for the backdrop.

Plate B also illustrates bank cover. Bank cover is designated as a separate line that is inland of the shoreline. Bank cover addresses cover by vegetation or structures. Fuchsia suggests the bank is bare with exposed soil in most places. Partial cover is illustrated in orange and total cover is shown in sea foam green.

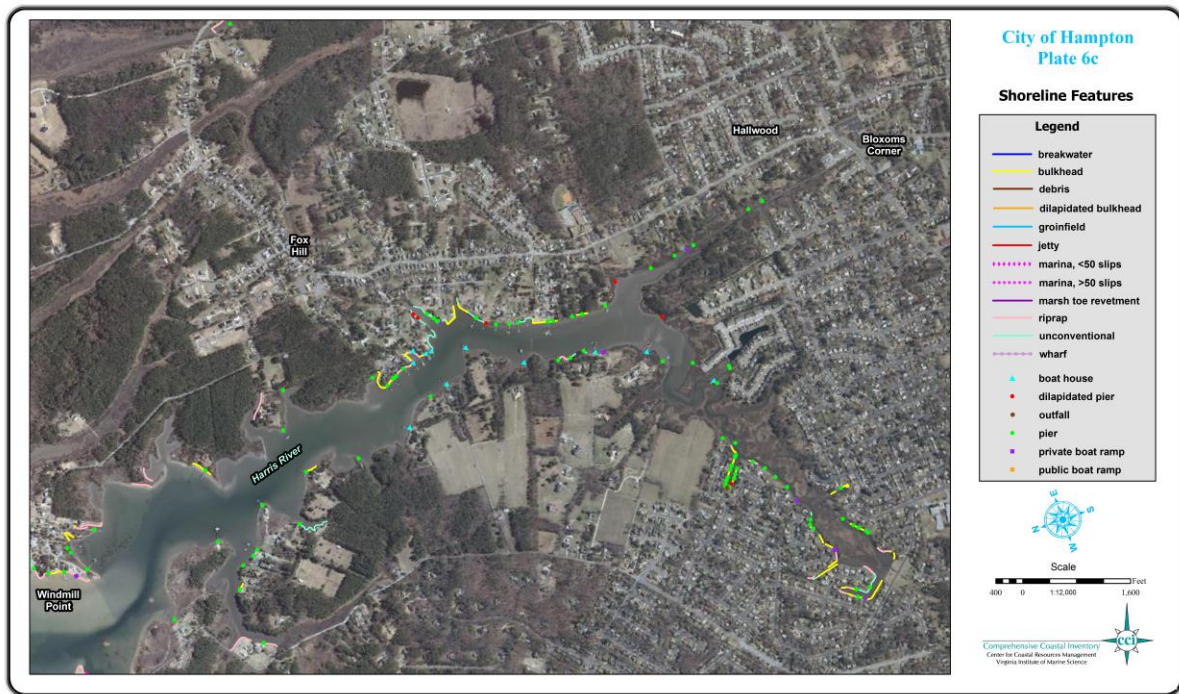
Figure 8. Map illustrating shoreline features for plate 6 in the City of Hampton

Plate C combines recreational and shoreline protection structures in a composition called Shoreline Features. These are generally anthropogenic alterations constructed to gain access to the water or to stabilize a shoreline from existing and future bank erosion. Linear features, described previously (Table 3), are mapped using color coded bar symbols that follow the orientation of the shoreline. Point features use a combination of colors and symbols to plot the positions on the map. Natural color imagery is used as a backdrop.

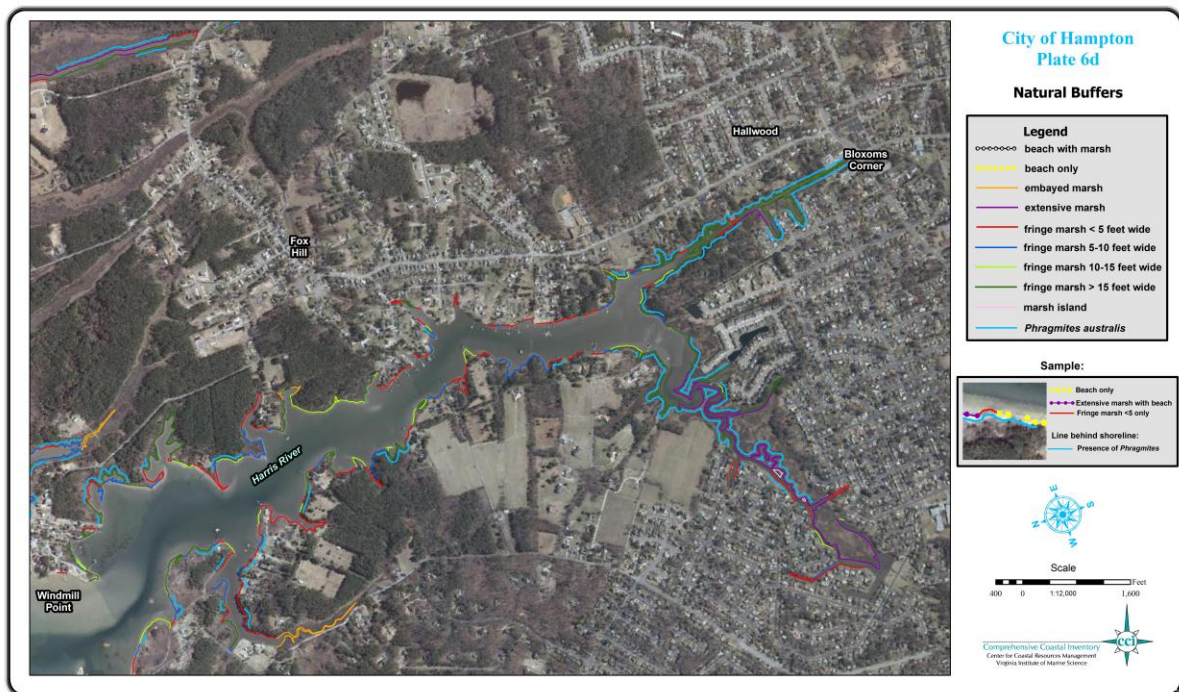
Figure 9. Map illustrating natural buffers for plate 6 in the City of Hampton

On Plate D, a pattern of small colored circles and lines along the shoreline describes any natural buffers present. These are limited to marshes and beaches. Orange lines represent embayed marshes. Purple lines are extensive marshes. Red lines indicate the presence of fringe marshes that are less than 5 feet in width. Dark blue lines represent fringe marshes that are 5-10 feet in width. Fringe marshes 10-15 feet wide are depicted with light green lines. If the fringe marsh is greater than 15 feet the lines will be dark green. The invasive species *Phragmites australis* is designated with a blue line shown inland of the shoreline. Beaches, if present, are delineated with solid yellow balls. If a beach co-occurs with a marsh, the shoreline is coded with balls that are color-coded based on the type of marsh.
