# PRECIOUS PLASTIC MONASH UNIVERSITY

Throughout the process of building and running the machines we found various problems which were not accounted for during the design phase. This document describes these issues and the solutions or work-arounds implemented in order to meet operational requirements. General changes were added to the original machine's designs not as solutions to any problems, but as general improvements to better suit the overall aesthetics or to make use of easily obtainable components. In the document, future possible upgrades have been added to help collaboration from other Precious Plastic chapters, so have fun, and let's recycle!

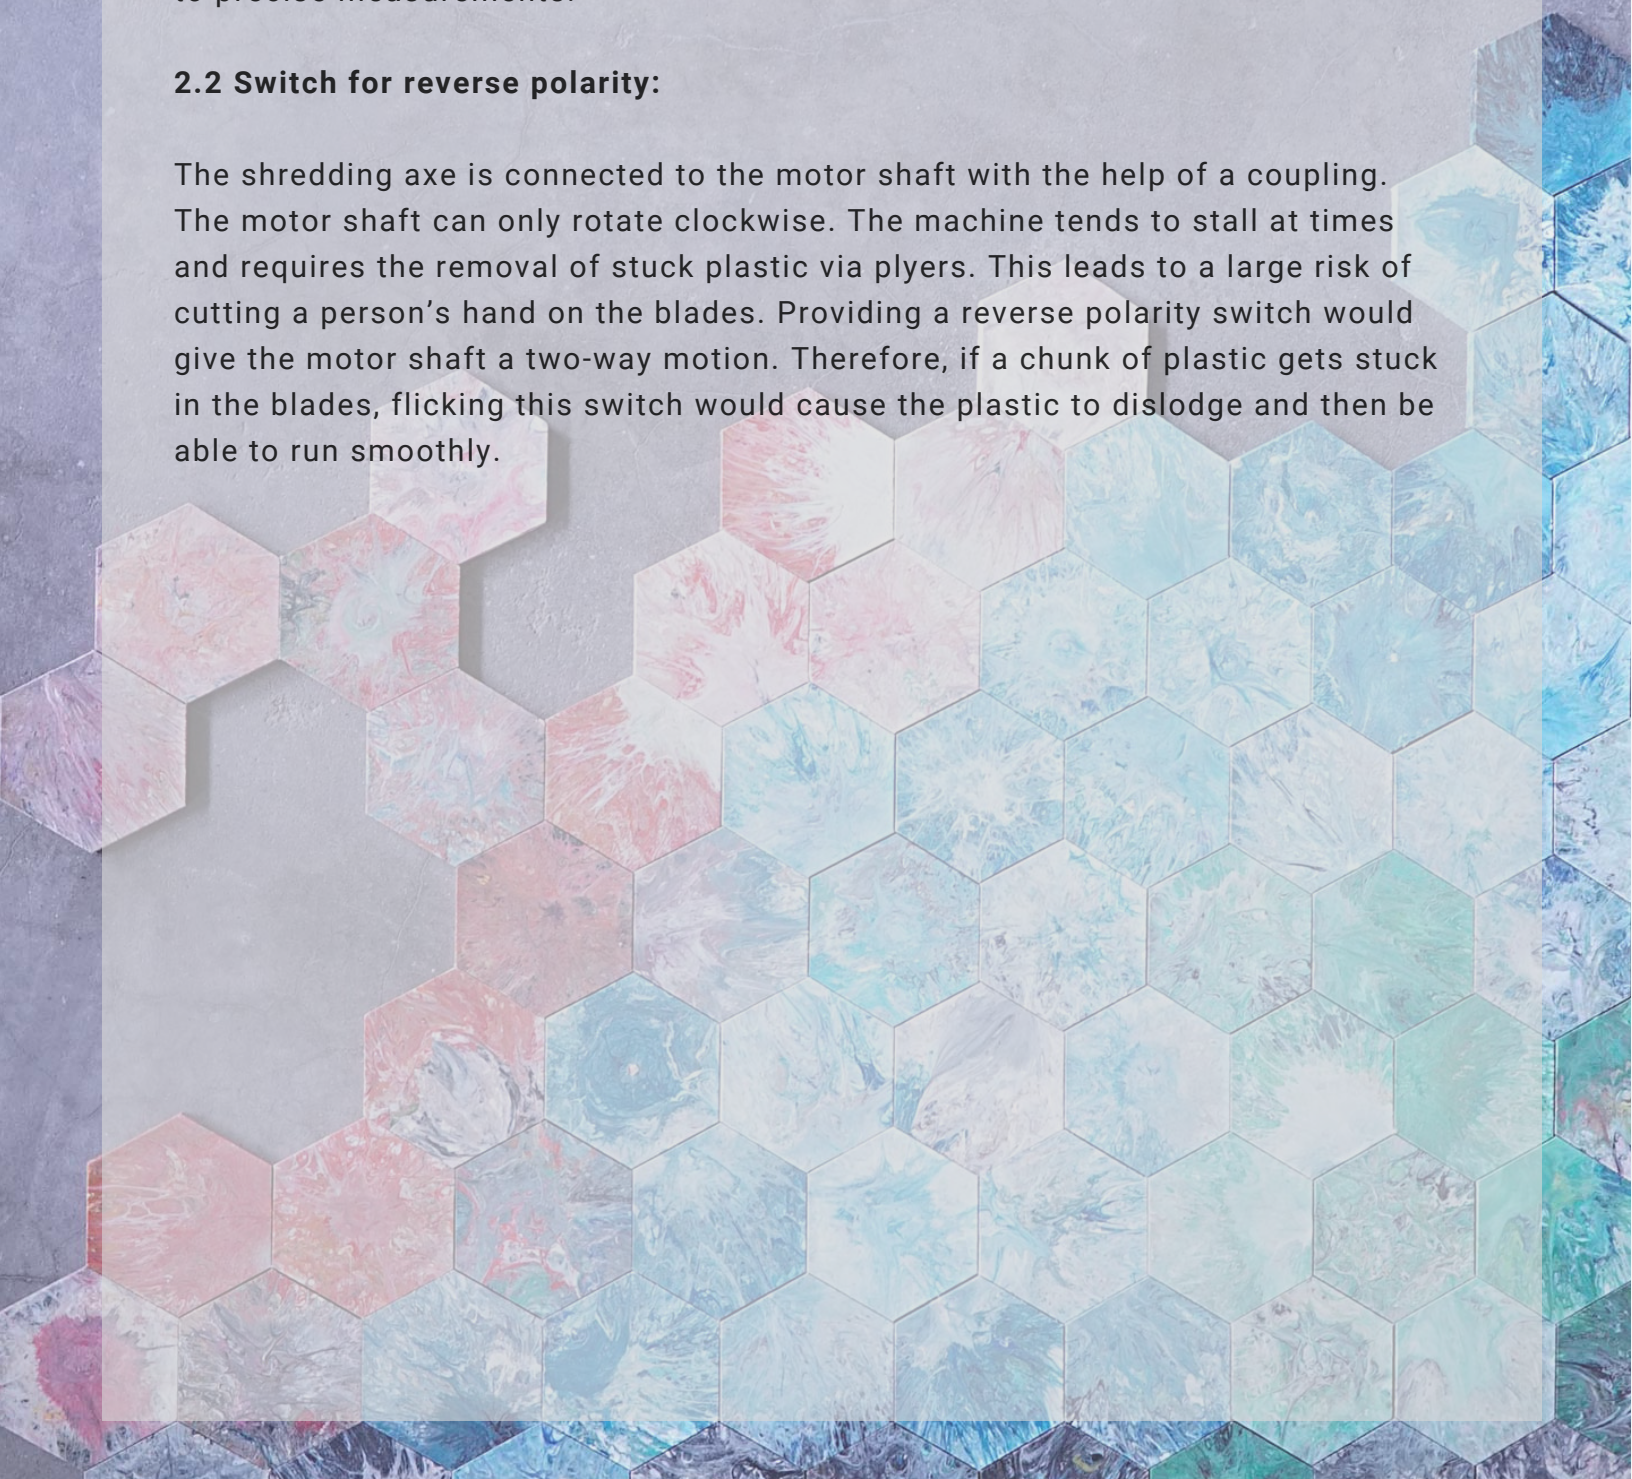
The shredding axe is connected to the motor shaft with the help of a coupling. The motor shaft can only rotate clockwise. The machine tends to stall at times and requires the removal of stuck plastic via pliers. This leads to a large risk of cutting a person's hand on the blades. Providing a reverse polarity switch would give the motor shaft a two-way motion. Therefore, if a chunk of plastic gets stuck in the blades, flicking this switch would cause the plastic to dislodge and then be able to run smoothly.
