## Rescuing the wreck of trading wherry “Maud of Great Yarmouth”

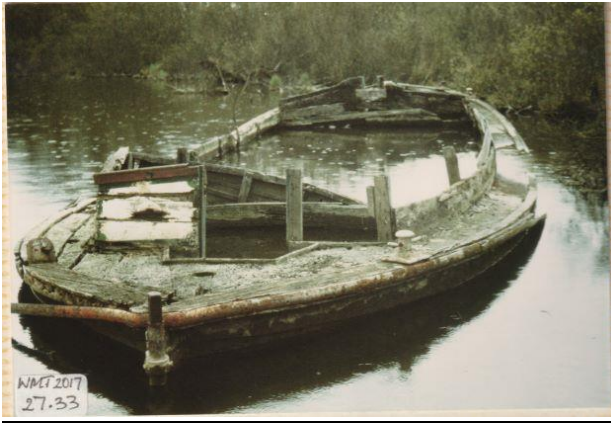
Photo No. 23

**Maud, in 1979, a sunken wreck in Ranworth Broad**

In 1979 the Pargeters first saw Maud in Ranworth Inner Broad. Two years later they came back to salvage her because she was the best wherry wreck they could find. She was also accessible. Her side decks were above the waterline at low tide and she should be able to be pumped out and re-floated.

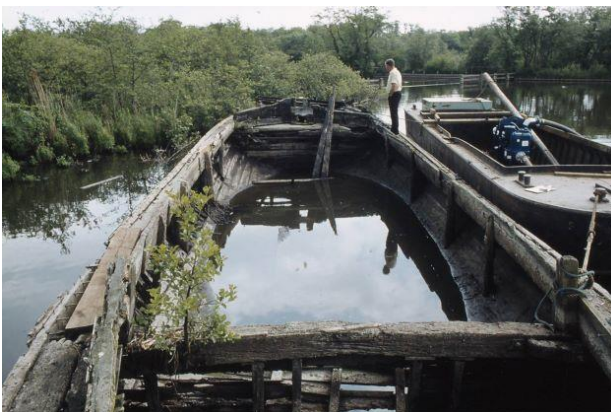
Photo No 24

**Maud, in 1981, partially pumped out**

River contractor Sunny Amis pumped the water and mud out of Maud's hold and re-floated her.

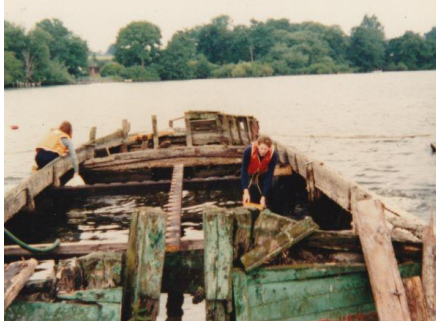
Photo No 25

### **The owners, Vincent & Linda Pargeter, start their latest project**

It was now possible to see parts of Maud that had been submerged. The strength of the framing and planking could not be easily assessed. It was prudent to do some strengthening of the hull before Maud was towed to the boatyard where she was to be lifted out of the water. On this occasion Vincent measured up for strengthening timbers that would be installed before she could be lifted out of the water.

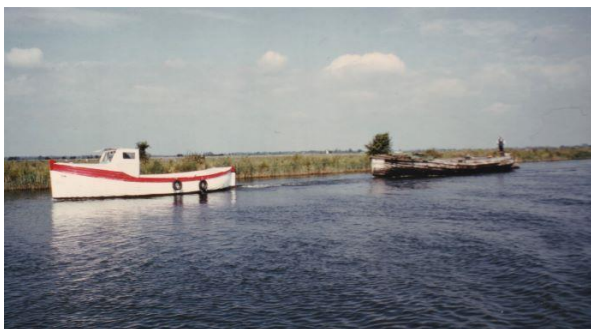
Photo No 26

### **Towing the wreck to Upton Staithe**

This was the start of Maud's journey to a new life. After the water was pumped out of her hold Maud was towed round to Upton, a journey of about 6 miles, with a pump on board just in case of need. The destination was Eastwood Whelpton Boatyard at Upton Staithe.

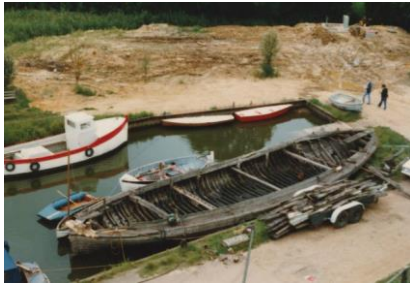
Photo No 27

### **At Upton, preparations are made for lifting the wreck**

This photo taken from above shows Maud's framing. On arrival the lining boards in her hold had been stripped out and you can see them loaded on the trailer at the bottom right of the picture. You can also see the strengthening timbers that had been installed across the hold to prevent Maud being crushed as she was lifted out.

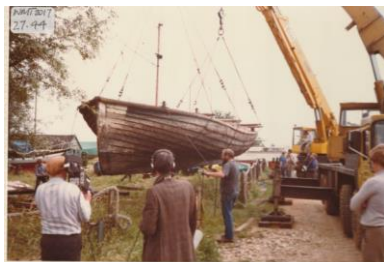
Photo No 28

### **Cranes have now lifted the wreck and are lowering it onto the ground**

There were some issues when the cranes arrived to do the lift. They had to be placed apart at the correct distance to allow their jibs to reach over the water above Maud. That meant that they had to lift her and then thread her between the two cranes before lowering her onto the bank. They had just enough reach to do the job, although warning bells sounded to warn that the lift was at the limit of their capacity. Maud weighed between 14 and 16 tons.

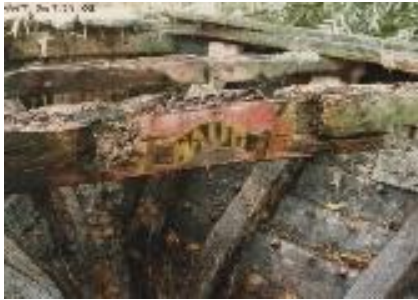
Photo No 29

### **Proof that the wreck was Maud**

None of the other wherry wrecks surveyed had names on them. The names of some other wrecks were known because people who had scuttled them remembered their whereabouts. Three wherries were known to have been dumped in Ranworth so it was good to have positive proof that this wreck was indeed Maud.

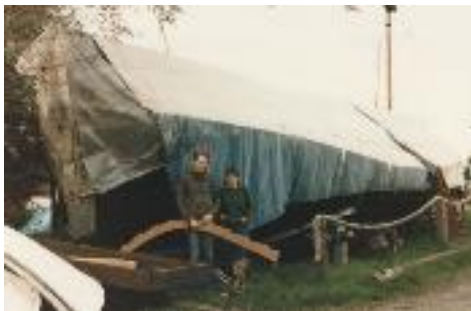
Photo No 30

### **Maud now roofed over, ready for restoration**

With Maud now on dry land it was important to cover her over to enable her to dry out. A temporary roof was constructed and covered with second-hand lorry tarpaulins. The roof had a secondary purpose – so that the hull of the boat could be used as a workshop while the restoration work took place. The photo shows the Pargeters standing at Maud's bows. In Vincent's hands is a hardboard pattern for shaping a new section of hull framing.
