# Seat Cushion - Lower - 2nd Row (Remove and Install)

FRT No: 13021101

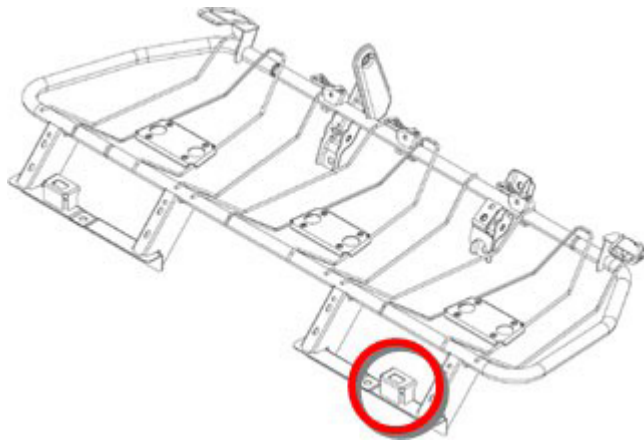
1. Remove the 2nd row center console assembly, if installed ([refer to procedure](#)).
2. Gently lift up the LH side of the 2nd row seat bottom cushion to expose the grommet tower.

**Caution:** Do not remove the cushion by forcefully pulling up on it. This might warp the cushion.

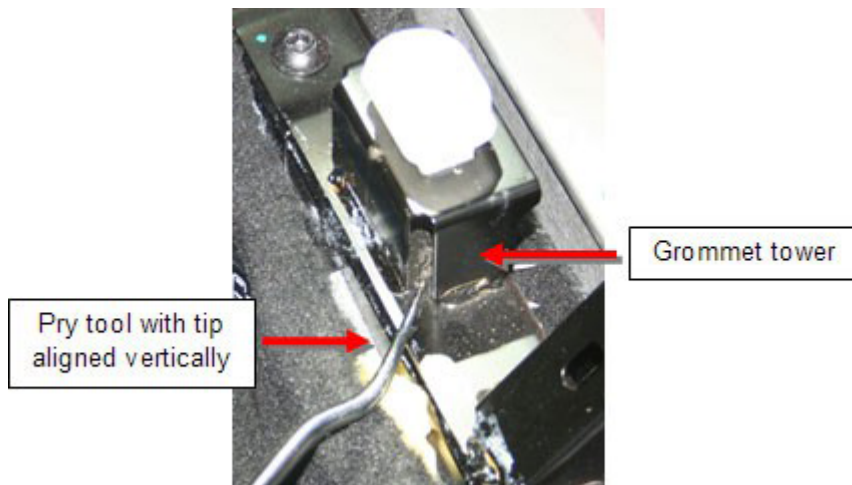
3. Hold a pry tool with the tip aligned vertically. Insert the pry tool into the vertical slot in the corner of the grommet tower.

**Note:** Shown with cushion removed for clarity.

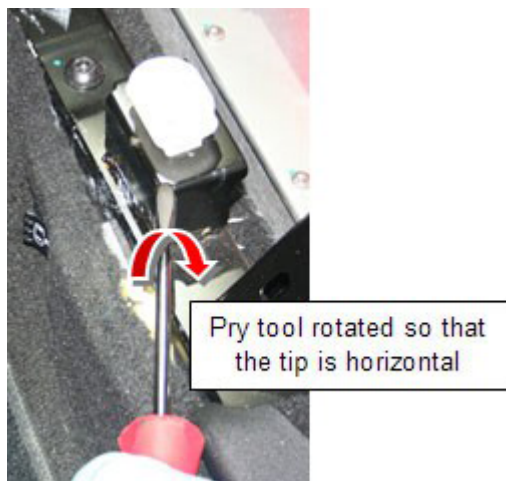
4. Rotate the pry tool so that the tip is in a horizontal position underneath the grommet.

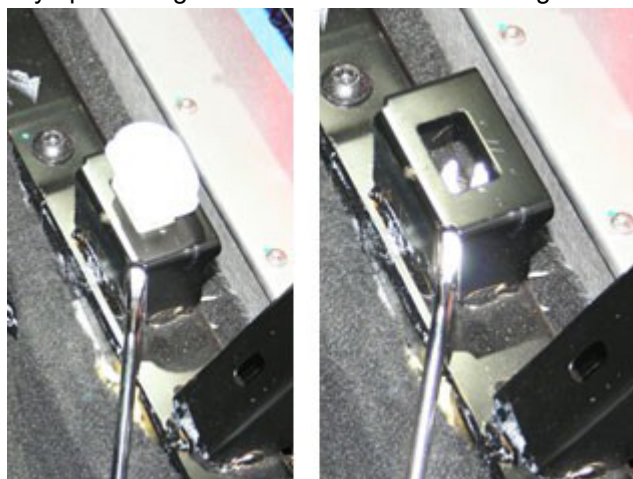
5. Pry up on the grommet to release it from the grommet tower.

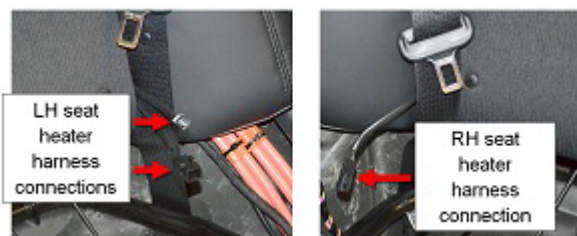
6. If the vehicle is equipped with the Cold Weather package, disconnect the 2 seat heater harness connections on the LH side of the vehicle and the 1 seat heater harness connection on the RH side of the vehicle.
