## **Progress Report 1**

*Group n° 3 – UC Projeto Aeroespacial*

As part of the Hangar 9 Solo restoration project, our team takes on the mission of bringing the aircraft's engine back to life. Our focus lies in inspecting, diagnosing, and repairing the engine to its full operational capacity. This involves in-depth analysis of its current state, identifying any worn-out components, and sourcing or creating replacements to ensure optimal performance and safety.

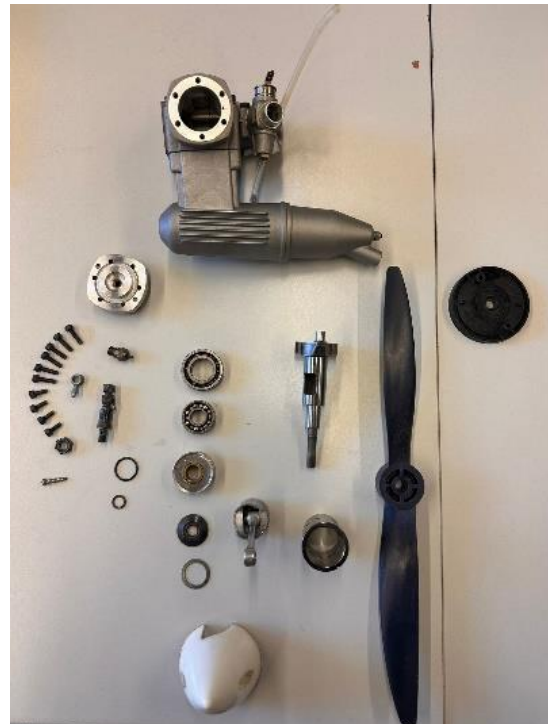
Our engine consists of 38 parts divided into 28 categories, which can be seen in our inventory. During the cataloging of the engine components, we noticed that the parts needed deep cleaning.

Nonetheless, we noticed that the ball bearings were heavily worn out and would most likely need replacing. Additionally, the piston, cylinder and connection rod were not functioning as expected, so we would probably need to replace them as well.

Number	Description	Ref.	Quantity	Status
1	PROP NUT	NA001	1	USABLE
2	PROP WASHER	HW008	1	USABLE
3	PROP DRIVE	DG4612	1	USABLE
4	TAPER DRIVE WASHER	DC4611	1	USABLE
5	BALL BEARING S	B006	1	REPLACE
6	CARB RETAINING BOLT	SP2110	1	USABLE
7	CRANKCASE	CK4607	1	USABLE
8	BALL BEARING L	B007A	1	REPLACE
9	CRANKSHAFT	CS4608	1	USABLE
10	GASKET SET	L001	1	USABLE
11	BACKPLATE	RB4609	1	USABLE
12	SCREWS S	S017	4	USABLE
13	CONNECTING ROD	CR4606	1	REPLACE
14	PISTON/CYLINDER	CP4604/5	1	REPLACE
15	PIN ASSEMBLY	P006	1	REPLACE
16	GASKET SET 2	HW4603	1	USABLE
17	CYLINDER HEAD	CH4601	1	USABLE
18	SCREWS L	S001T	6	USABLE
19	GASKET SET 3	HW004	1	USABLE
20	SCREWS L 2	S018	2	USABLE
21	GASKET SET 4	HW010	2	USABLE
22	SILENCER	MF003A	1	USABLE
23	MAIN NEEDLE VALVE	MN4626	1	USABLE
24	GASKET SET 5	HW007	1	USABLE
25	POPPET VALVE	MNP002	1	USABLE
26	GASKET SET 6	HW010	1	USABLE
27	FUEL NIPPLE	OS2124A	1	USABLE
28	CARBURATOR	CM4613-1	1	USABLE

During the cleaning, we realized that ball bearing S and ball bearing L [number 5 and 8] would need to be replaced, as well as the piston, cylinder, and connecting rod [number 13 and 14], due to the fact that the piston gets stuck at the top dead center, making it difficult to complete a full cycle.

The ball bearings have already been replaced, but we will have to wait for the rest of the components before we can proceed with the assembly of the engine.

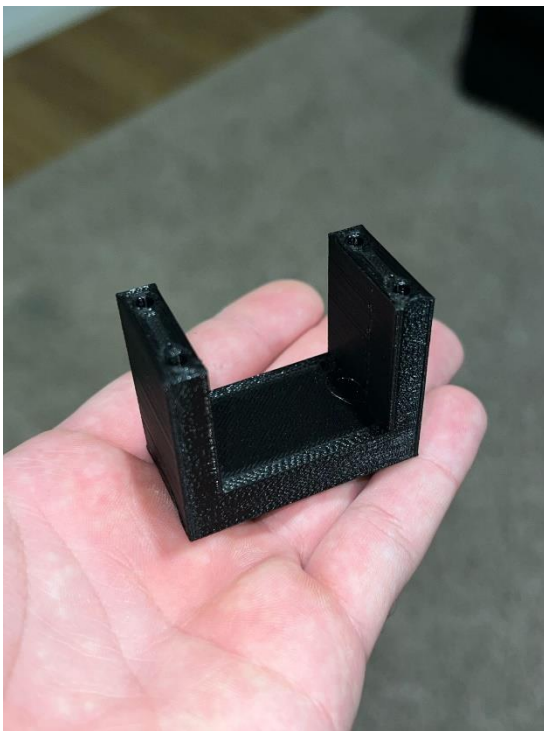
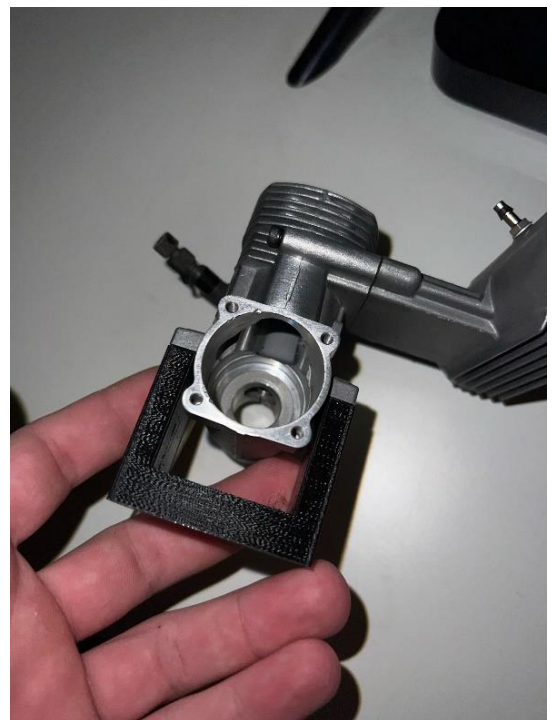
While waiting for the new parts to arrive, we modeled and 3D-printed an engine support. This will allow us to tune and test it without needing the entire structure of the airplane.
