Assessing Compliance to Minimum Service Standards of Indonesian Toll Roads: An Examination of the Padaleunyi Toll Road

Abstract: The primary objective of this study encompasses the evaluation of the Padaleunyi Toll Road's service performance, particularly in relation to Indonesia's established minimum service standards for toll roads. Given that the Padaleunyi Toll Road currently stands at mid-life in terms of its service duration, it is crucial to undertake this assessment to predict its remaining useful life. Criteria for measuring minimum service standards' fulfillment were diversified to cover the conditions of the toll road, average vehicular speed, accessibility, mobility, safety parameters, availability of rescue units and service assistance, environmental impact, and features of rest and service areas. The employed research methodology was based on the guidelines provided by Regulation 16/PRT/M/2014 from the Indonesian Ministry of Public Works. Findings indicate a compliance level of 66.04% to the minimum service standards, with the poorest indicator being the condition of the toll roads at a mere 14%. This study hopes to contribute by offering comprehensive insights into

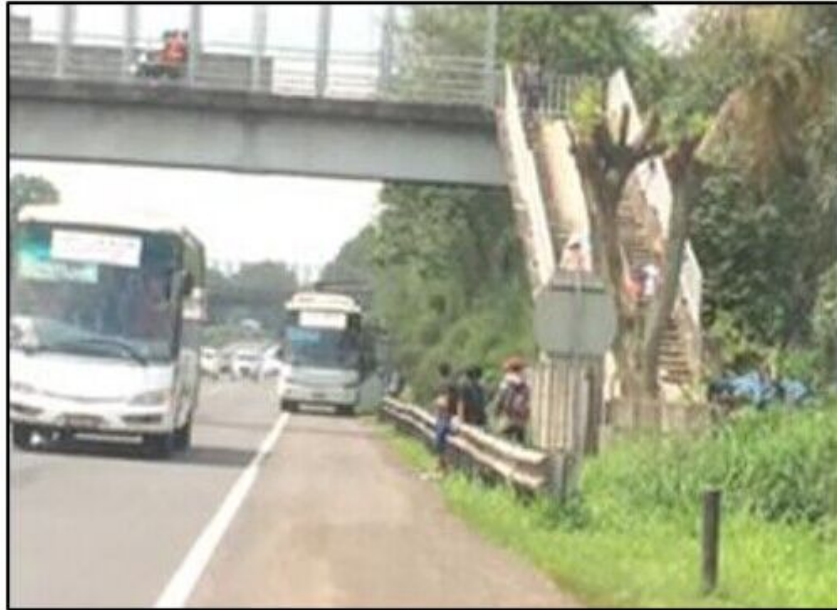
Figure 4. Absence of right-of-way fence
