CENTER FOR ASTRONOMY SIGNAL PROCESSING AND ELECTRONICS RESEARCH

IMPORTANT SCIENCE SAFETY NOTICE # 001

IBOB Repair Instructions for Science Safety Notice #001

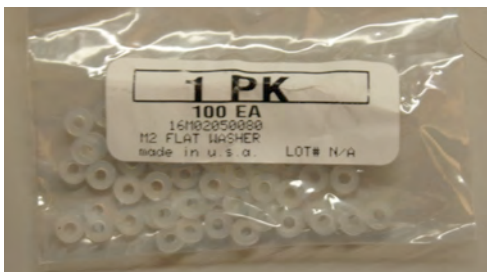
Nylon 6/6 plastic washer, 5mm OD, thickness, .67 to .93mm, M2 Size, www.mcmaster.com P/N 95610A110

Step 1: Acquire replacement screws and insulating washers (screws x 4, washers x 4, per IBOB). Optional: Locktite 222MS or equivalent for screw threads.

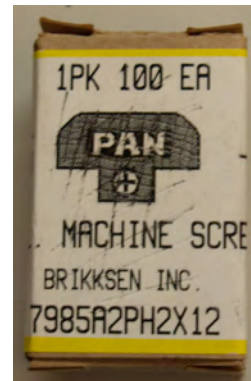
18-8 stainless steel Phillips head machine Screw, M2 Size, 12mm Length, .4mm Pitch, www.mcmaster.com P/N 92000A019

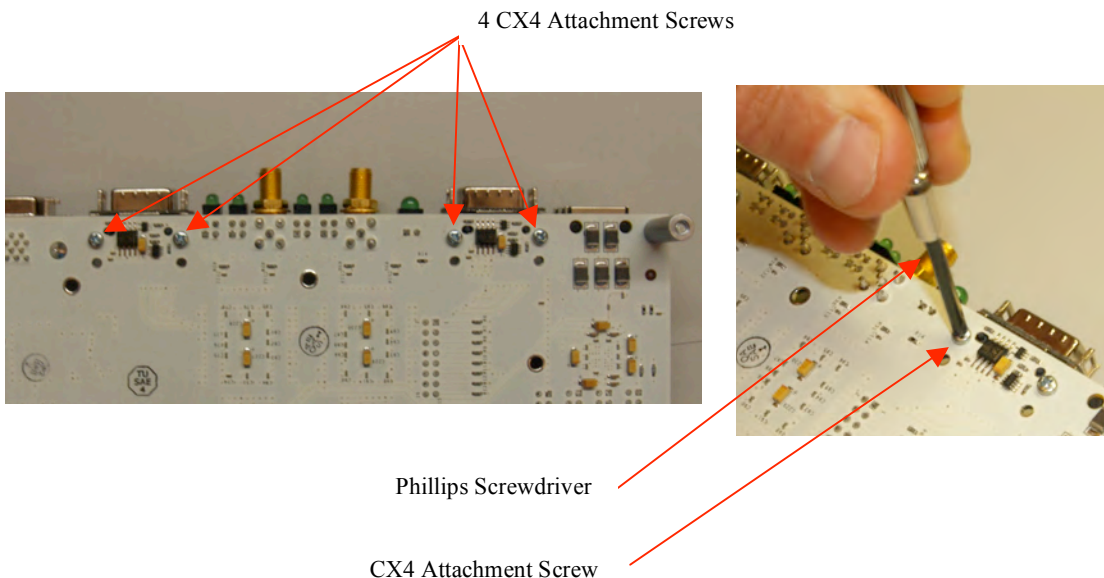
Step 2: Remove CX4 attachment screws using a Phillips head screwdriver.

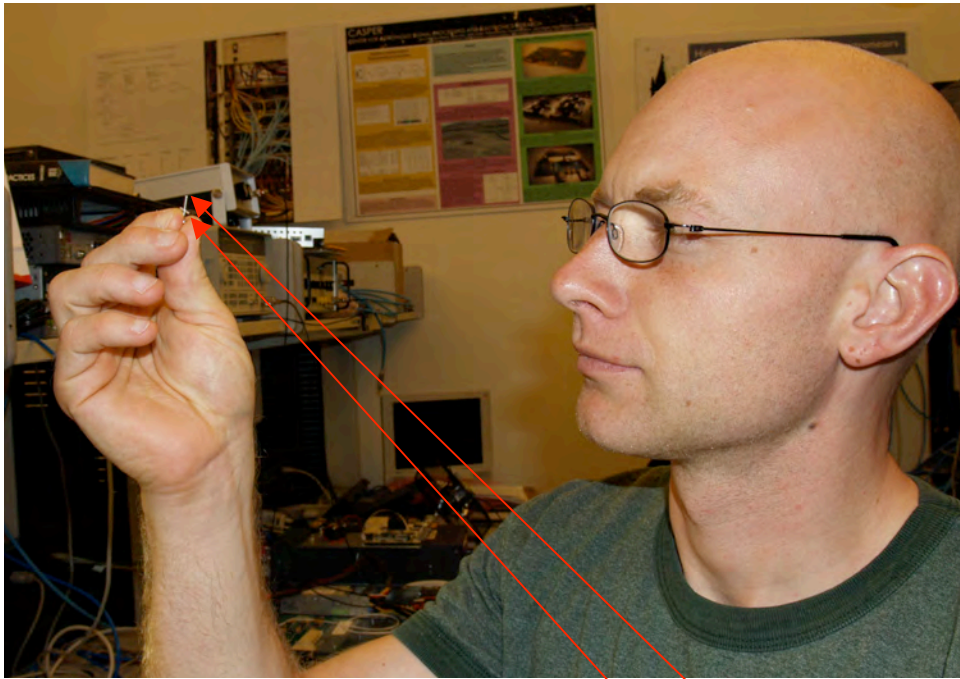
Step 3: Push 18-8 stainless steel replacement screws into 6/6 nylon plastic washers.
Optional: Apply Locktite 222MS or equivalent to screw threads.

18-8 Stainless Steel Replacement Screw

6/6 Nylon Plastic Washer

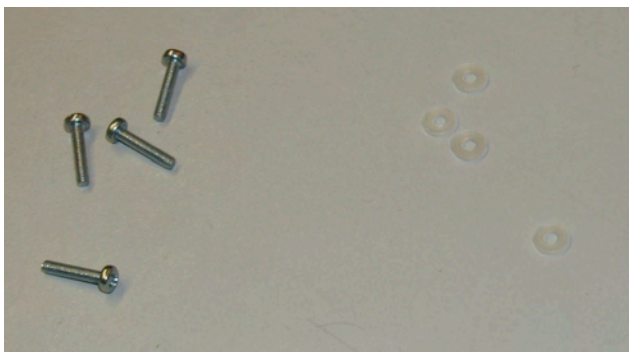
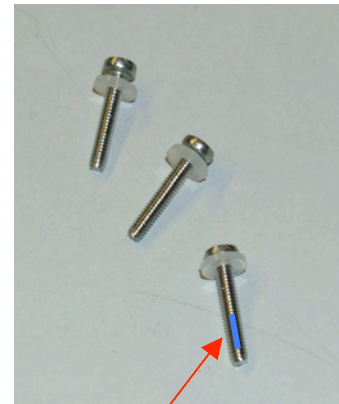
Optional: Locktite 222MS or equivalent would be applied here.

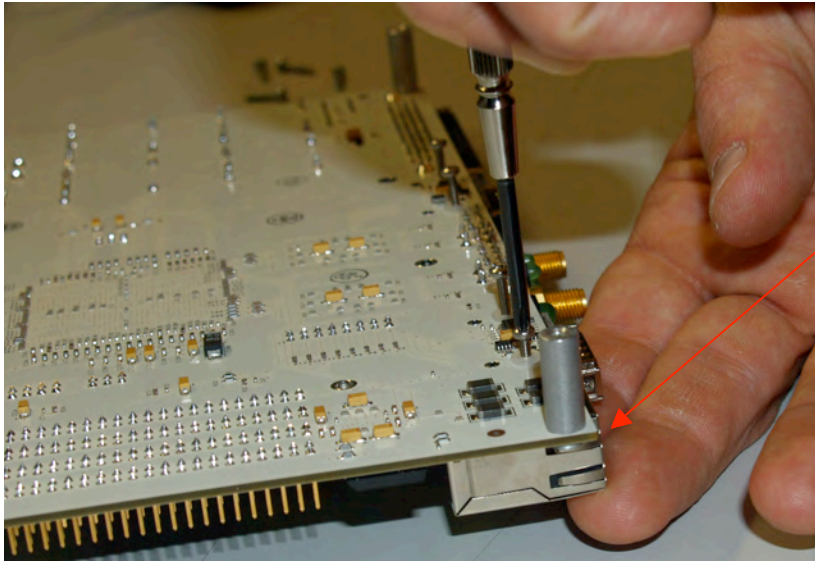
Step 4: Replace removed CX4 attachment screws with new screw/washer combinations.

Note use of hand for support.

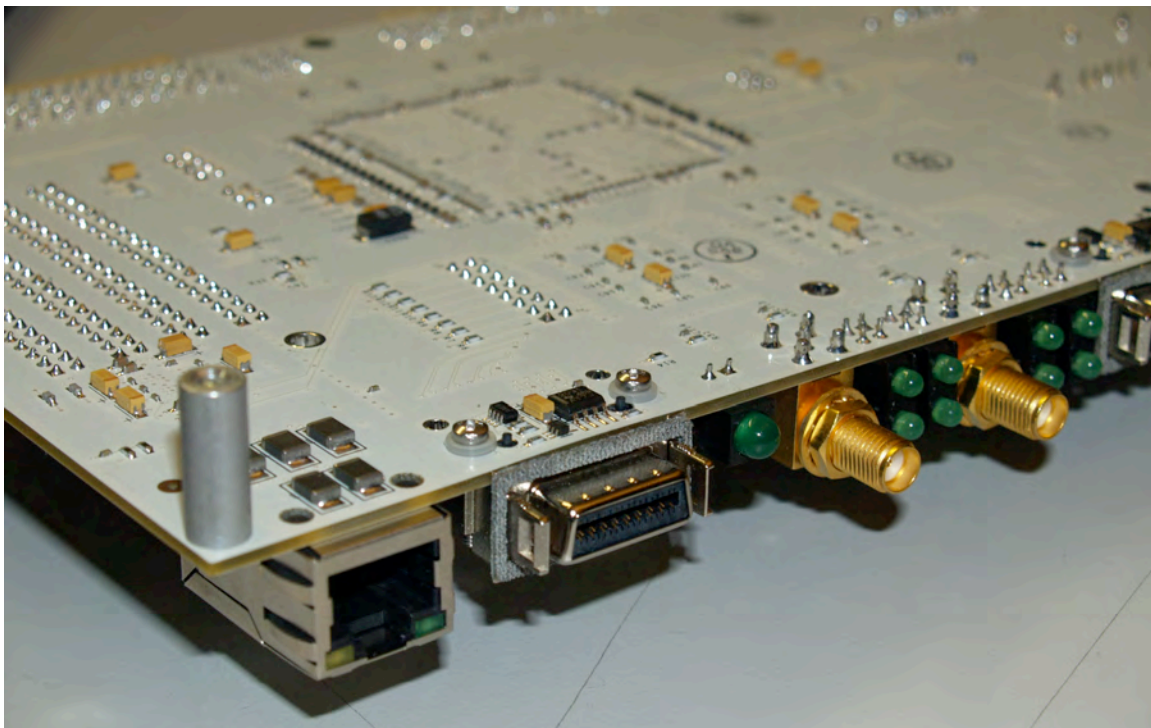
Completed Repair: Science Safe.
