SEM Image Analysis Report

Generated on: 2025-03-30 14:11:49

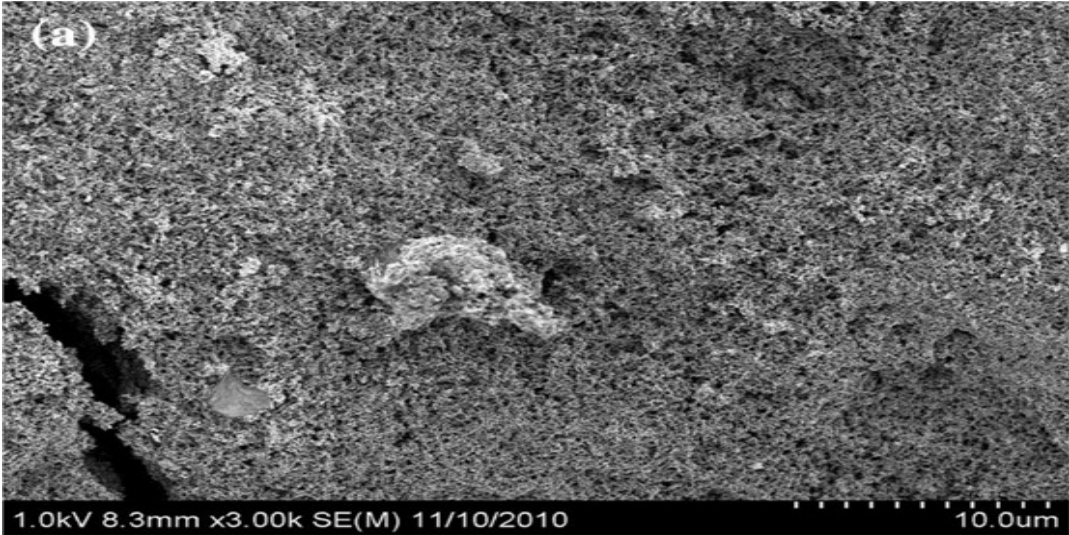
Multi-Otsu Segmentation Analysis

- Porosity (Holes, Cracks): 127.23 μm^2 (0.06%)
- Pollutants, Sediments: 268.73 μm^2 (0.12%)
- Matrix (Base Material): 384.70 μm^2 (0.17%)
- Metallic Particles: 375.24 μm^2 (0.16%)
- High-Reflectivity Contaminants: 202.06 μm^2 (0.09%)

Particle Shape Analysis

Shape Type	Count
Irregular	34
Ellipse	6
Polygon	6

Circularity Distribution

Average Circularity: 0.24
