COMMUNITED EXTRA-ARTICULAR SCAPULAR BODY FRACTURE SURGICAL FIXATION AND FUNCTIONAL OUTCOME

AUTHOR: Dr BORRA JYOTHI VENKATA SAI KISHOR CHANDRA. POST GRADUATE.

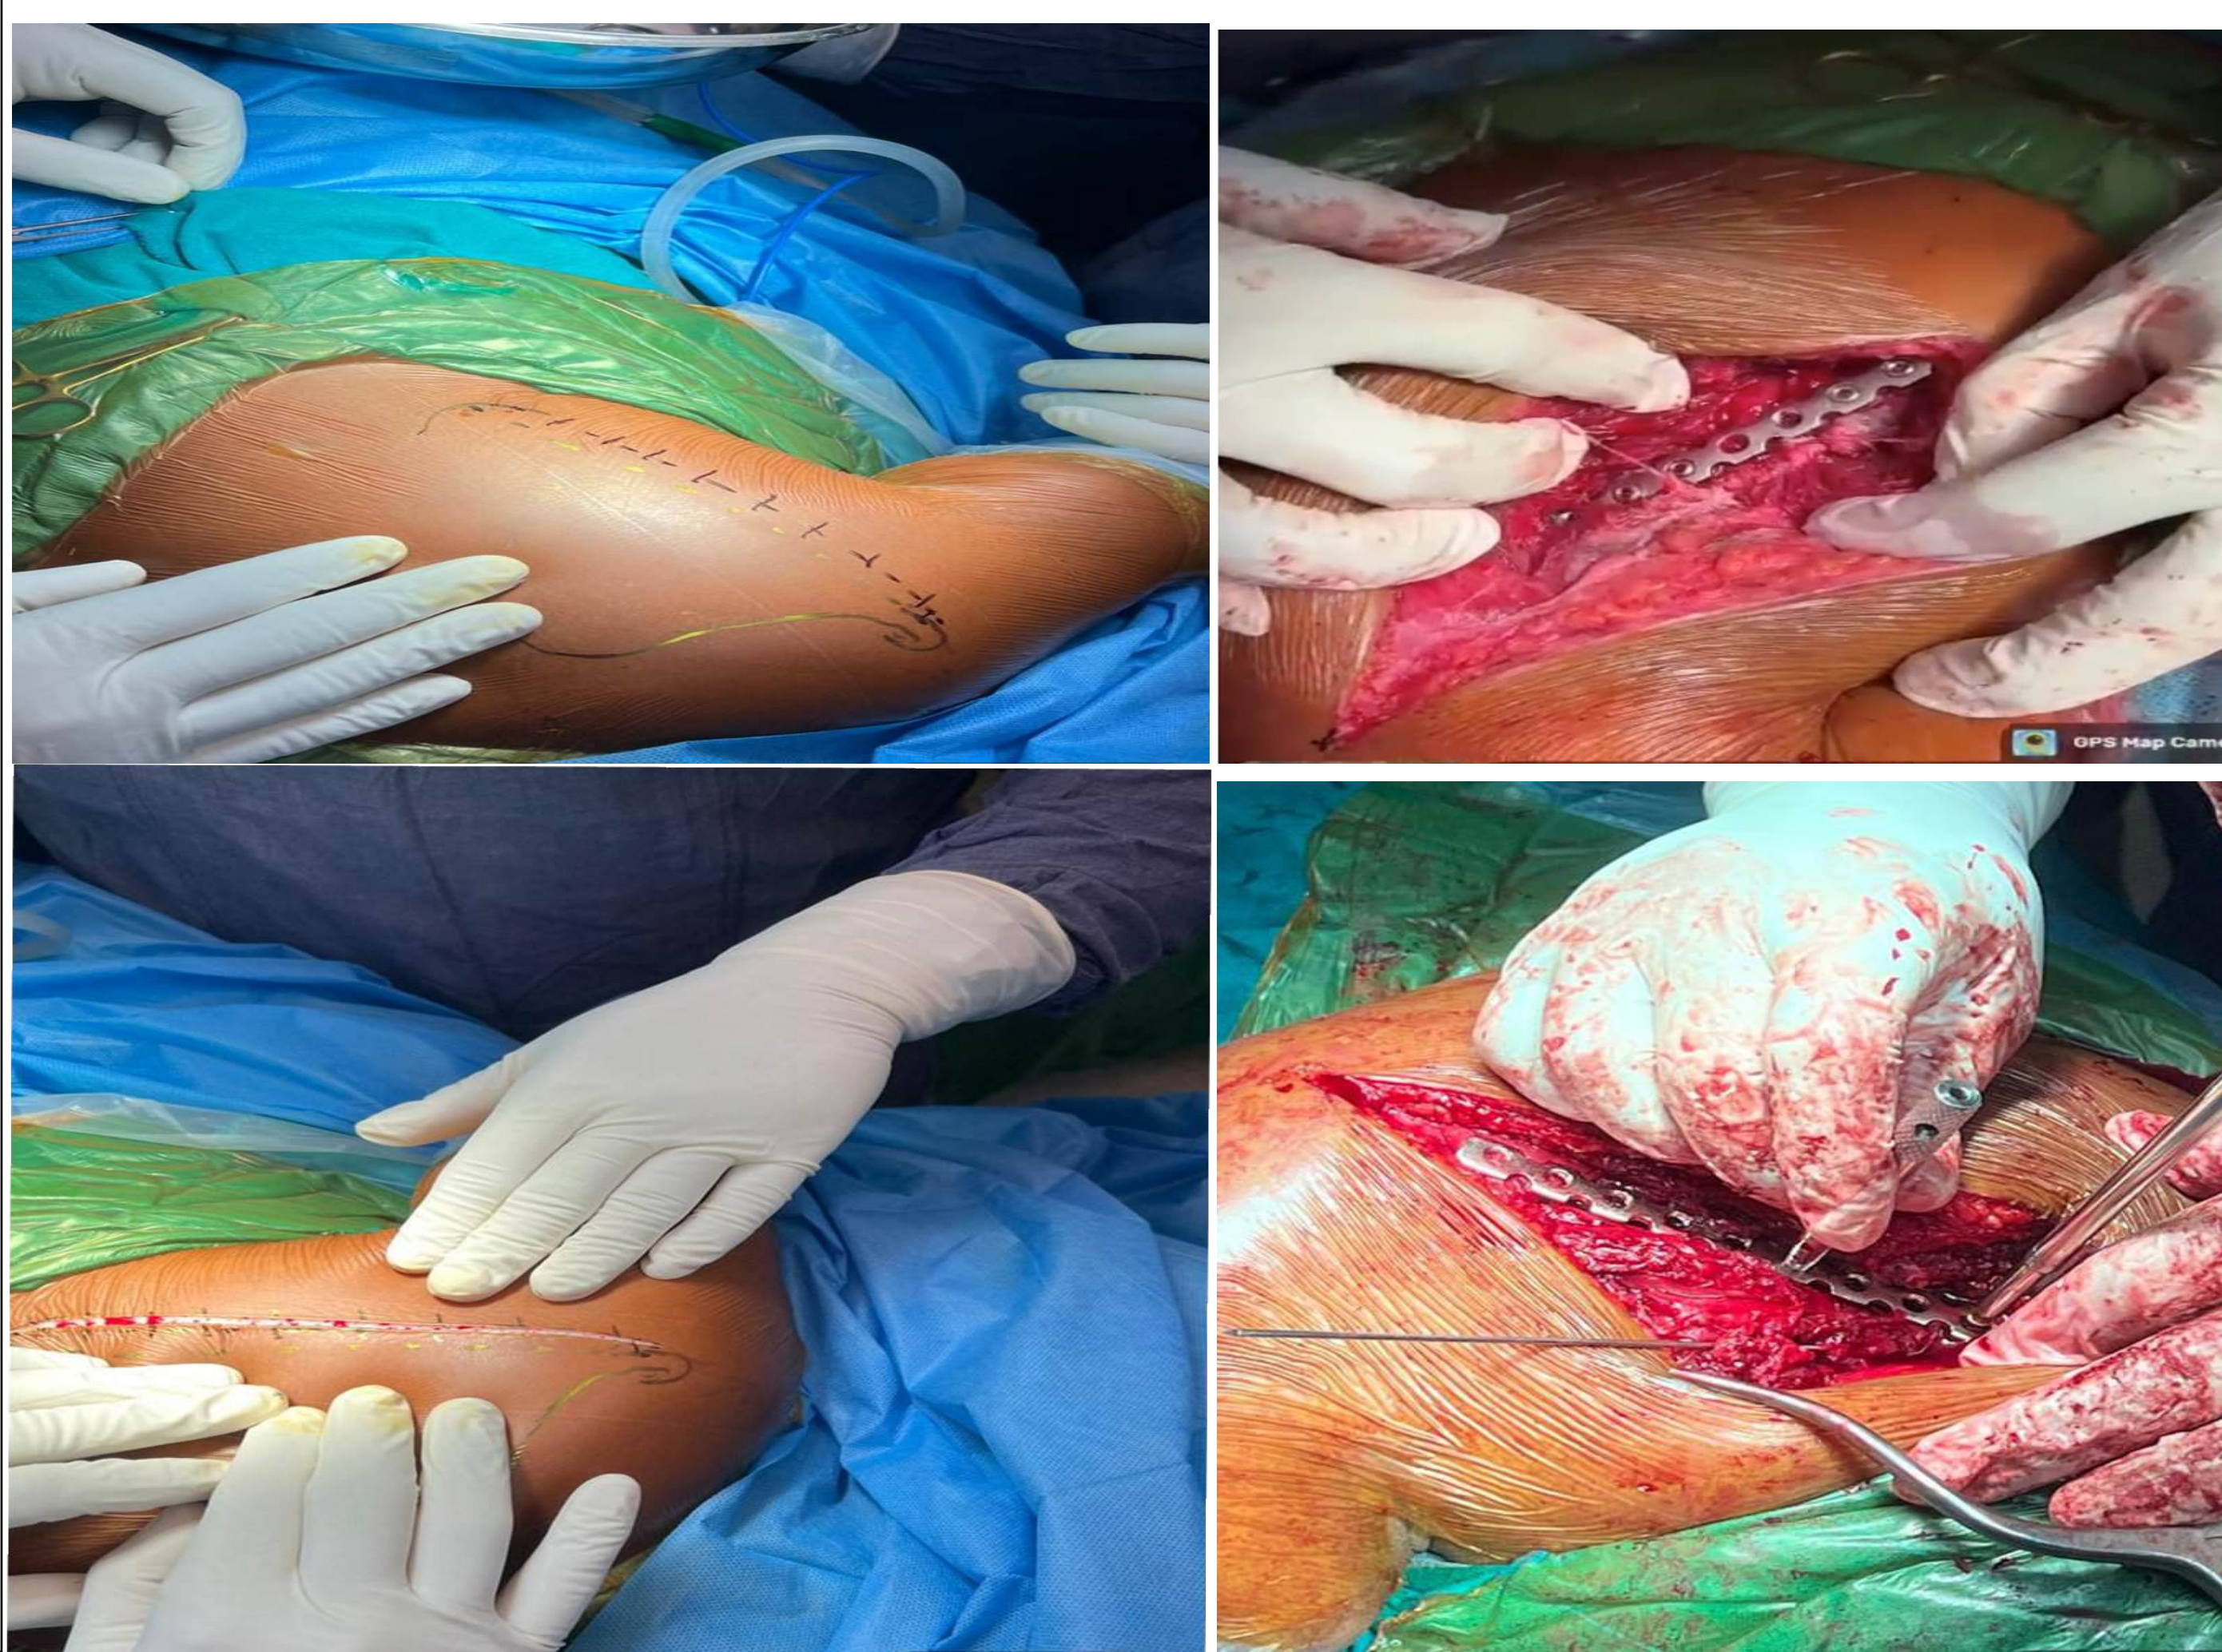
OPERATIVE FINDINGS

After routine preoperative evaluation and anesthesia clearance, the patient was positioned in a lateral decubitus position. A posterior Brodsky approach was used. A 10–12 cm skin incision was made starting from the posterior corner of the acromion and extending distally up to the inferior pole of the scapula, parallel to the lateral border of the scapula. Skin and subcutaneous tissues were incised, and the interval between the deltoid and teres minor muscles was identified and carefully separated. The fracture fragments along the lateral border of the scapula were exposed. The levator scapulae muscle was split to expose the inferior pole of the scapula. The inferior and lateral borders of the scapula were adequately visualized. Fracture fragments were cleared of interposed soft tissue, anatomically reduced, and aligned. Fixation was achieved using reconstruction plates contoured to the scapular anatomy and secured with screws. Wound closure was done in layers over a suction drain.
