Appendix A

Cathedral Gallery

This appendix presents the full visual record of the Cathedral Complex case study, showing the region-growing clustering process, intermediate mesh results, and final reconstructed model.

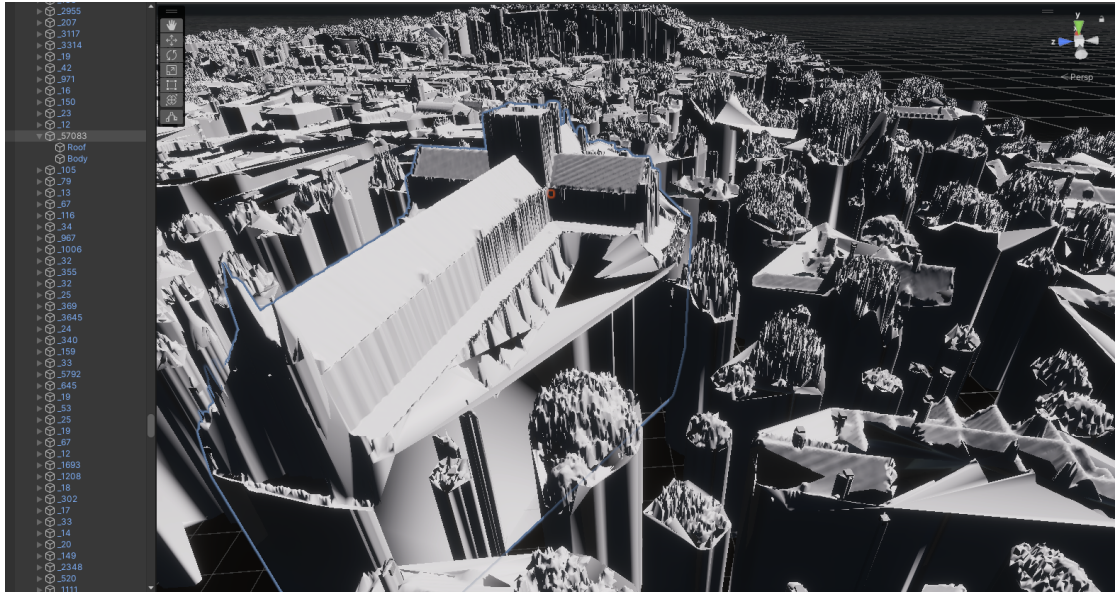
FIGURE A.1: Structural anomaly identified during large cluster list model generation.

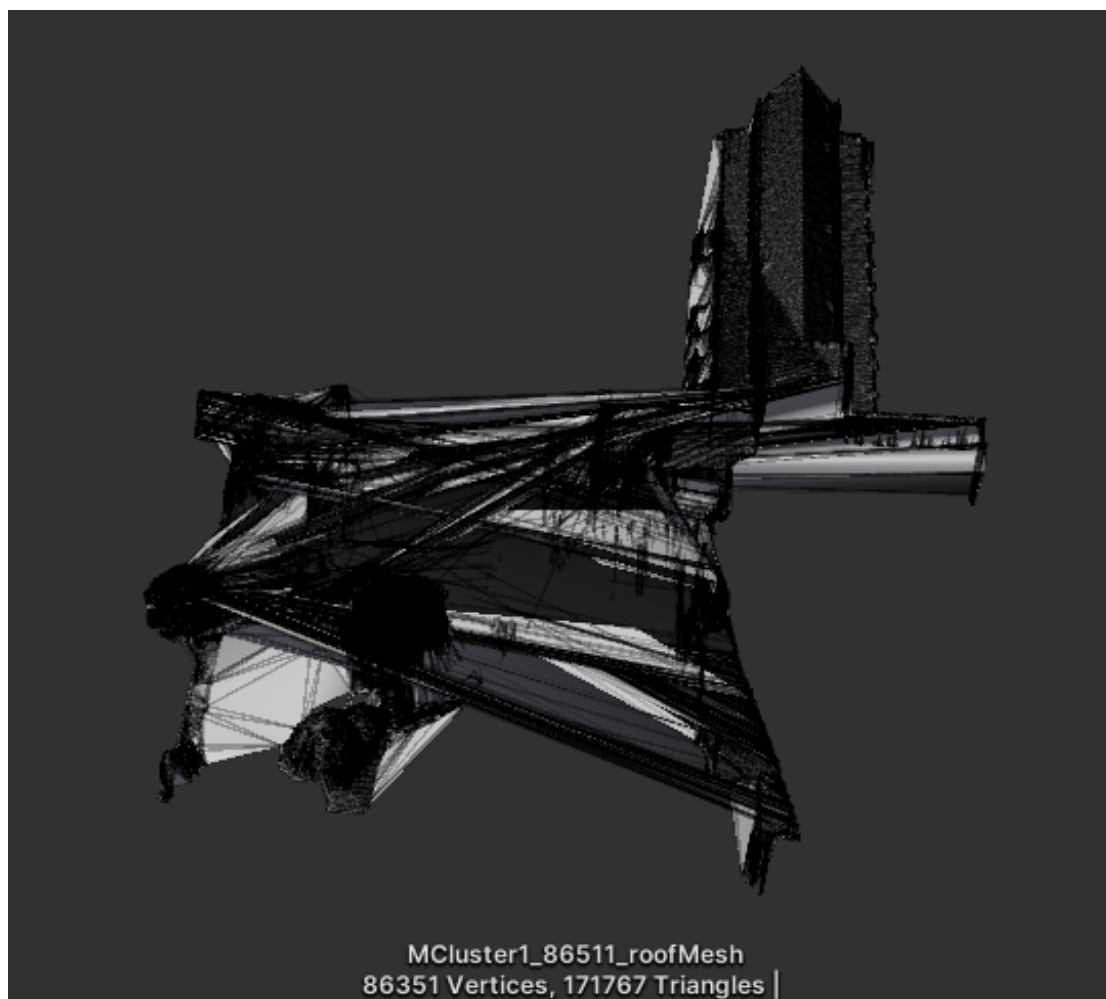
FIGURE A.2: Roof mesh of the original complex showing anomalies: spurious triangles and structural bridges.

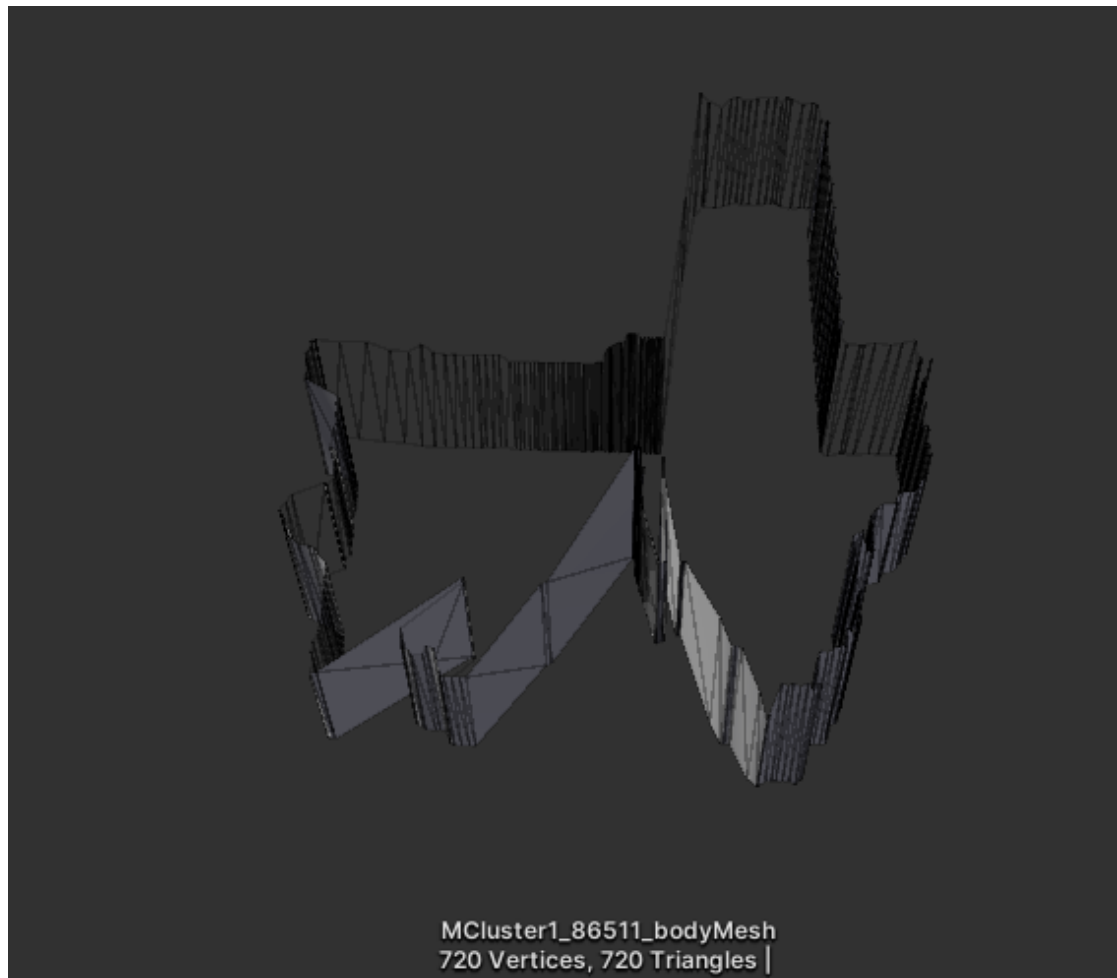
FIGURE A.3: Body mesh of the same complex showing that the boundary estimation was close to correct.

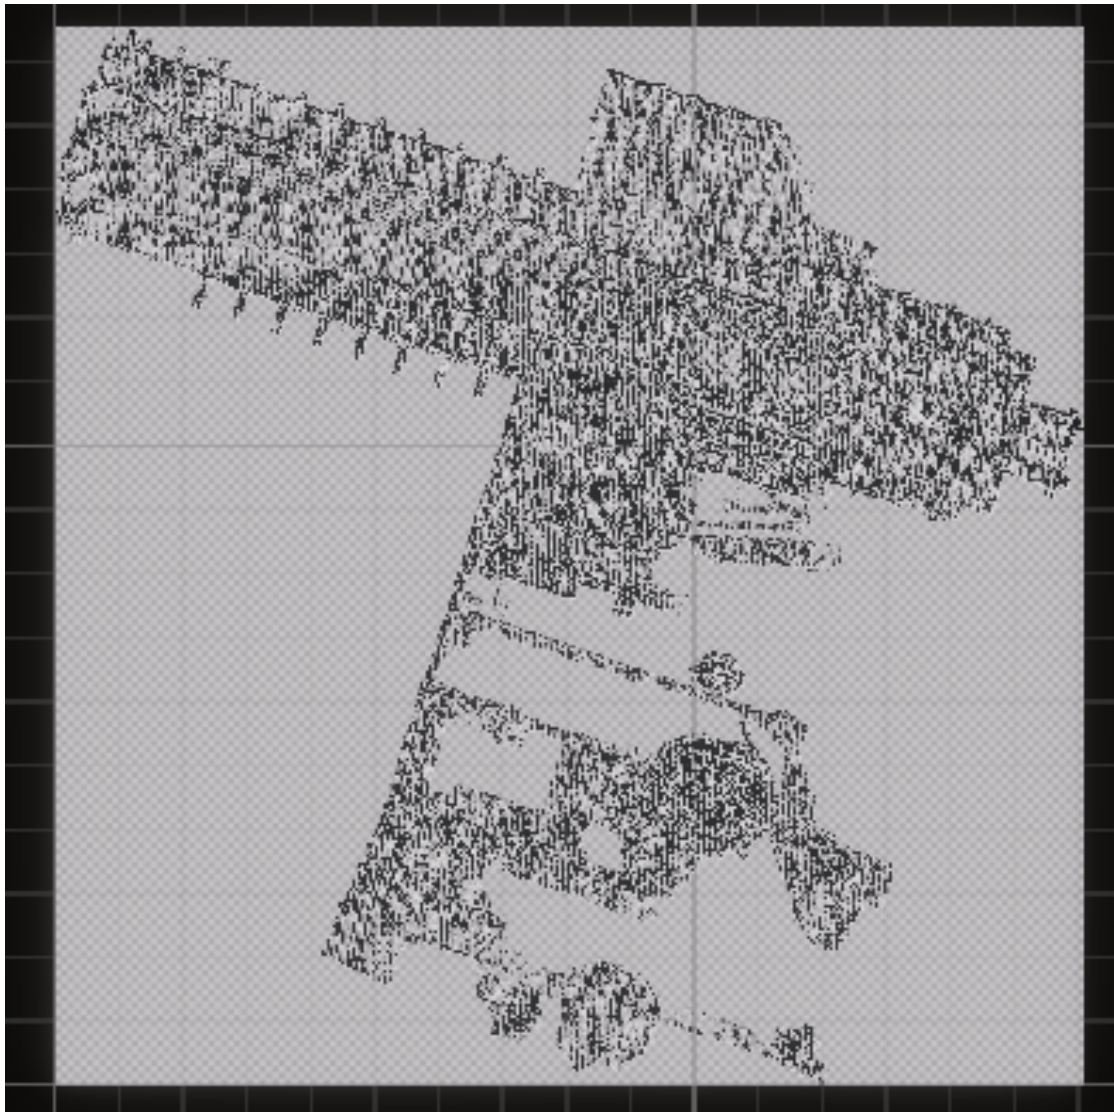
FIGURE A.4: Cathedral complex cluster extracted with a 1.0 m radius threshold (90,544 points). The created collection was used as input for the Terrain Generator. A low resolution and top-down view were used to make the cluster points easier to distinguish.

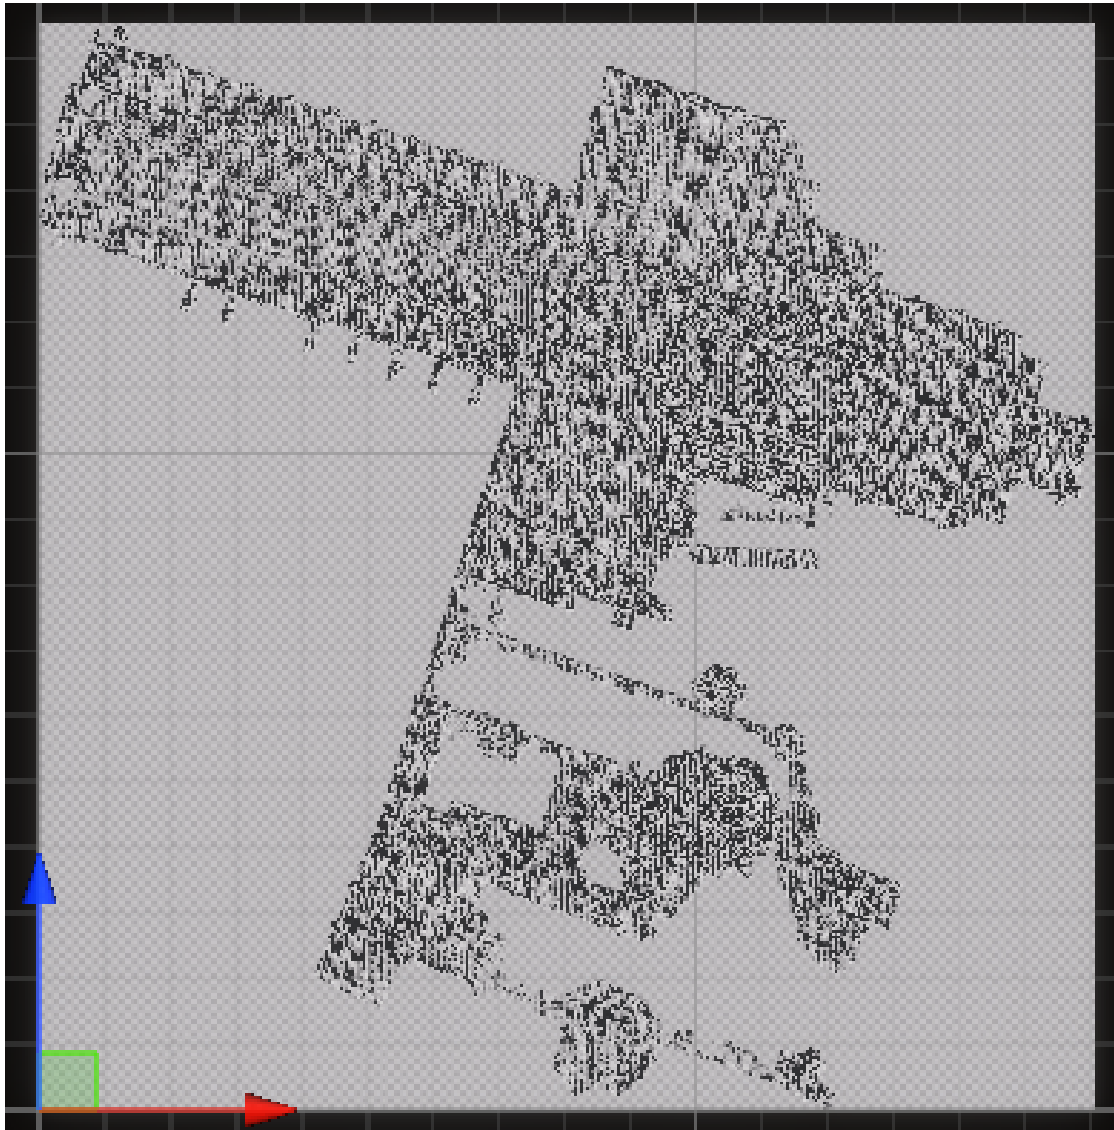
FIGURE A.5: Cathedral complex cluster extracted using an 8.0 m radius threshold. This collection was later used as input for the Terrain Generator. A low resolution and top-down view were used to make the cluster points easier to distinguish. Although subtle, some points were indeed removed — a "spot the difference" challenge.

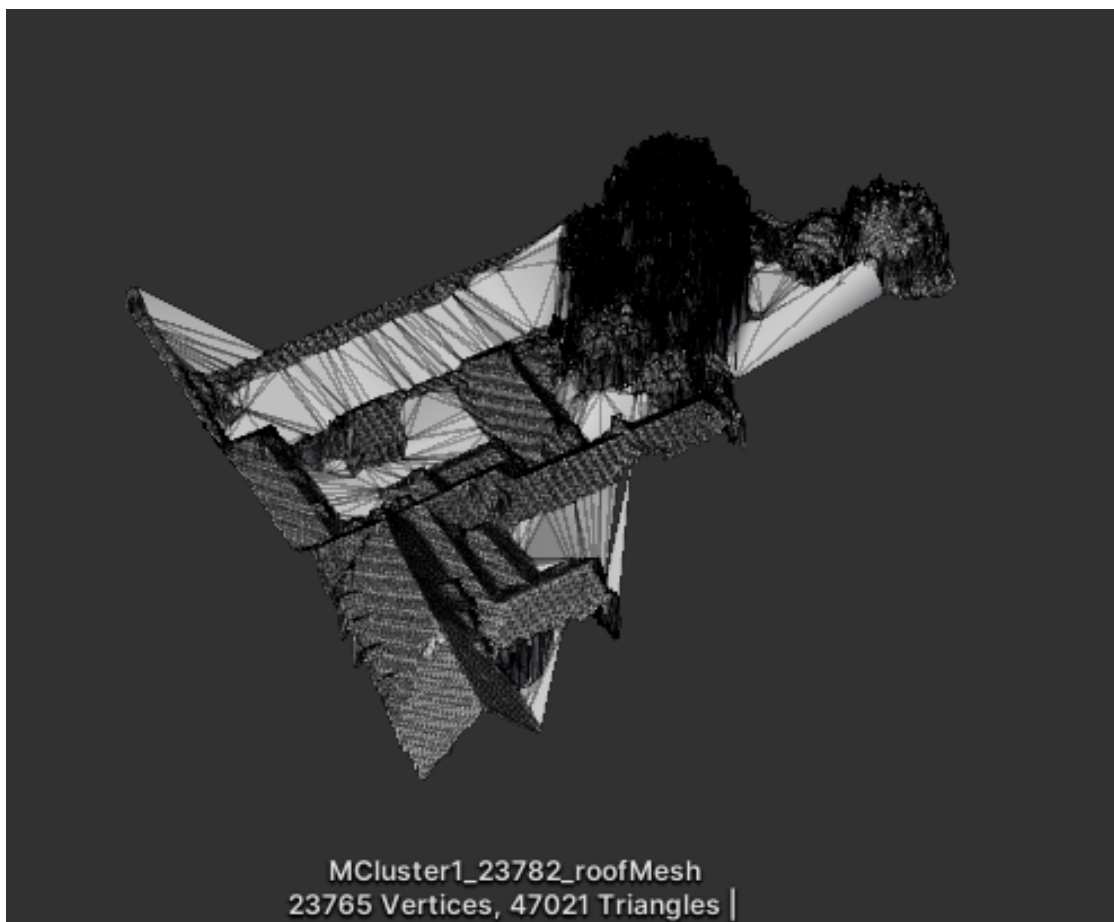
FIGURE A.7: Roof mesh reconstructed from the side building subcluster, with anomalies eliminated.

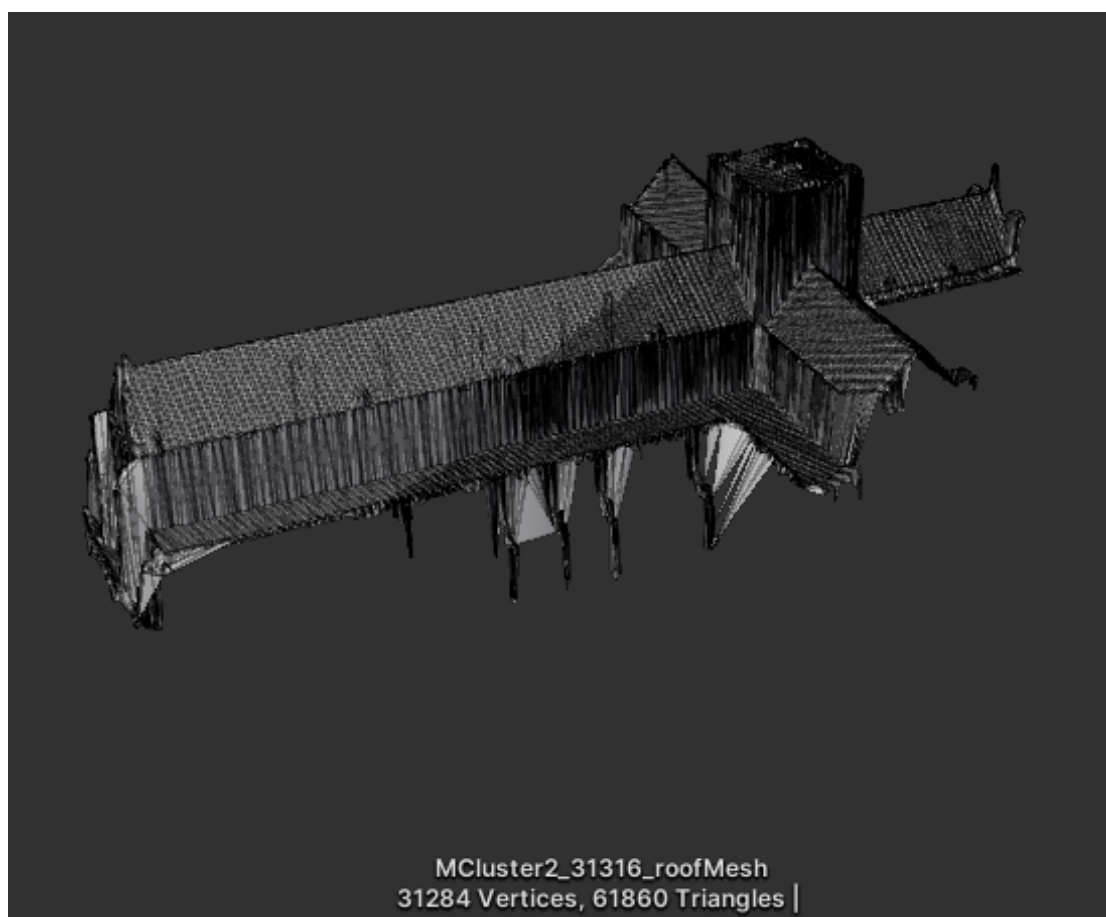
FIGURE A.8: Roof mesh reconstructed from the main nave subcluster, with anomalies eliminated.

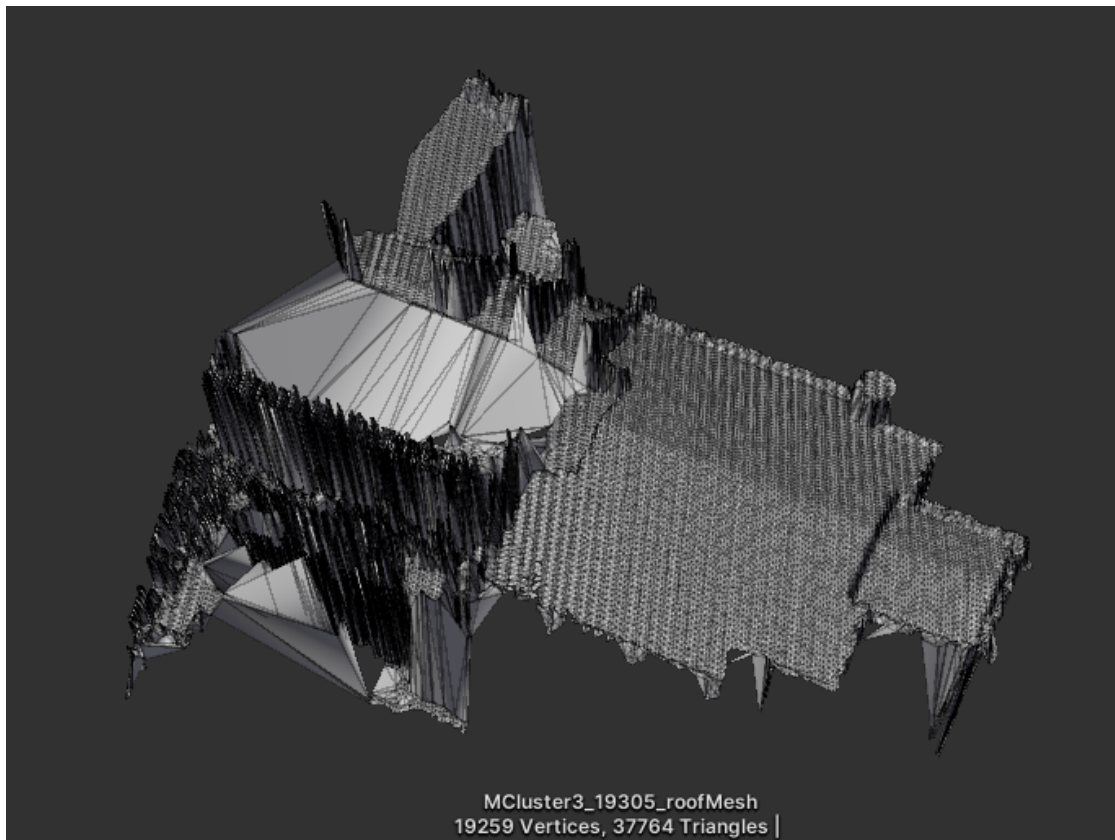
FIGURE A.9: Roof mesh reconstructed from the altar subcluster, with anomalies eliminated.

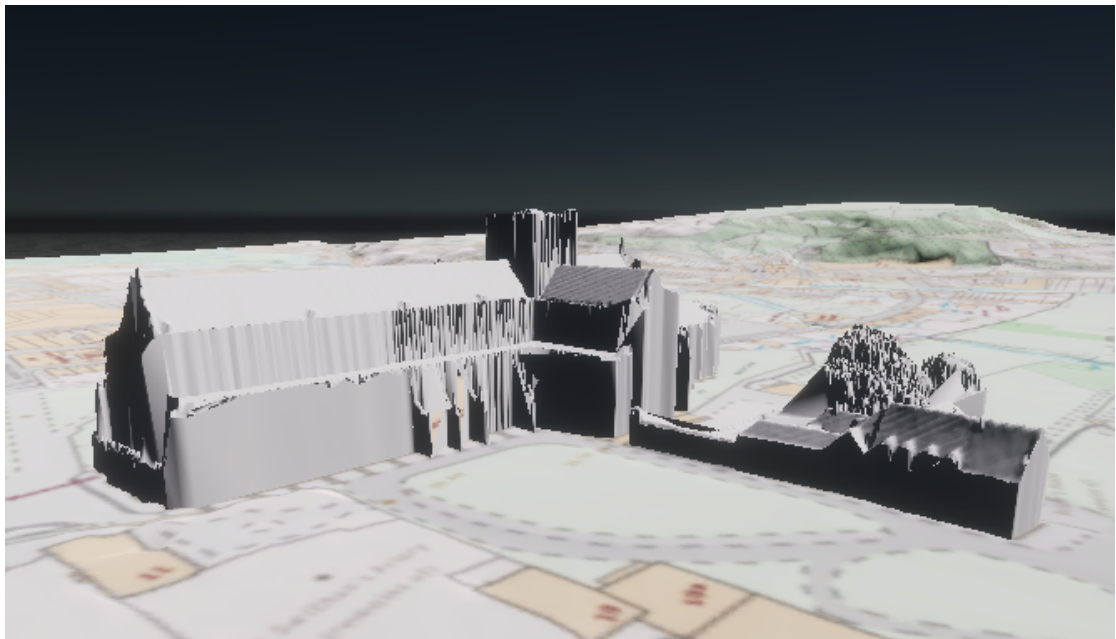
FIGURE A.10: Cathedral complex rebuilt from three subcluster models, accurately placed by the pipeline.
