Automated Feature Engineering

More about geo_level_id

About the materials (has_superstructure_...)

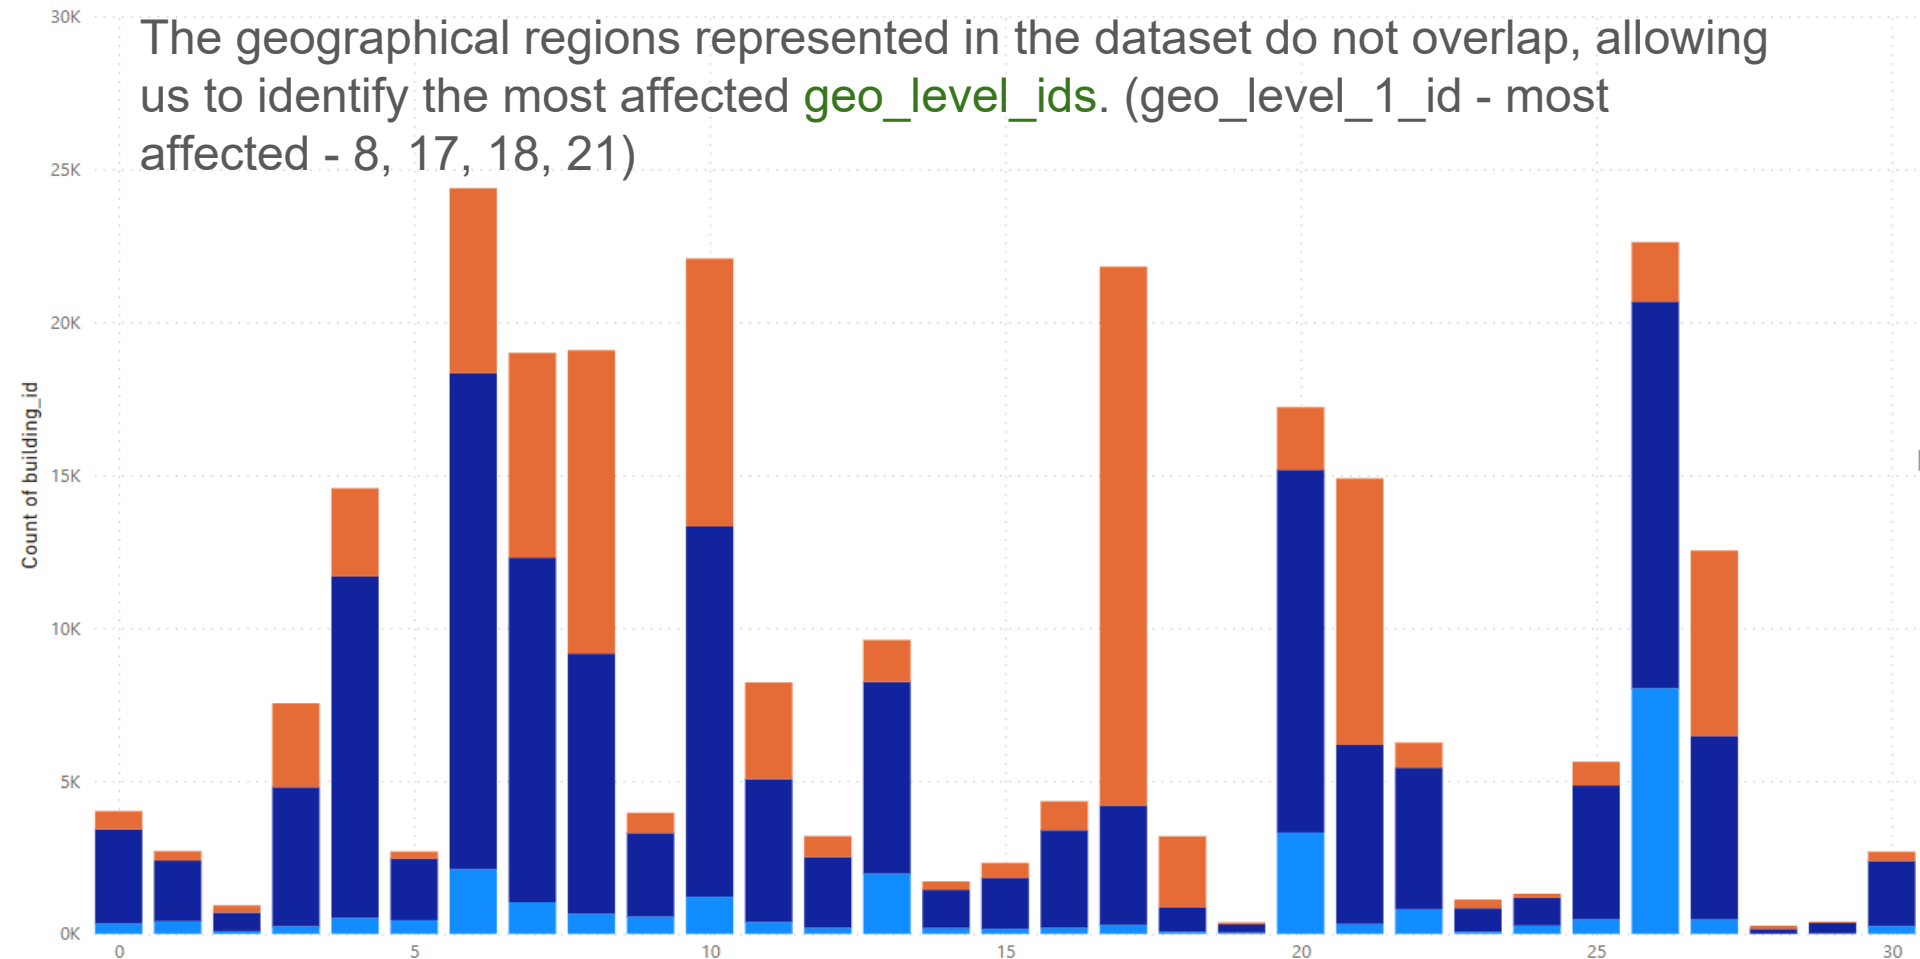
The geographical regions represented in the dataset do not overlap, allowing us to identify the most affected **geo_level_ids**. (geo_level_1_id - most affected - 8, 17, 18, 21)

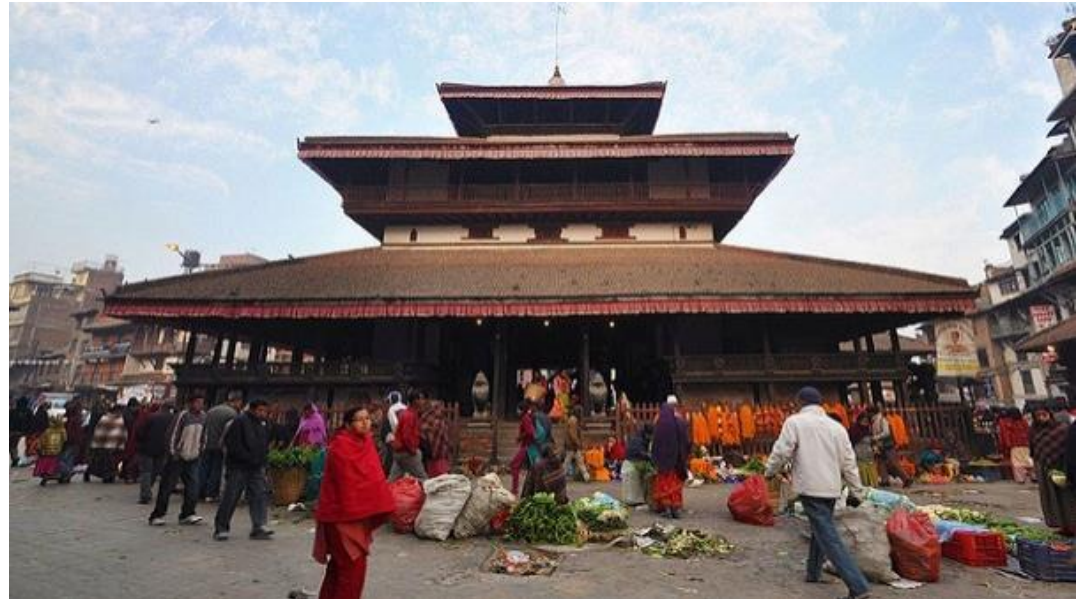
It is believed that the **Kasthamandap Temple** was constructed from a single Sal tree trunk, known for its enhanced strength and resistance to environmental factors.

This three-tiered pagoda was formerly used as a **shelter** for merchants and travelers journeying from Tibet to India. Such small inns in the Kathmandu Valley were not uncommon.

The goal was to find some significant, well-known building, such as the **Kasthamandap Temple**

Basing our findings on the material - wood, and considering the age of the buildings, along with the fact that the temple was previously used as a hotel, we have tentatively identified this temple (and the **Durbar Square** itself) in our dataset.

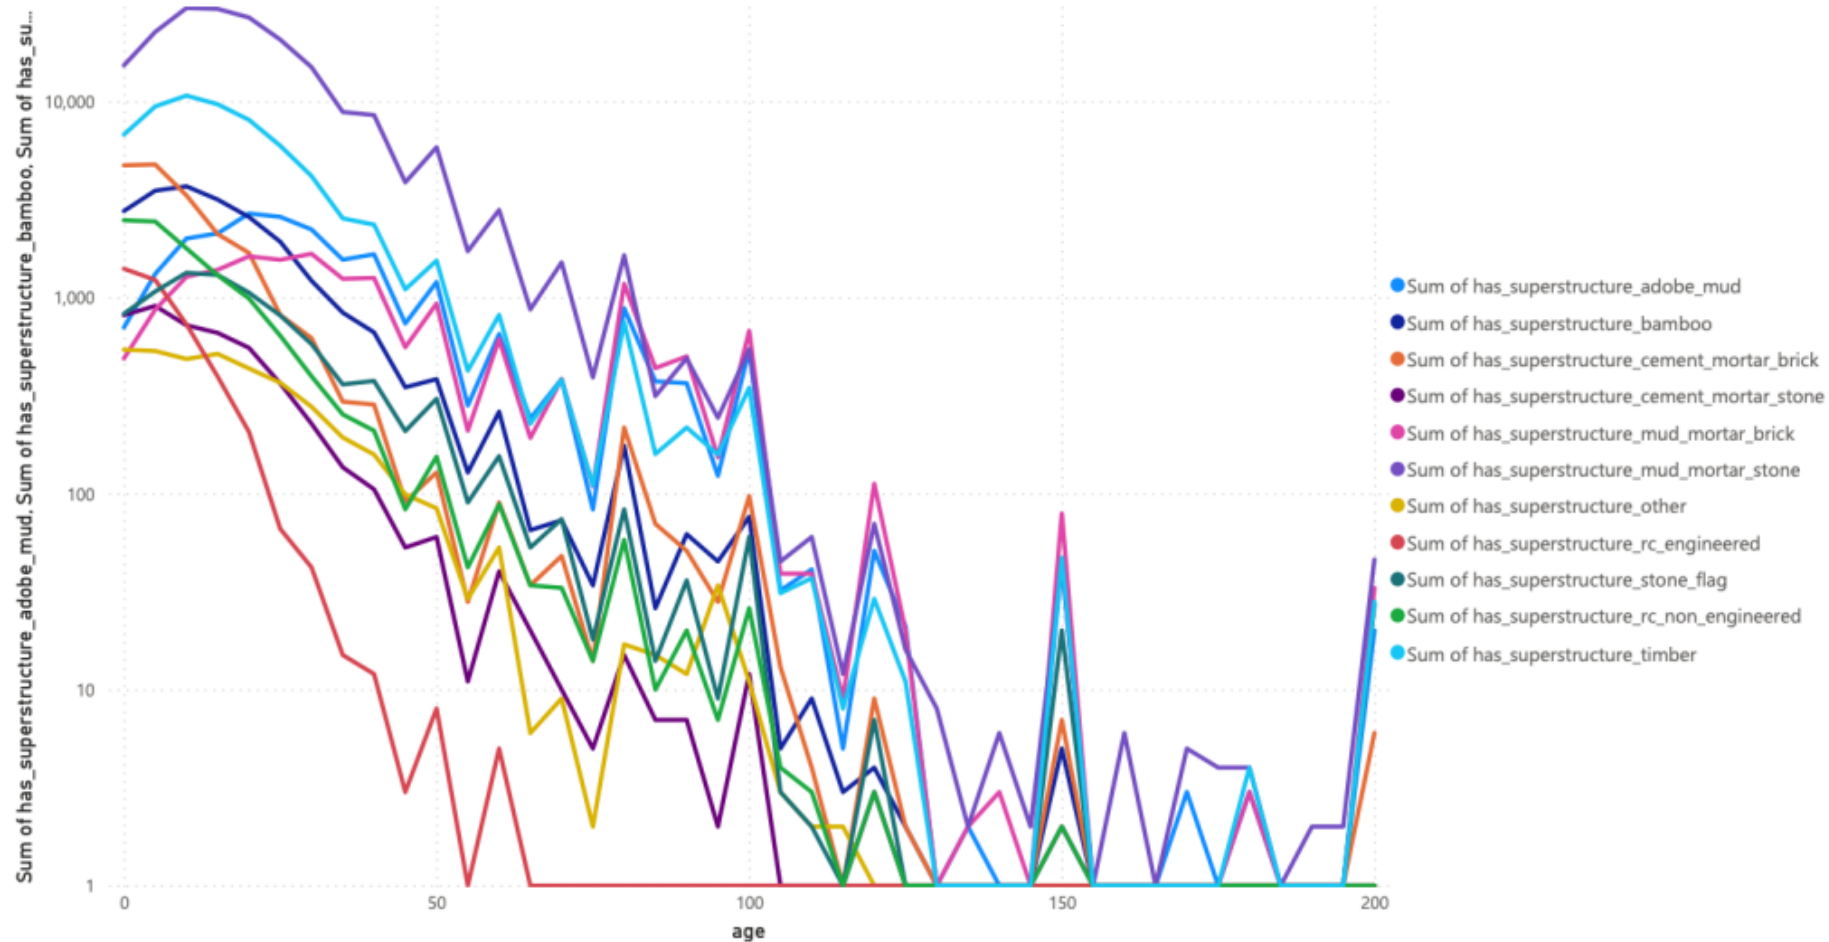
Sum of has_superstructure_adobe_mud, Sum of has_superstructure_bamboo, Sum of has_superstructure_cement_mortar_brick, Sum of has_superstructure_cement_mortar_stone, Sum of has_superstructure_mud_mortar_brick, Sum of has_superstructure_mud_mortar_stone, Sum of has_superstructure_other, Sum of has_superstructure_rc_engineered, Sum of has_superstructure_stone_flag, Sum of has_superstructure_rc_non_engineered and Sum...
