TECHNICAL REPORT

Group 17

This project will provide a comprehensive analysis of site T at the University of Wales Trinity Saint David in Lampeter, which in great part constitutes the surroundings of the Sports Hall.

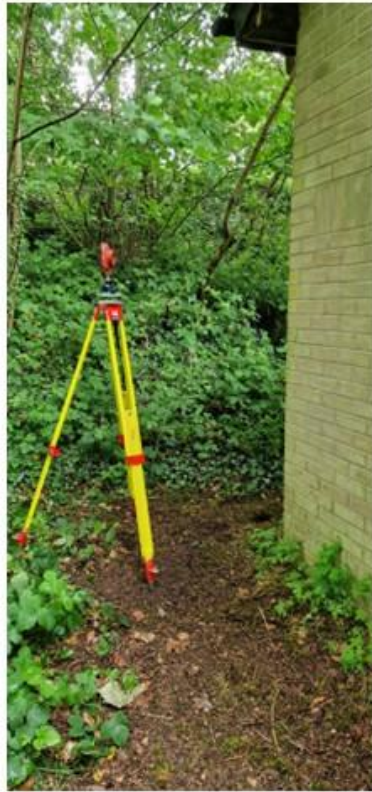
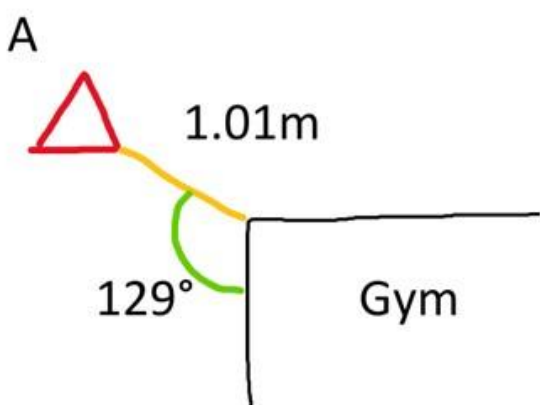
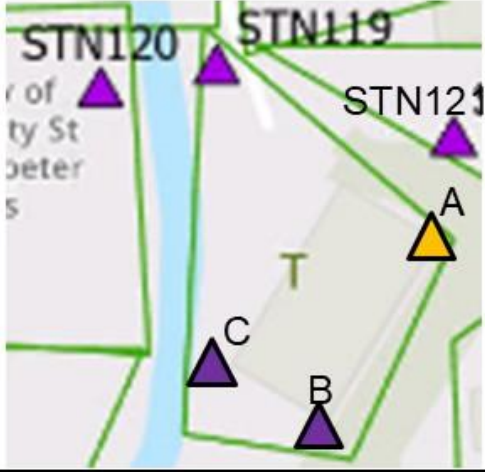
7.1 Appendix A: Full Description of Station A

UCL	
Station Description Sheet	
Station Identifier:	A
Project:	SURV_LAMP
Date:	04/06/2025
Coordinates	
Easting	258120.608
Northing	248116.195
Height	116.03475
Coord. System:	Ordinance Survey (Newlyn)
Notes:	Wooden peg in ground in the northeast of the Sports Hall.
Image of Marker:

Marker A was established in line of sight between ST119 and Marker B and can be located via a wooden peg placed by the team at that point. Its location has proven to be somewhat of a challenge for the team, due to the very restricted space in which it was possible to operate.

Full information on Marker A can be found in Appendix A.

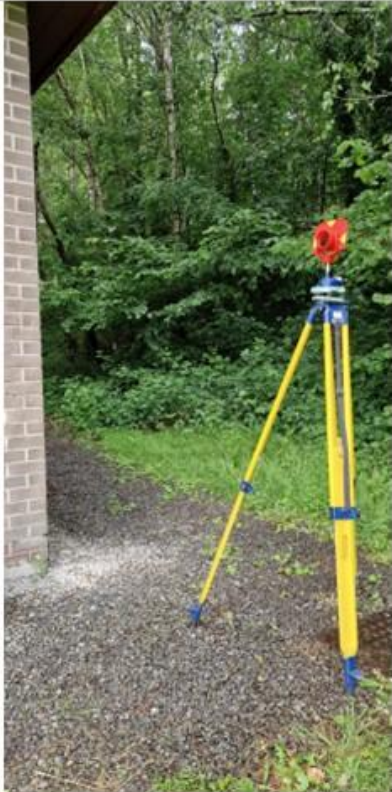
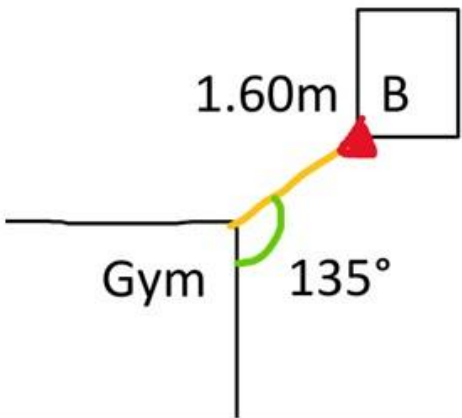
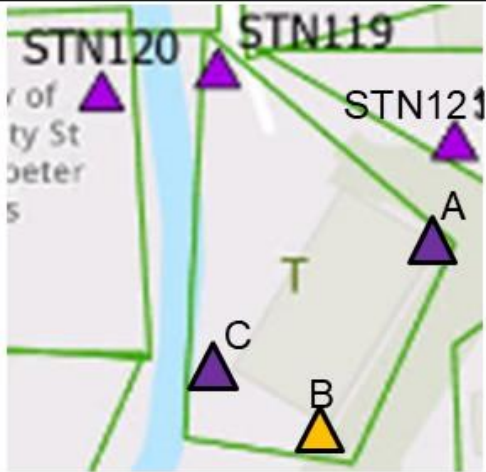
7.2 Appendix B: Full Description of Station B

UCL	
Station Description Sheet	
Station Identifier:	B
Project:	SURV_LAMP
Date:	04/06/2025
Coordinates	
Easting	258096.368
Northing	248079.307
Height	115.9515
Coord. System:	Ordnance Survey (Newlyn)
Notes:	Outermost corner of manhole cover southeast of the Sports Hall.
Image of Marker:

Marker B was established on the furthest point of the site from ST119, or in other words, behind the Sports Hall. More precisely, Marker B is situated on the outermost corner of the manhole cover that can be found there. Gravel at that permanent marker has proven to be difficult to work with, and the surveying team has taken additional precaution to ensure accurate readings.

Complete data for Marker B can be found in Appendix B.

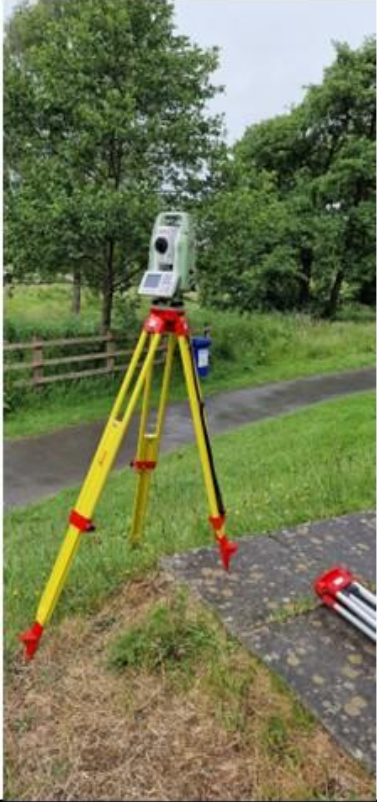
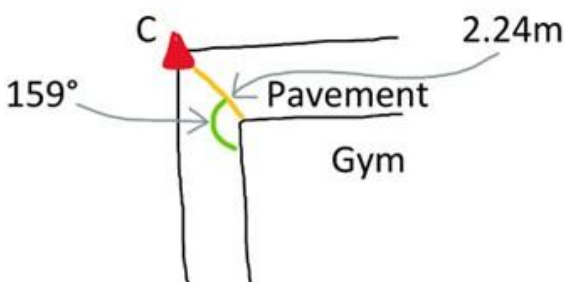
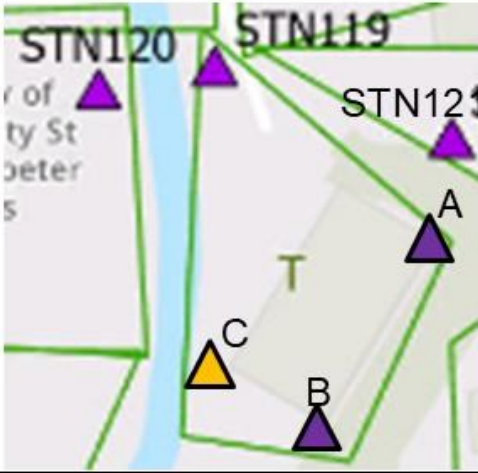
7.3 Appendix C: Full Description of Station C

Date:	04/06/2025	
Coordinates		
Easting	258078.734	
Northing	248090.456	
Height	116.13925	
Coord. System:	Ordnance Survey (Newlyn)	
Notes:	Outer corner of pavement southwest of the Sports Hall.	
Image of Marker:

Marker C is in direct line of sight of Marker B and ST119. It can be found on the outer corner of the pavement surrounding the Sports Hall. The team had to ensure stability of the slope at that point, as measurements were taken in wet weather. Furthermore, the team ensured that readings taken at that point were checked multiple times, due to the difficulty of taking the former on a high angled slope.

Data including coordinates and height for Marker C can be found in Appendix C.
