BELL-LESS TOP DISTRIBUTOR REPLACEMENT JOB

Problem Statement:-

Project Overview:-

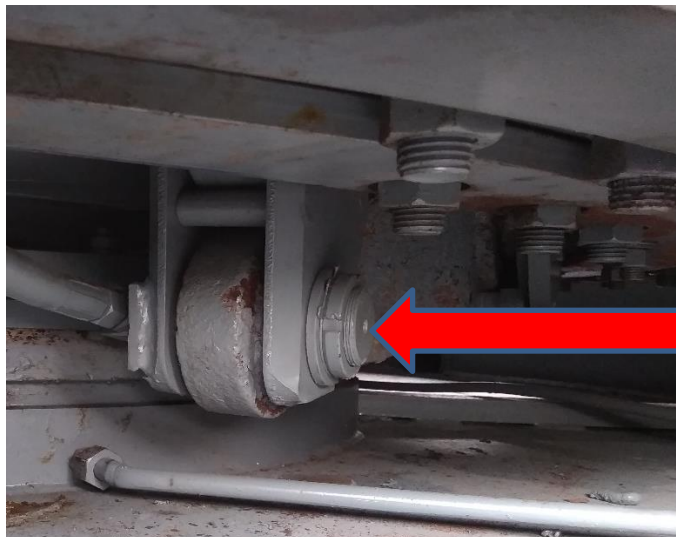
Below figure showing the location of distributor breakdown

Breakdown of Alpha drive connecting pin was the reason behind the replacement of distributor

Therefore it was decided to replace the distributor in the coming Gunning S/D of BF3.

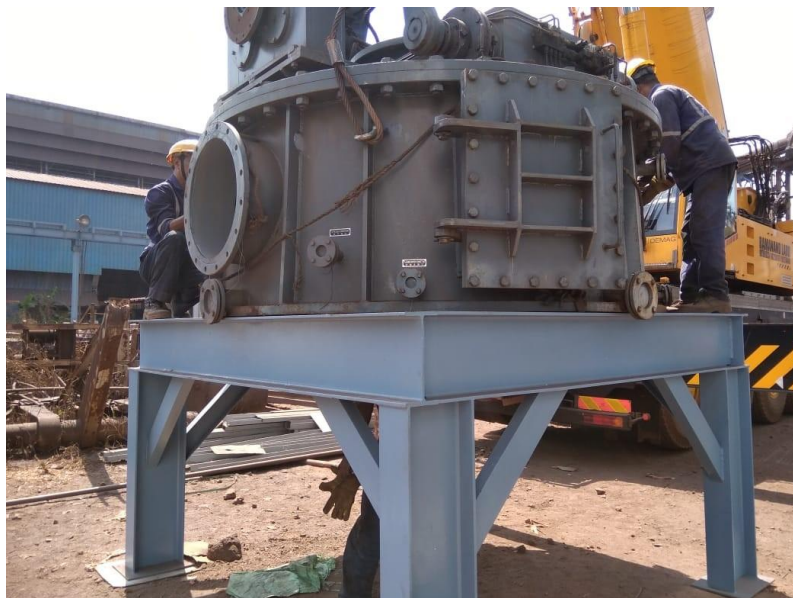
Spare Distributor was placed on Stand for trial:-

Beta drive Gear Box was installed & the spare distributor was made to run for trails, following is the current trend of the same.

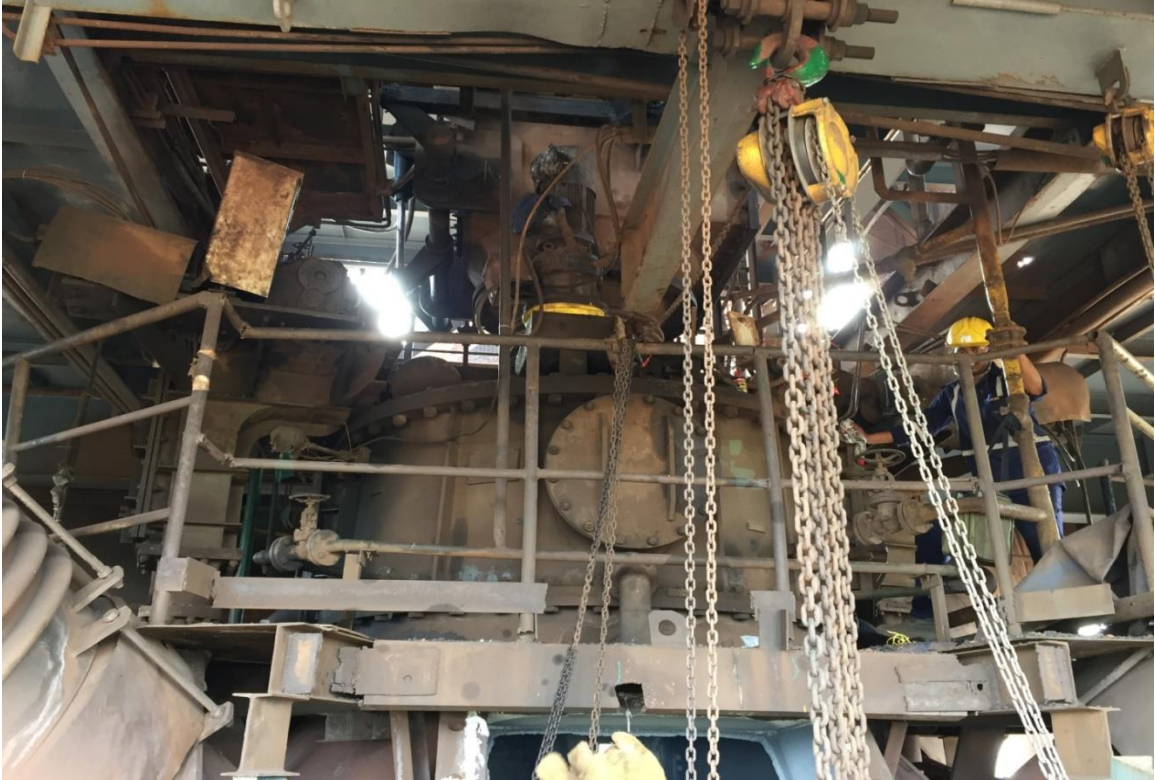
Setup of Existing Distributor Removal

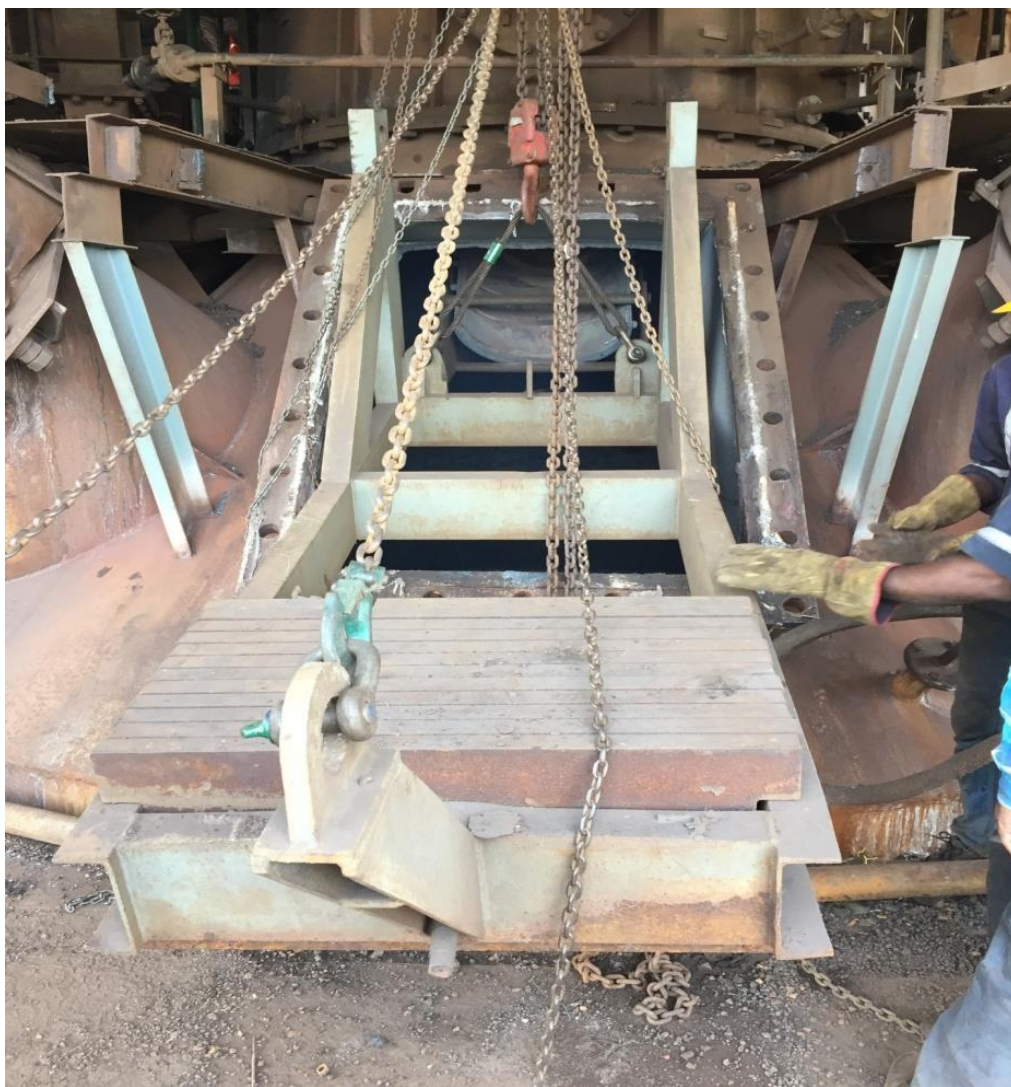
Arrangement Done For the Chute Replacement

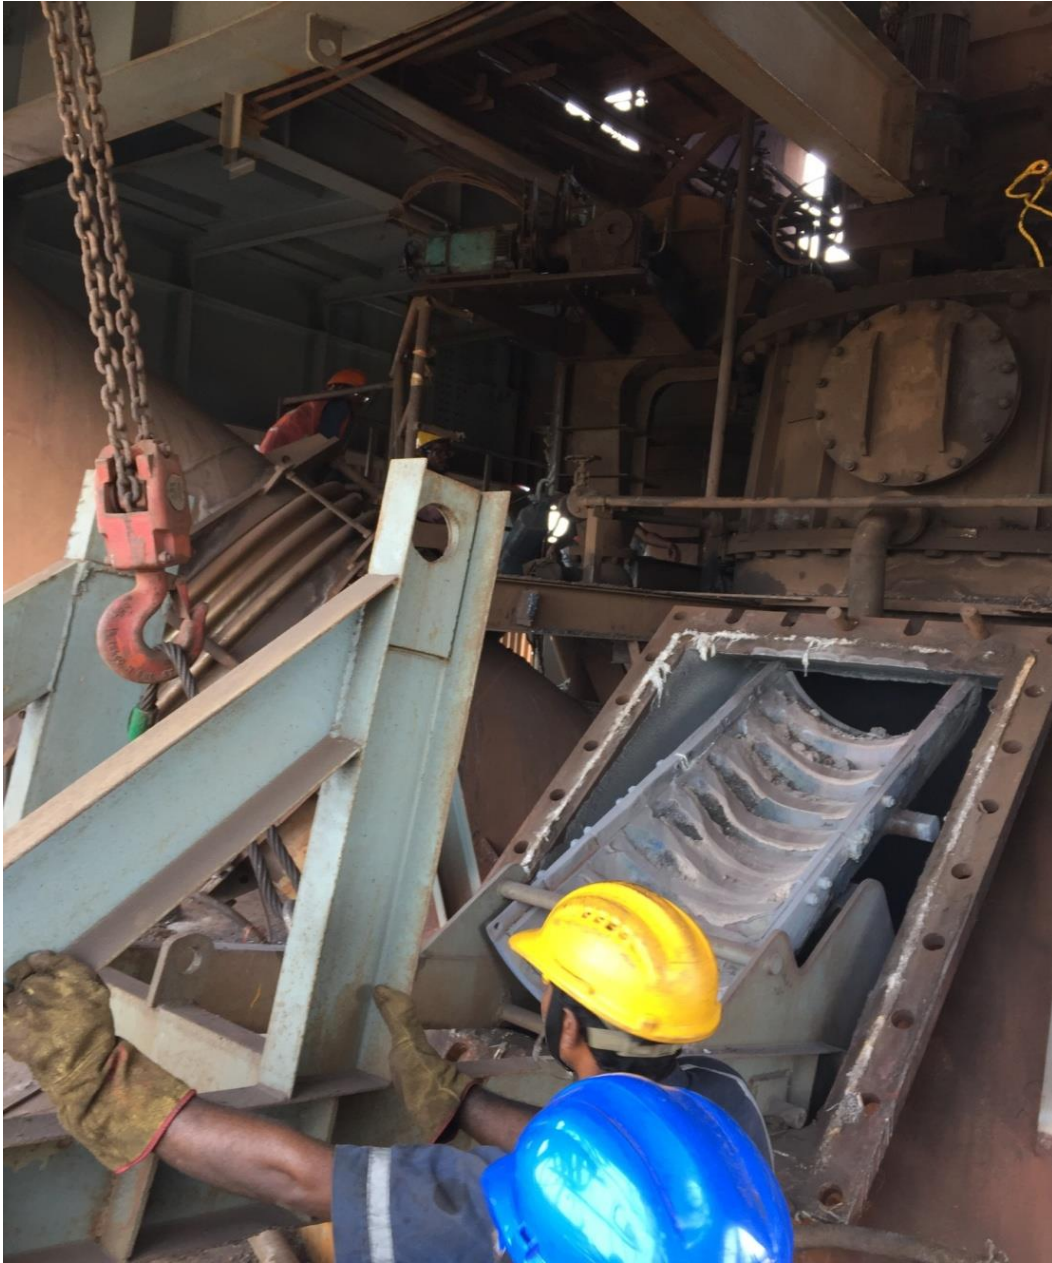
Chute Removal

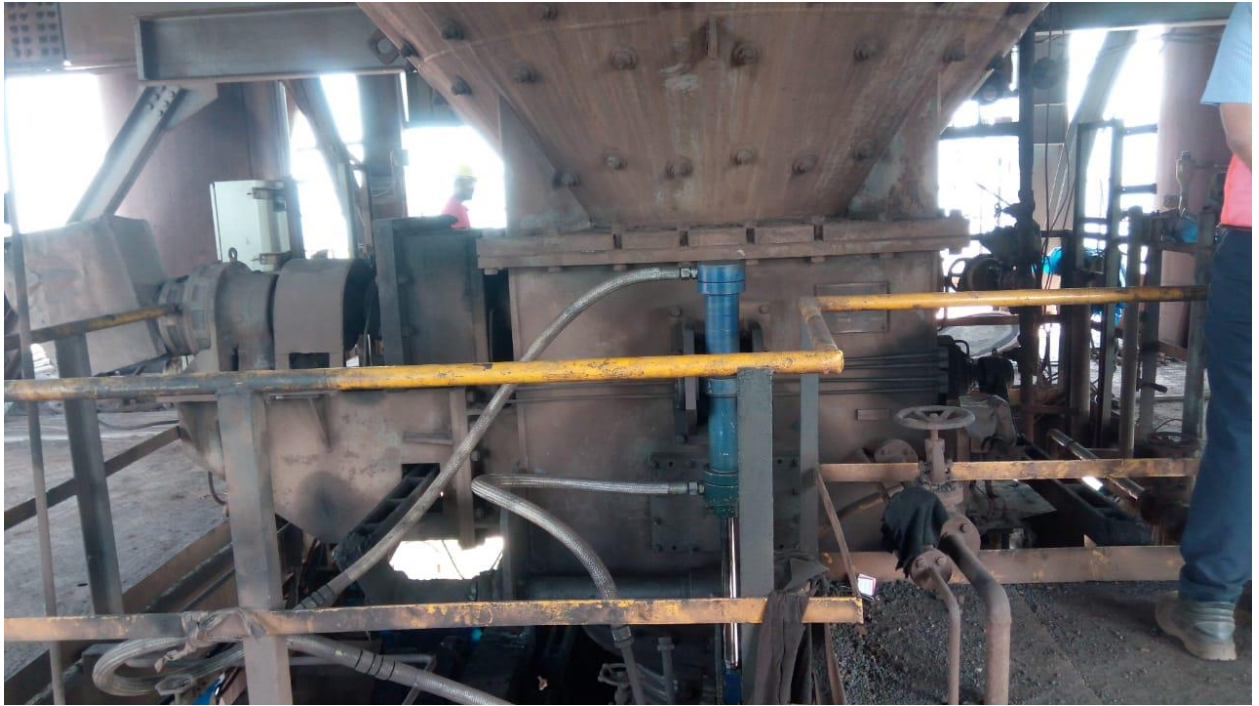
Hydraulic Cylinder Removal

7. Expansion bellow was removed by using chain pulley block.
8. Isolation of LSV hydraulic lines was done and hydraulic cylinder was removed.

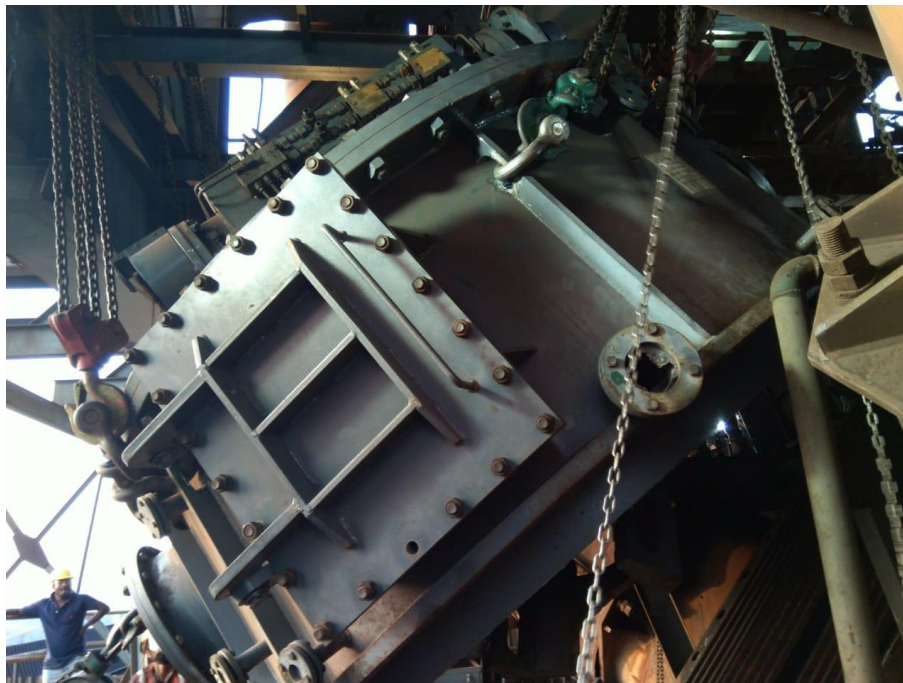
9. Base bolts of Distributor were loosened and distributor was removed using chain pulley block.
10. The top hedge & crown ring area was covered with meshes to prevent fall of material / person inside the furnace.

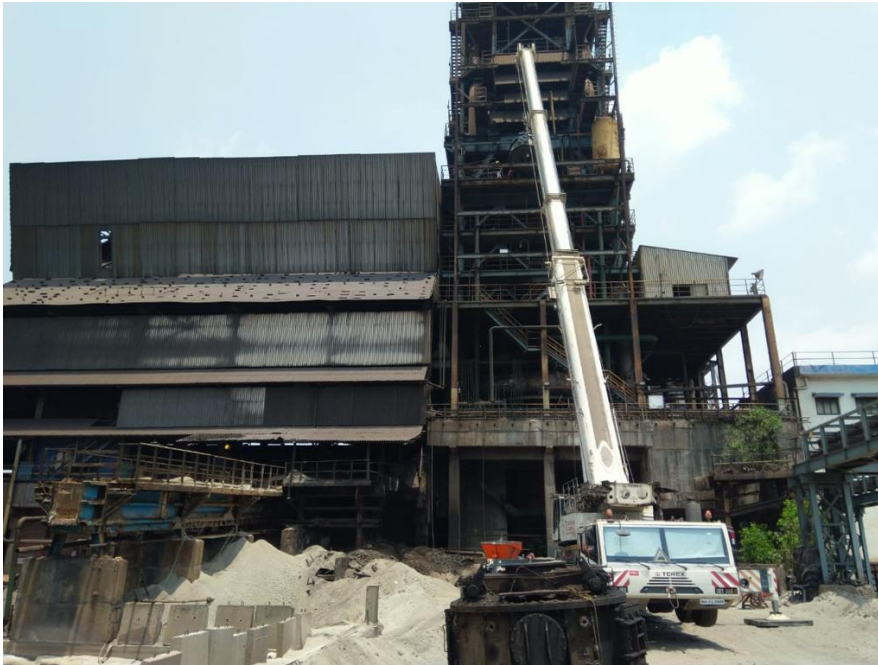
200T Crane being used for lowering the Existing Distributor to Ground Level

11. Further the distributor was shifted to ground level towards SGP side using AC – 350 Terex crane with appropriate counterweight making the crane capacity of 200T after making a proper lifting plan.

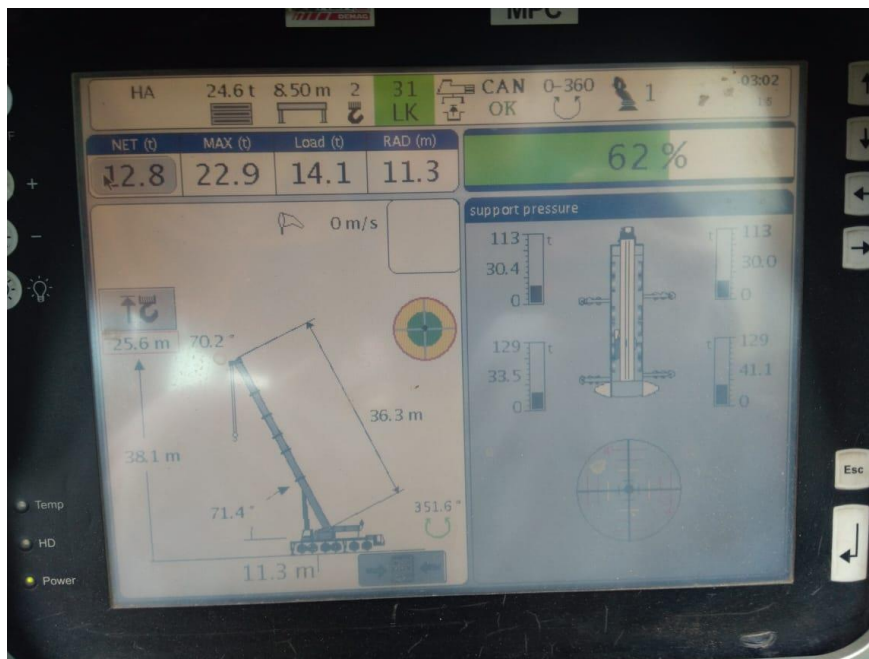
Lifting details of distributor

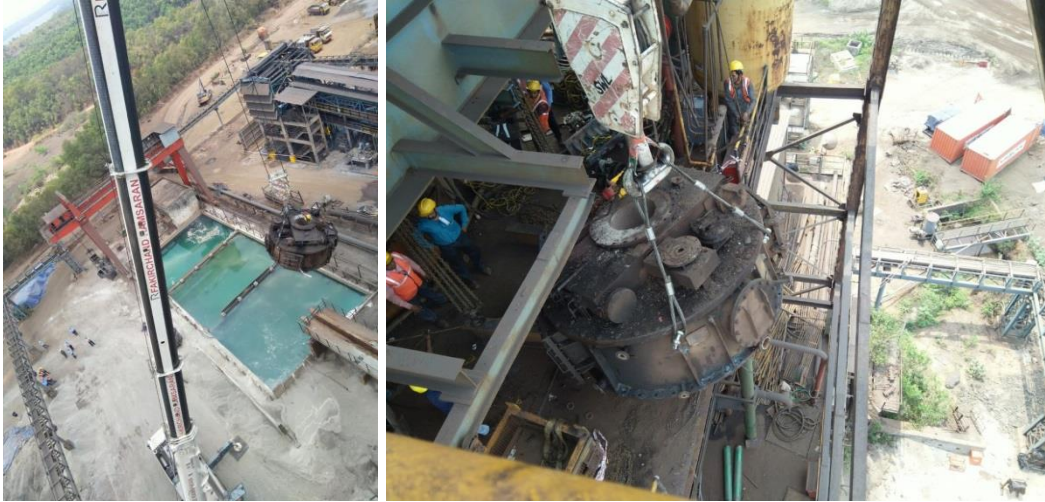
New Spare distributor being taken up from ground level to 27.4 meter height

11. New Distributor was shifted from ground level to 27.4 m platform using the same crane.

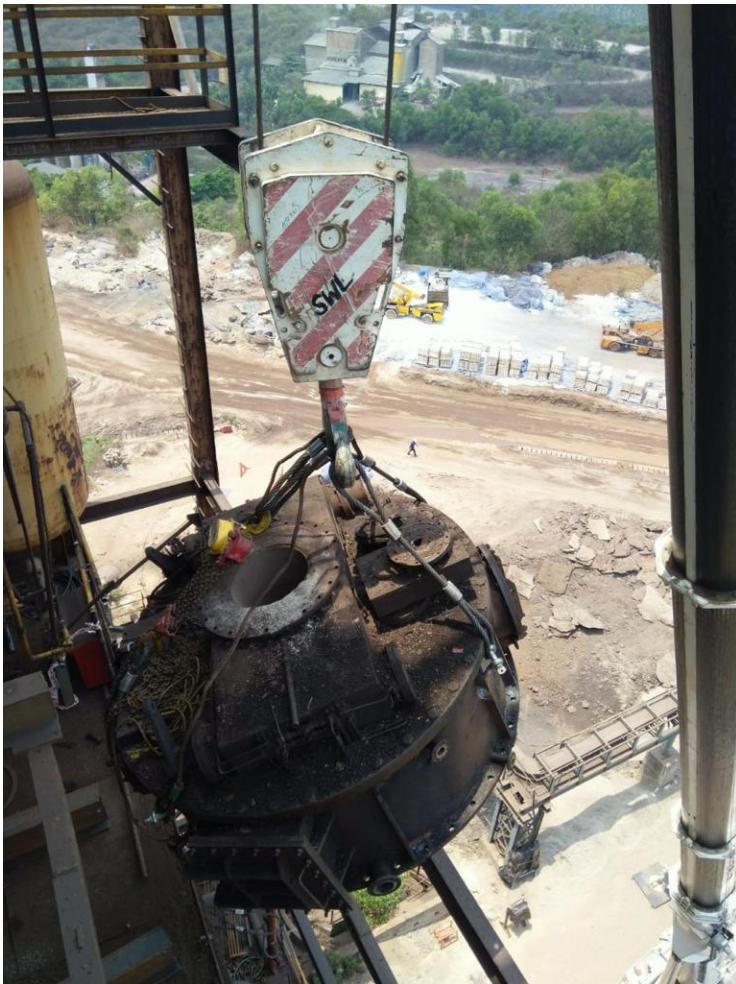
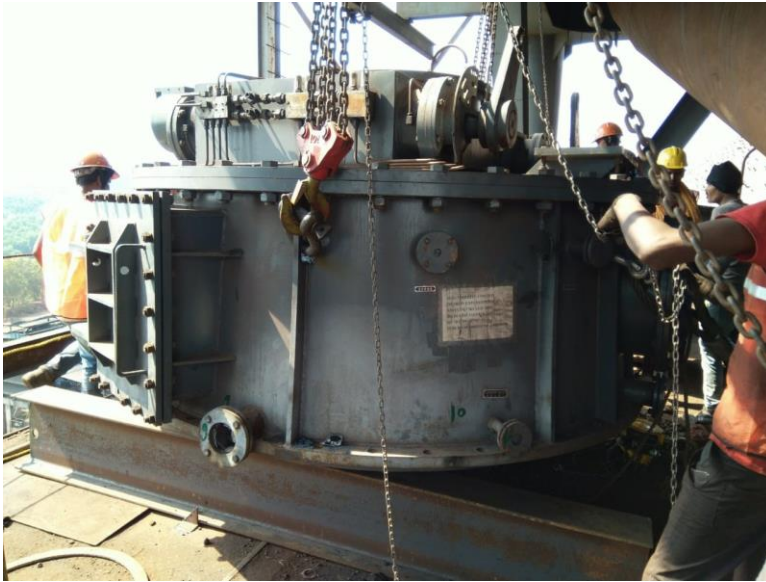
Arrangement made at 27.7 meter to place distributor

The two ISMB-400 beam of 3 meter long were placed parallel to each other on the 27.7 meter platform as shown in above figure.

The distributor was shifted from ground level to 27.7 meter with the help of AC-350 Terex crane and was placed on ISMB-400 beam.

Altogether 6 chain blocks of 10T and 2 chain blocks of 5T were used to lift and place the distributor at its original position.

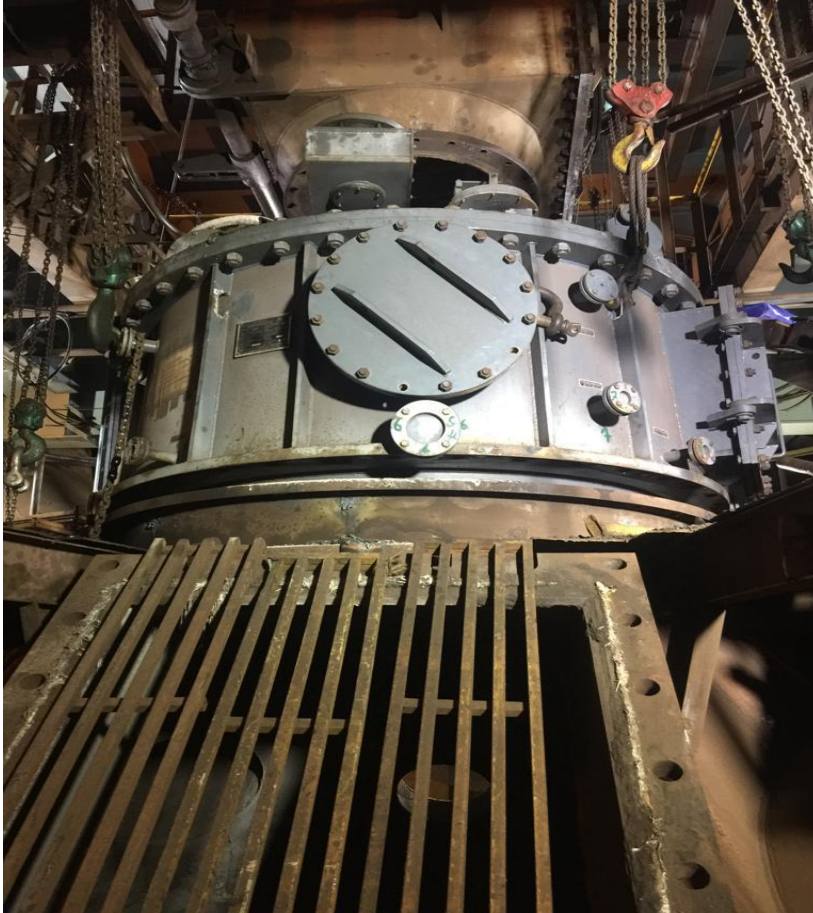
NEW DISTRIBUTOR ERECTION

Above figure show the complete orientation and installation of new distributor.

12. Tightening of base bolts of distributor and expansion bellow was done.
13. Stock rod 1 & 2 assembly drive gear box and motor was positioned using chain pulley block.
14. LSV hydraulic cylinder was placed and positioned as per requirement and the hoses were connected.
15. Alpha and Beta drive gear box and motor was positioned and ensured sufficient oil is available in Alpha and Beta gearbox.
16. All the Water, Nitrogen and lubrication lines were connected to the distributor as per Circuit requirements.
17. Electrical and Instrumentation departments were informed to connect power supply cables for Alpha and Beta drive, Stock rod drive 1 & 2 and BFRV.
