Crane Wire Rope Damage and Nondestructive Inspection Methods

Herbert R. Weischedel,
NDT Technologies, Inc.
P.O.Box 637, South Windsor, CT 06074
www.ndttech.com

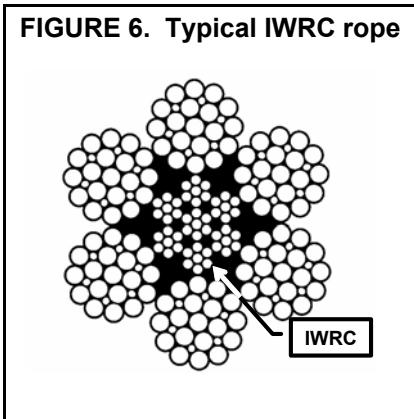
FIGURE 6. Typical IWRC rope

Similar nicking and fatigue patterns occur in IWRC (Independent Wire Rope Core) ropes. Figure 6 shows a typical cross-sectional diagram of such a rope.¹ For IWRC ropes, the outer wires of the outer strands have a larger diameter than the outer core strand wires. To minimize inter strand nicking between the outer strands and the IWRC, these ropes are designed such that the wires of the outer strands and the IWRC are approximately parallel. (This is usually achieved by choosing a *lang lay* construction for the IWRC and an *ordinary lay* construction for the outer strands.)

Typically, the wires of the outer strands are well supported by their neighbors while the outer wires of the IWRC are relatively unsupported.

The result of these geometrical features is that, under fluctuating tensile loads, the outer IWRC wires are continuously forced into the valleys between the outer strand wires and then released. This mechanism results in secondary bending stresses leading to large numbers of core wires with fatigue breaks. These breaks can be very close together and can form groups of breaks. Eventually, the IWRC can break, or it can even completely disintegrate into short pieces of wire about half a lay length long. This condition is commonly called *complete rope core failure*.

Figure 11 shows the results of an IWRC rope inspection (Figure 6). The chart recording indicates a severe breakup of the independent wire rope core. As previously discussed, this is strong evidence of heavy fluctuating tensile fatigue loading. Note that the LMA and LF traces show the typical patterns of broken and missing wires. The *missing wire* patterns even indicate that short pieces of broken IWRC wires might have fallen out of the rope. In addition, together with the findings of a visual inspection, the chart together with a visual inspection indicates severe corrosion, including corrosion pitting.

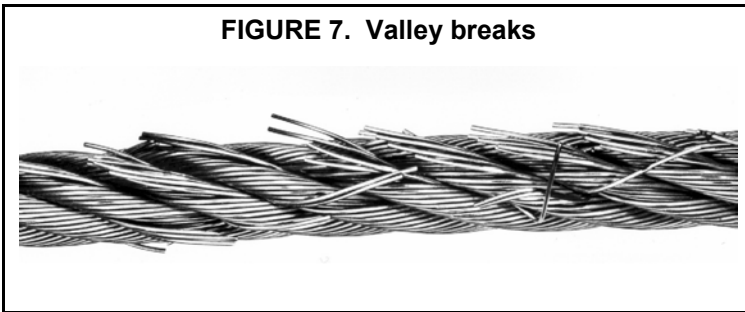
FIGURE 7. Valley breaks

As the IWRC fails, the outer strands lose their radial support. This allows the wires of the outer strands to bear against each other tangentially. The resulting inter strand nicking restricts the movement of the strands within the rope. Without this freedom of movement, secondary fatigue breaks in the wires of the outer strands will develop at the strand tangent points. Because these fatigue breaks develop in the valleys between the outer strands, they are also called *valley breaks* (Figure 7).

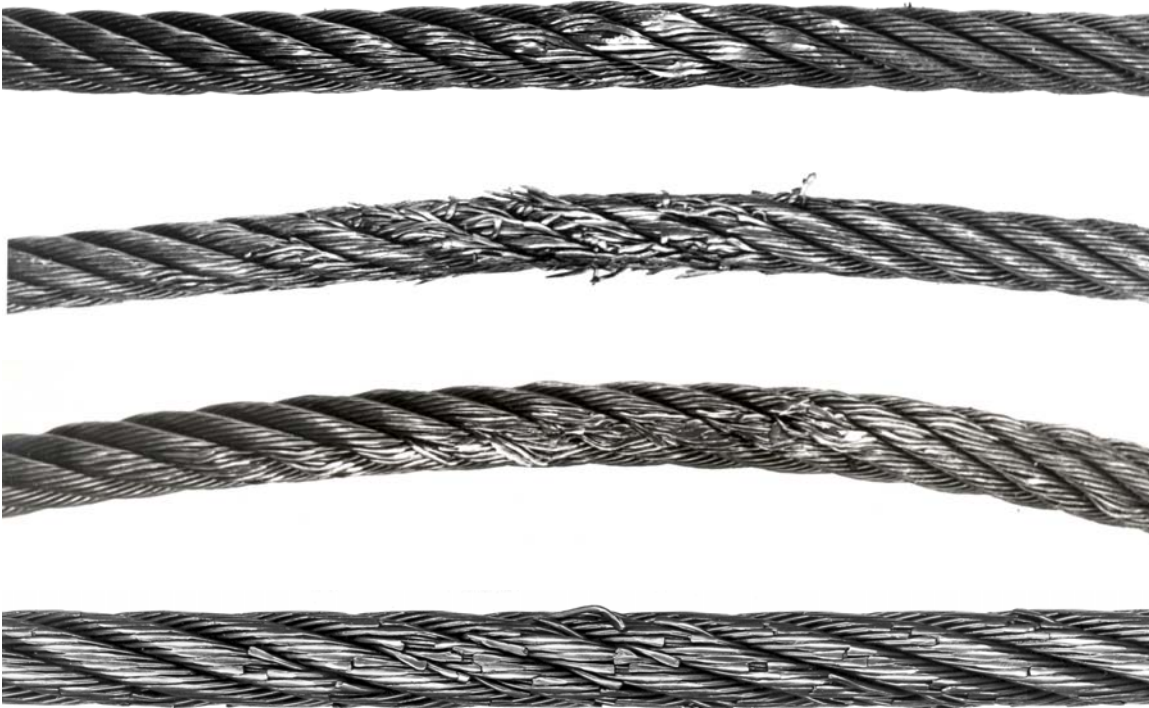
FIGURE 8. Rope damage caused by multi layer drum winding

If a rope section travels on and off a grooved multi layer drum, it goes through a bending cycle. Rope sections spooling in the first layer are bent around a smooth drum surface. When the second layer comes in, rope sections in the first layer will be spooled over, compressed and damaged on the upper side by the second rope layer. Rope sections spooling in the second and higher layers will be damaged on all sides during contact with the neighboring wraps. In addition, they will bend around the very rough surface created by the previous rope layer, leading to additional wire damage. It is obvious that by these mechanisms the rope will be damaged far more than by just one bend on a single layer drum.

The point where the rope is squeezed between the drum flange and the previous wrap, as it rises to form the next layer, is an area of accelerated wear. Typically, the slap of the rope at the crossover points can cause peening, martensitic embrittlement and/or wire plucking with the associated rope damage as the rope crosses over from layer to layer on a drum. Further, if the

lower layers were not spooled under sufficiently high tension, the lower wraps can be displaced by the incoming rope section, allowing it to slide down between them. This can lead to severe rope damage. Various types of rope damage caused by drum winding are shown in Figure 8.

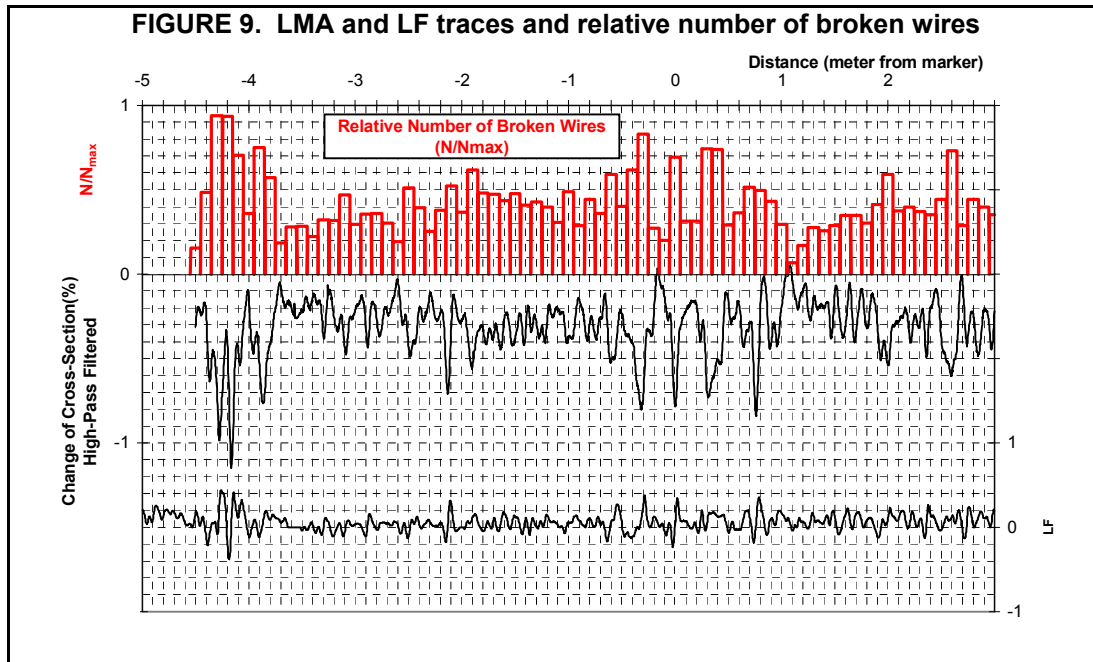
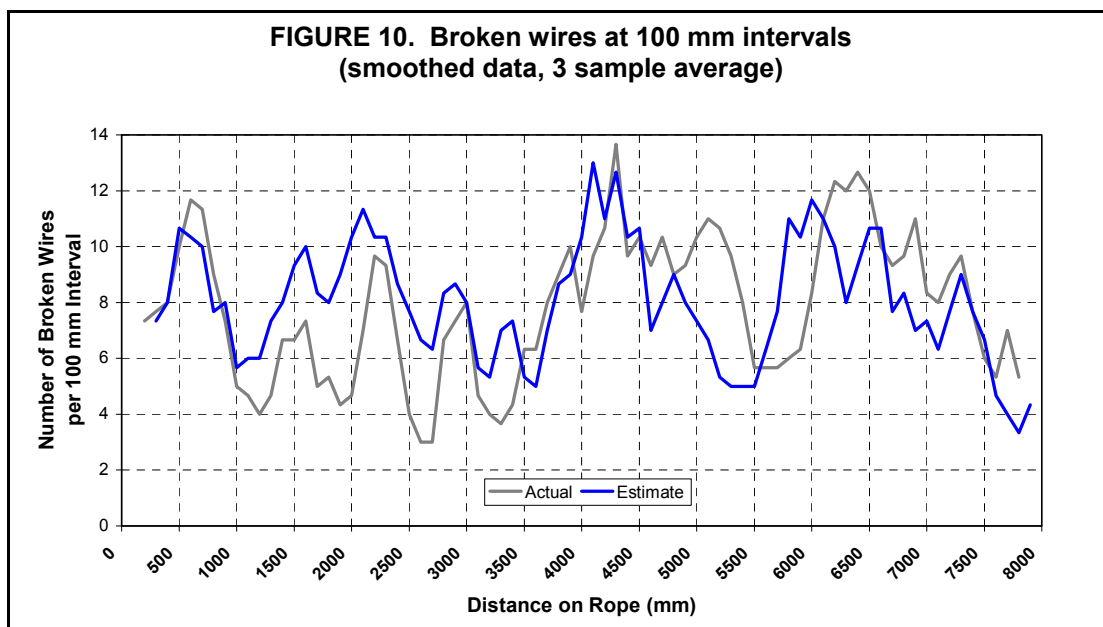
The estimated number of broken wires per 100 mm of rope length, N , derived from the LMA trace, is shown on the top of Chart 9. Here, N_{\max} denotes the maximum number of broken wires per 100 mm of rope length. Based on the operating history of this and similar ropes, a value of $N_{\max} = 20$ can be estimated.

The rope was subsequently disassembled to determine the actual number of broken wires per unit of rope length. Broken wire estimates together with the actual number of broken wires along the length of the rope are shown in Figure 10. Considering the fact that the LMA trace not only indicates broken wires but also inter strand nicking, internal wear and other disturbances of the rope structure, there is a good correlation between the actual and estimated number of internal broken wires. The correlation between actual and estimated number of broken wires up to a rope distance of about 4500 mm is very good. Beyond this distance, there is an offset, which is probably due to a distance measurement error during disassembly of the rope.

A destructive break test of the rope showed a 30.2% loss of breaking strength. On the other hand, the second layer of strands of the rope (see Figure 5) represents about 30% of the total rope cross-sectional area. This leads to the hypothesis that, for this rope, the second layer of strands has lost all load-bearing capability.

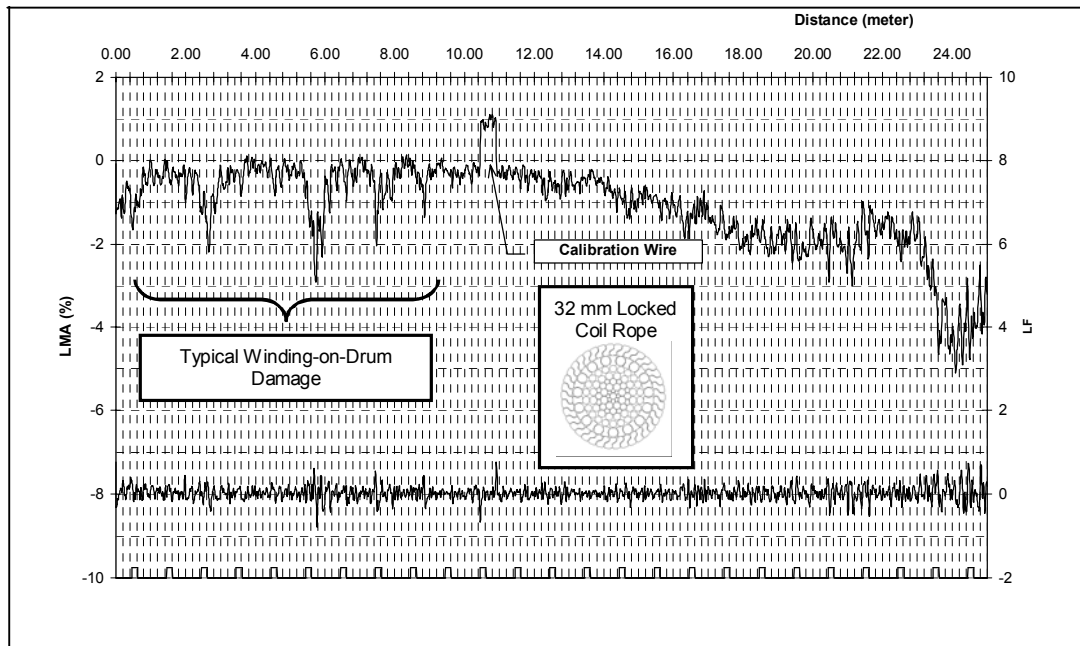
FIGURE 12. Chart of winch rope inspection

This locked coil rope was mounted on a mobile winch for approximately 10 years after 3 months earlier use on a friction winder installation. Its cross-sectional diagram is shown as part of Figure 12. The rope showed clear evidence of external corrosion, variable along the test length. Using retirement criteria that are appropriate for visual inspections, this rope would have been rejected for further use. Due to its service history the rope was not believed to contain any internal local defects.

Findings of electromagnetic inspection. Figure 12 shows an EM inspection chart of this rope. The maximum measured LMA is 5.1% compared to the best section on the rope covered by the chart. Note that the most convenient calibration method for EM inspections is to attach a calibration wire with known cross-sectional area to the rope. In the present case a wire bundle that represents about a 1% increase in rope cross-section was taped to the rope and used for calibration. This is indicated in the chart of Figure 11.

The chart shows variable corrosion, corrosion pitting and, possibly, broken wires. As discussed previously, the slap of the rope at the crossover points can cause peening, martensitic embrittlement and/or wire plucking with the associated rope damage as the rope crosses over from layer to layer on a drum. The deterioration pattern indicated to the left of the chart is typical for ropes that wind on a drum with the worst deterioration occurring at the crossover points as the rope slips from layer to layer while winding on a multilayer drum.

Examination after dismantling. After dismantling, the rope showed severe corrosion on the outer layer and also significant corrosion on the second layer. The third layer showed less corrosion, and from the fourth layer onward the rope appeared undamaged, because lubricants were still present. No local defects were found.

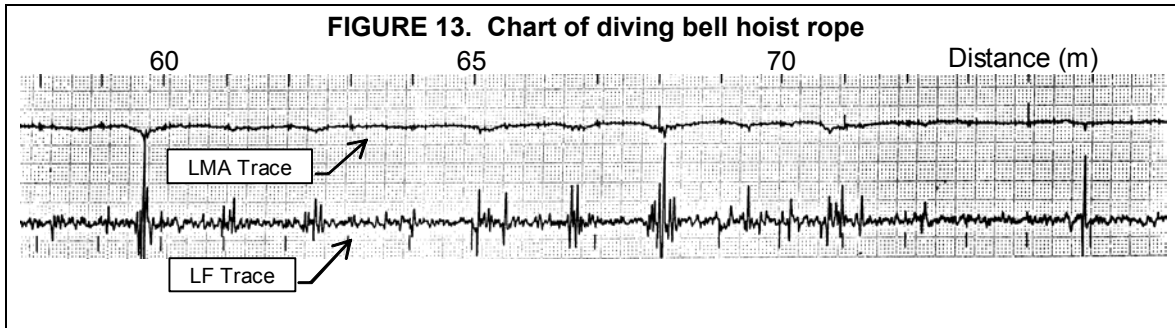
Figure 13 shows an EM inspection chart recording of a 30 mm die-formed multistrand diving bell hoist rope. When using non-rotating diving bell ropes, there are normally several layers of rope on the drum. The slap of the rope as it crosses over from layer to layer on the drum can cause peening, martensitic embrittlement and/or wire plucking with the associated damage.

This rope shows periodic groups of broken wires at these cross-over points. This damage is visible. Usually, the external deterioration progresses faster than the internal wire fatigue damage that is typical for multi strand ropes. Therefore, many non-rotating ropes that are wound on drums are replaced because of external damage, long before they will fail due to internal wire fatigue. However, the possibility of internal fatigue damage should always be considered for these ropes.

The maximum LMA for the rope under test is 1%. The rope section shown is subjected to the full in-air weight as the bell is lowered and raised. On the basis of the EM inspection, a decision was made to cut and re-terminate the rope behind the first defect about 58 m from the diving bell.
