Moisture Damage Evaluation of Asphalt Mixtures using Image Analysis

BTP –Report

Department of Civil Engineering
Indian Institute of Technology Kharagpur
Autumn 2022-23

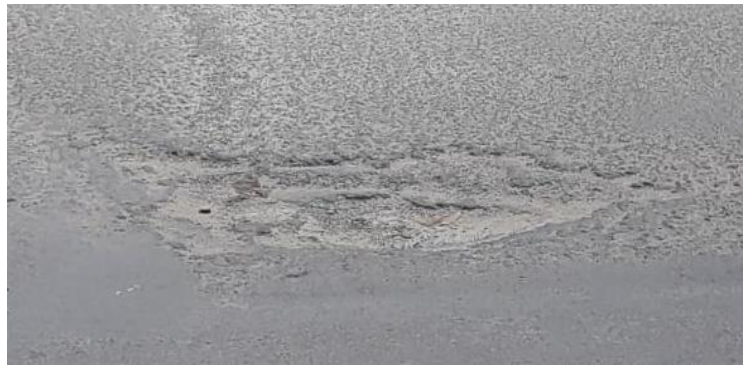
Figure 1 Moisture damage

Flexible pavements are structures designed, built and maintained over a foundation to carry vehicular loads. They are exposed to different weather conditions which results in moisture damage leads to failures such as stripping, raveling and pot holes as shown in figure 1. The durability or integrity related to moisture damage plays an important role in other types of damage or distress, such as rutting and fatigue. Thus, moisture damage in hot mix asphalt (HMA) is one of the major concerns in durability of flexible pavements. The moisture damage can be defined as the progressive functional deterioration of a pavement mixture by loss of the adhesive bond between the asphalt cement and the aggregate surface and/or loss of the cohesive resistance within the asphalt cement principally from the action of water.

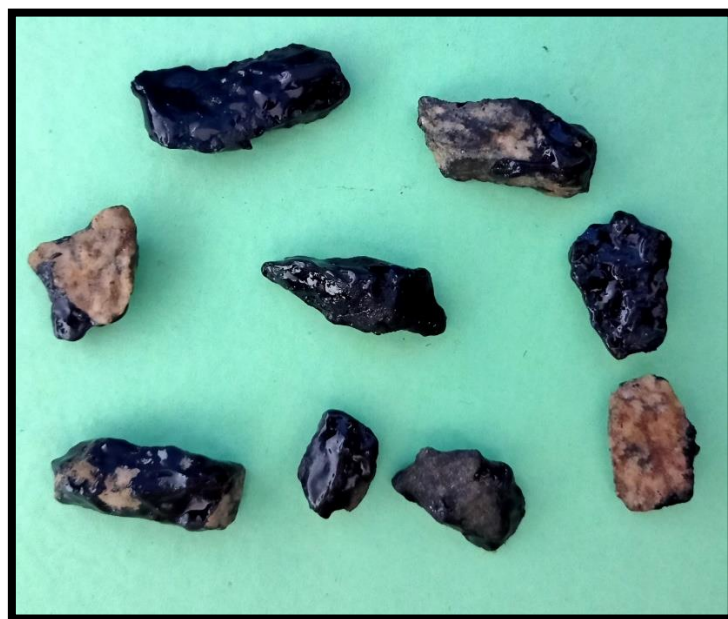
For the development of algorithms, a trial water boiling test was conducted and the images were captured using mobile camera as shown below. Later the images were processed using OpenCV, numpy, and matplotlib library functions available for Python coding. Also, the trial coding is given below.

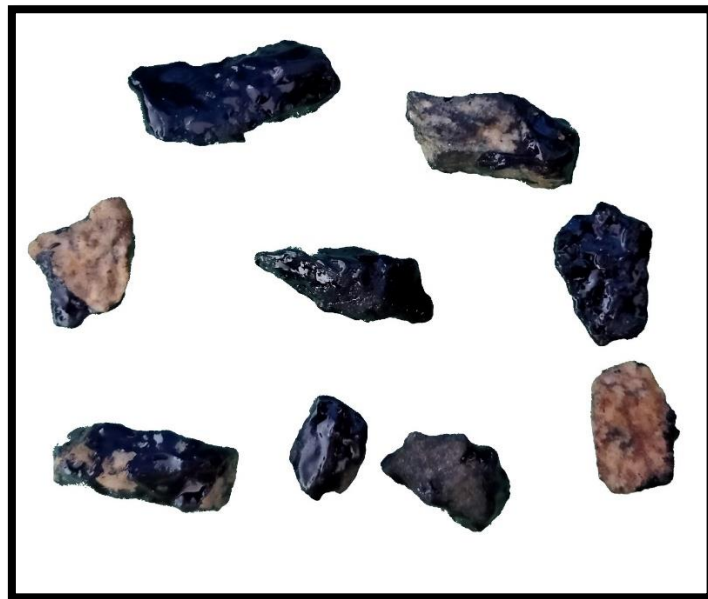
Output of step:1

Initially picture is with green background then background is masked with black pixels then after changed black pixels to white pixels.

From the trial it can be observed that white sparkles are observed on the bitumen surface in the image. Later these white sparkles were considered as background when the images are converted to white background which reduces the accuracy of the results.

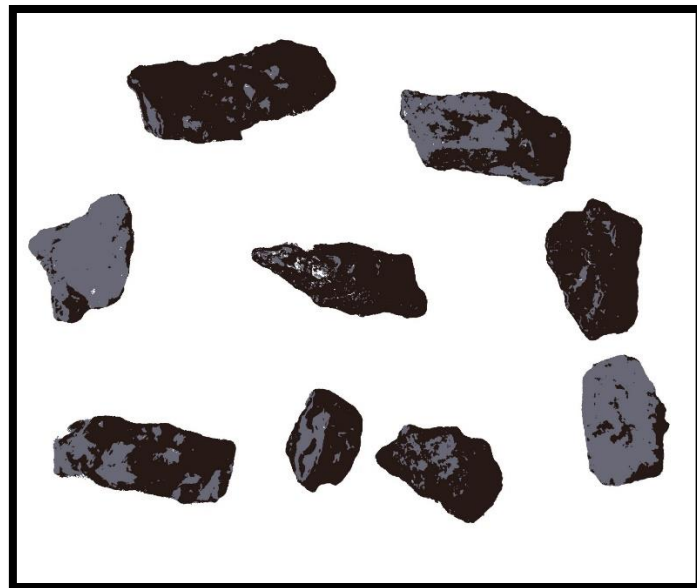
Output of step:2

Now the picture is with white background and all other remained the same Through image segmentation whole picture is converted into three segment colors.

Step 2 output image contains three different colors. White refers to background and black refers to bitumen and gray refers to aggregate. Calculating the number of pixels covered by each color.

After performing the boiling water test due to moisture damage on asphalt mixture the amount of stripped area is 43.36%.
