Shoreline change along Kerala, south-west coast of India, using geo-spatial techniques and field measurement

Abstract

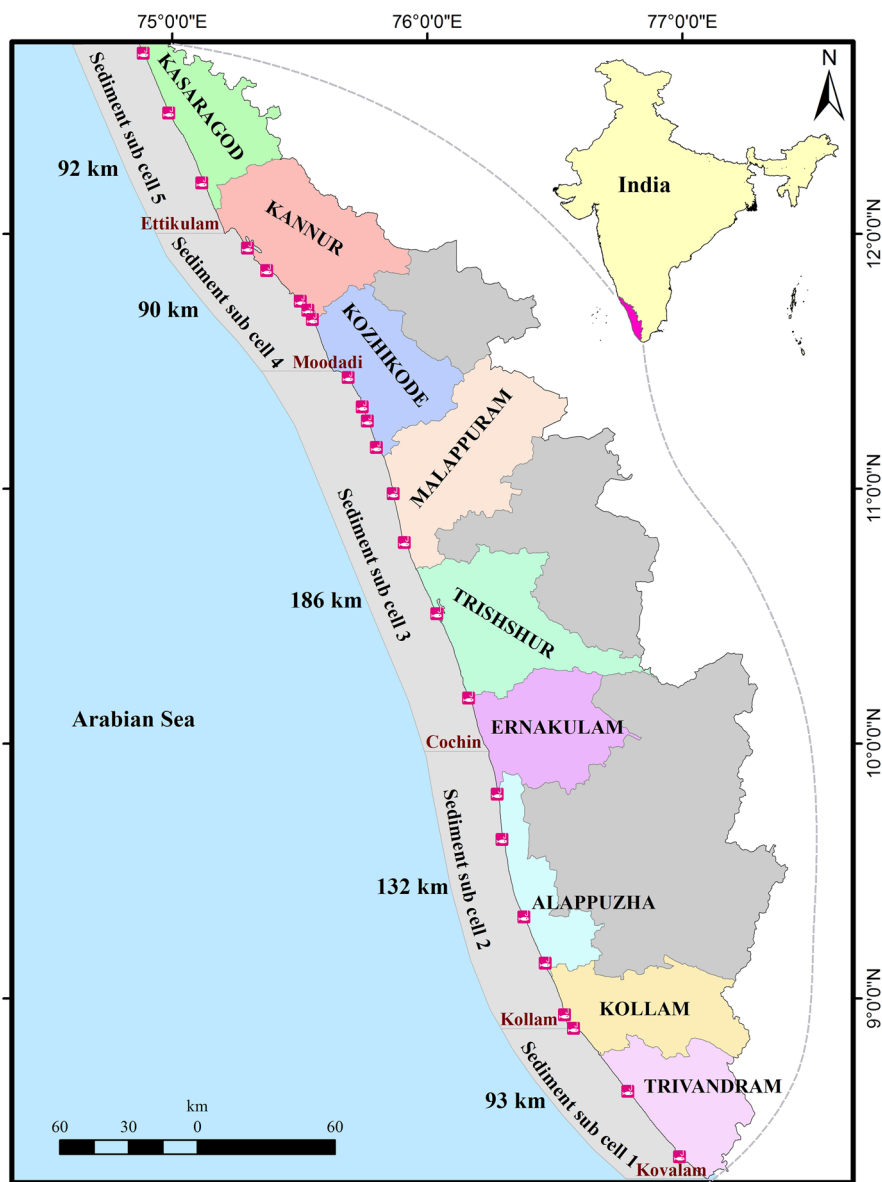
Fig. 1 Study area with five different sediment sub-cells

The Kerala coast was divided into five divisions based on sediment sub-cell criteria (NCSCM 2014) for detailed analysis. The sediment cell is defined as the length of the coastline and associated near-shore areas where movement of sediment is largely a self-contained. Distribution of these five sediment sub-cells from south to north is shown in Fig. 1, and the length of each sediment sub-cell is tabulated in Table 3. The sediment budget and the transport rate play a significant role in determining the stability of the coast which is primarily governed by the coastal processes prevailing in the area. The longshore sediment transport (LST) has significant influences in shoreline change pattern (Sheela Nair et al. 2015). Long-term shoreline study for five different cells was calculated for the past 26 years (1990–2016) using ten different datasets. The rate thus obtained from

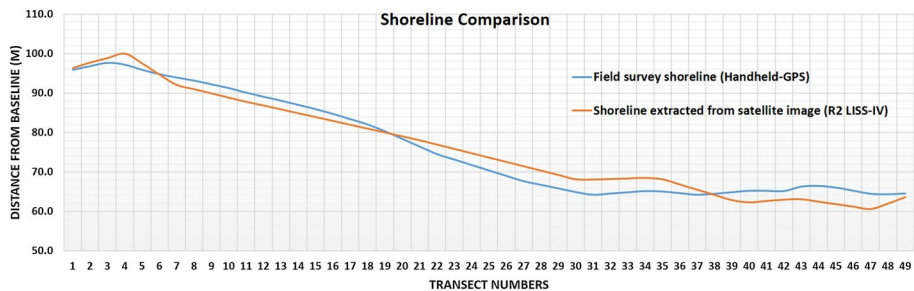
Fig. 2 Comparison of field-surveyed shoreline position with satellite-extracted shoreline along Punnapra beach, Kerala

Field survey was conducted to track the shoreline positions during satellite pass time using handheld GPS (Trimble GEO XH 6000) at five different locations (Poovur, Punnapra beach, Paravanna beach, Mahe and Manjeshwar region). This handheld GPS (Trimble GEO XH 6000) provides the data with an accuracy of 1–3 m. 1 km coastal stretch was surveyed at each location separately. Shoreline positions were particularly tracked to compare and validate with the shoreline extracted from satellite images. Plate 1 shows the shoreline tracking using handheld GPS at Punnapra beach. The tracked shoreline is then compared with the shoreline extracted from 2016 LISS-IV (5.8 m) satellite images as shown in Fig. 2. Comparison shows that the field-surveyed shoreline positions were well matched with the shoreline extracted from images. The comparison shows that the maximum difference between two shoreline positions is within a pixel limit (5.8 m). The comparison of shorelines provides the higher confidence level with the extracted shoreline position.

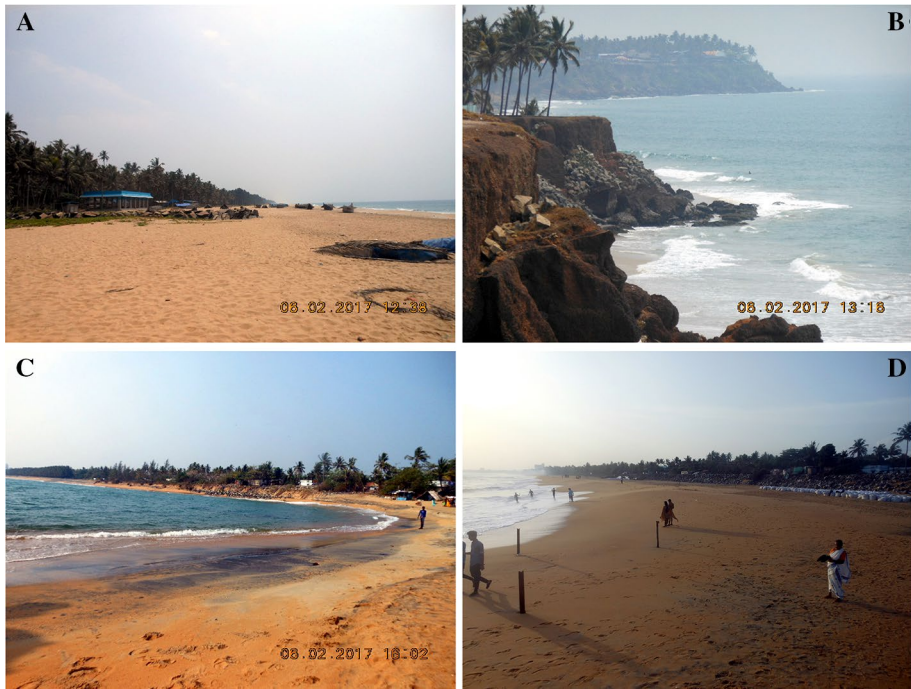
Plate 2 **a** Rathikkal location where groins were buried in sand. **b** Slumping of lateritic cliff at Varkala. **c** Field photograph showing depletion of sand towards the north of broken vessel during pre-monsoon (Feb 2017) at Eravipuram. **d** Field photograph showing sand deposition towards the north of broken vessel during monsoon (July 2017) season at Eravipuram

b; Noujas and Thomas 2018). After Thazhampally, stable to low accretion was noticed till Varkala region. From field survey, it was noted that the seawall at Kayikkara was abandoned. Even the Rathickal region where series of groins (20 numbers) were filled with sediments is shown in plate 2a. This indicates that the coast is experiencing accretion at a faster rate. From the analysis, this particular coastal stretch was noticed with moderate accretion. 15-km stretch from Varkala to Eravipuram was seen with low erosion. Slumping of a lateritic cliff at Varkala was very prominent due to which even the cliff region was protected with seawall. Plate 2b shows the slumping of a lateritic cliff at Varkala region. South of Thangassery fishery harbour was noticed with a moderate-to-low accretion pattern. This may be due to the southern breakwater which traps the sediments, thereby making the region with sediment-rich coast. About 2.5 km south of southern breakwater, a broken dredger ship was trapped along the coast at Eravipuram. The vessel that washed ashore has become a matter of concern for the coastal people as it had the direct influence on the sediment transport, thereby altering the coast seasonally on either side of the broken ship. This broken ship acts as an asymmetric tombolo landform. Field survey was undertaken in both the pre-monsoon and monsoon seasons to understand the seasonal impact on the coast. Plate 2c shows the depletion of sand towards the north of broken vessel during pre-monsoon (Feb 2017). But, plate 2d shows the same location during monsoon (July 2017) with sand deposition. Analysis along sediment cell 1 clearly shows similar pattern of accretion along the southern side of the fishing harbour and erosion along the northern side. According to Noujas et al. (2014), the wave pattern along Thiruvananthapuram District is south–south-west (SSW) direction during fair season and west–south-west (WSW) direction during monsoon season. This trend indicates net sediment transport is towards north during most of the year. The overall pattern of the sediment sub-cell I shows 36% of

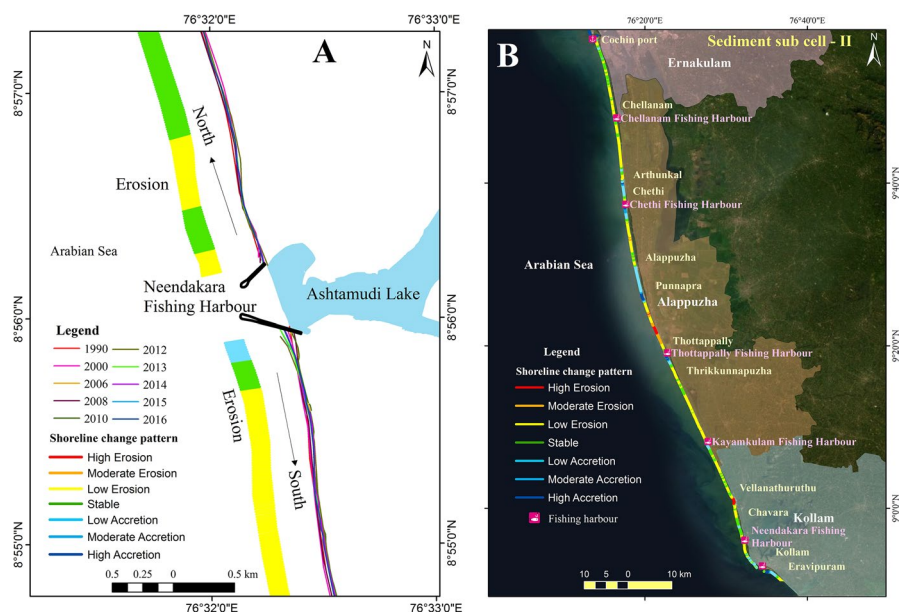
Fig. 4 **a** Shoreline change result on either side of Neendakara fishing harbour. **b** Long-term shoreline rate for sediment cell II

The result indicates that the erosion/accretion of shoreline change rate on either side of the breakwater was a peculiar phenomenon along this sub-cell. This may be due to the orientation of the coastline. This sediment cell covers entire coastal district of Alappuzha and few portions in Kollam district. According to Sheela Nair et al. (2015), the coastline orientation along Alappuzha District is 255° with respect to true north and the wave direction is 221° – 250° . All three categories (stable, erosion and accretion) were noticed on both sides of fishing harbours. Chellanam fishing harbour in particular has not shown any significant alteration to the coast. This gives indirect evidence about the sediment transport and its local morphology which decides the erosion/accretion of the coast. But due to the coastal orientation, the net littoral sediment transport is towards north for entire year (Sheela Nair et al. 2015). Sheela Nair et al. (2015) has reported that the monthly average significant wave height along Alappuzha coastal district is between 0.68 and 2.52 m and wave direction is 221° – 250° . Shoreline change indicates 54% of the coast was noticed with erosion. 19% and 28% of the coast fall in accretion and stable condition. The overall change pattern suggests that the coast was dominated with high per cent of erosion as shown in Fig. 4b.

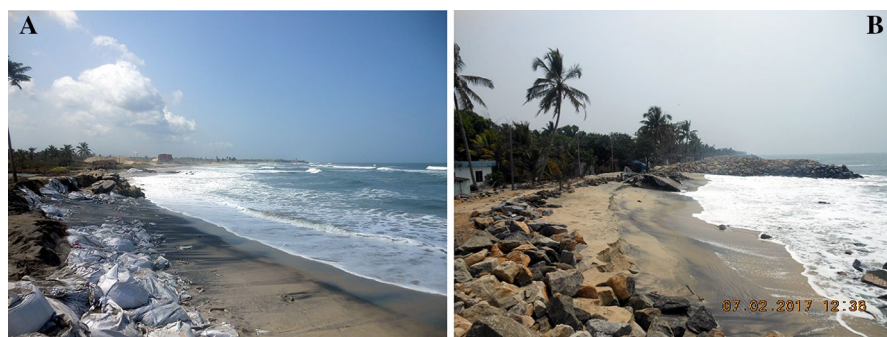
Plate 3 **a** Vellanathuruthu where the coast affected by sand mining process. **b** Slumping of seawall at Ambalapuzha

Mineral and Metal Limited (KMML) along the coastline of Chavara, Kollam, has played a significant role in altering the coastline. Noujas and Thomas (2015) reported Vellanathuruthu mining site as one of the erosion hot spots based on their direct field measurements. Seawall can be seen on either side of the mining site to protect the coast. There is an open space of about 800 m between these seawalls. Due to high wave actions, the open coast at this region was altered as a bay-like structure (plate 3a). 22-km stretch from Kayamkulam to Thottappally fishing harbour was seen with low erosion. This stretch too was protected with artificial structure (seawall and groins) to protect from erosion. About 3 km south of Thottappally fishing harbour was noticed with moderate-to-high accretion due to

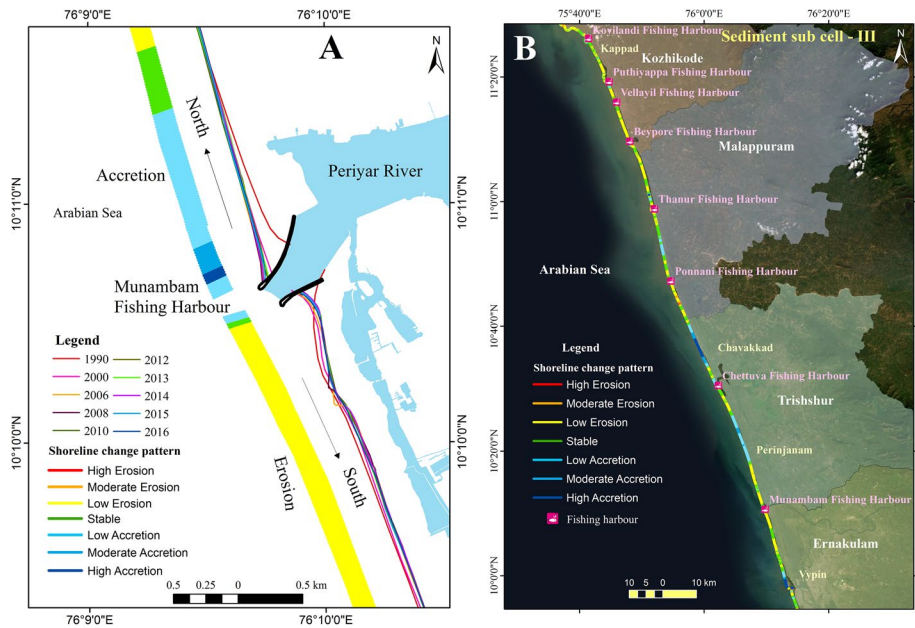
Fig. 5 **a** Shoreline change result on either side of Munambam Fishing Harbour. **b** Long-term shoreline rate for sediment cell III

The overall long-term shoreline analysis of sediment sub-cell III indicates that 43% of the coast was falling in erosion category followed by the stable with 32% and accretion with 25%. Accretion/erosion pattern varies for all fishing harbours. Munambam, Chettuva and Ponnani fishing harbours show similar pattern of shoreline change on either side of the breakwaters, which indicates that the net sediment transport is towards southern direction, whereas Puthiyappa, Koyilandi, Beypore and Vellayil fishing harbours show the opposite trend and hence indicates that the net sediment transport is towards northern direction. Change in sediment transport direction indicates that the longshore sediment transport is governed by the local condition and morphology of the coast. Figure 5b shows the shoreline change patterns for sub-cell III with seven different classes.

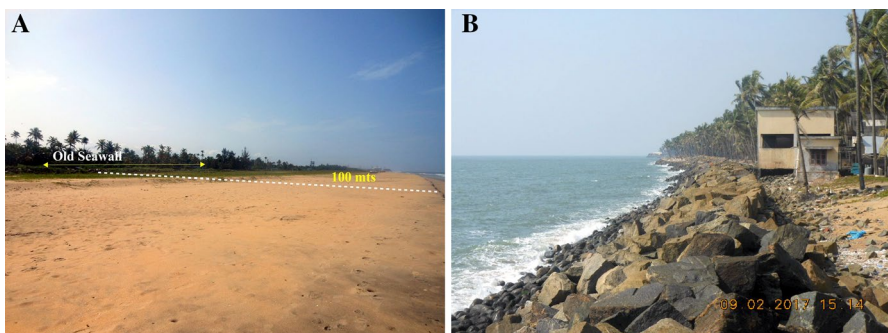
Plate 4 **a** 100 m width of sand deposition along Elamkunnappuzha region, Kerala **b** Erosion at Tannithura, Kerala, during pre-monsoon (February month)

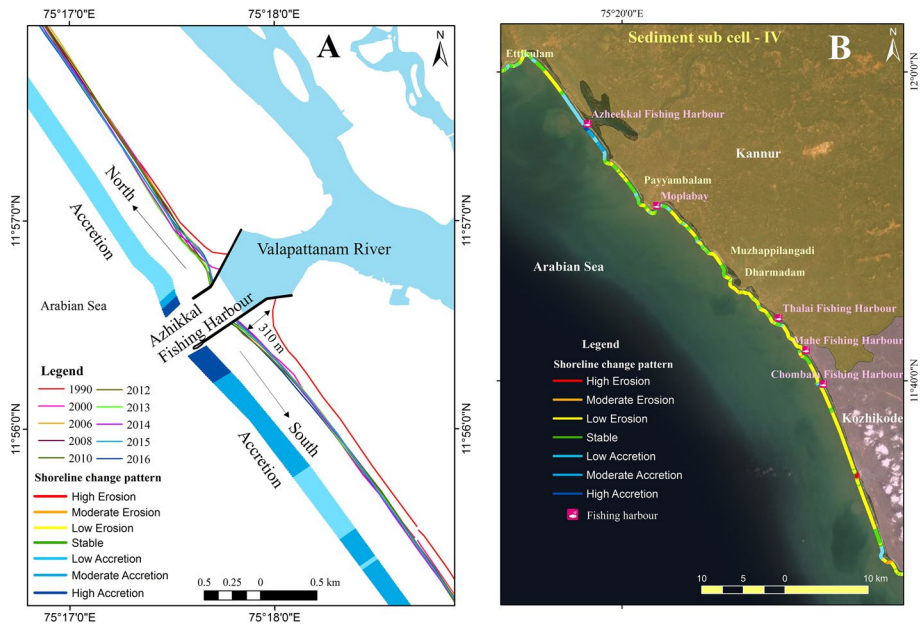
Fig. 6 **a** Shoreline change result on either side of Azhikkal Fishing Harbour. **b** Long-term shoreline rate for sediment cell IV

From the long-term analysis, 52% of the coast was noticed with erosion. Remaining 15% and 32% of the coast falls in accretion and stable condition. Erosion and stable pattern were seemed to be more dominated in the sub-cell. This sediment cell has more significance as some of the fishing harbours such as Thalai fishing harbour and Moplabay fishing harbour were located at a bay region. Due to orientation of the coast, the headlands act as a natural barrier to these fishing harbours and form a bay-like structure. Sediment transport at this sediment cell is towards northern direction. Apart from Azhikkal where accretion was dominant, all other fishing harbours showed similar stable to low eroding pattern. Long-term shoreline change pattern for sub-cell IV is shown in Fig. 6b.

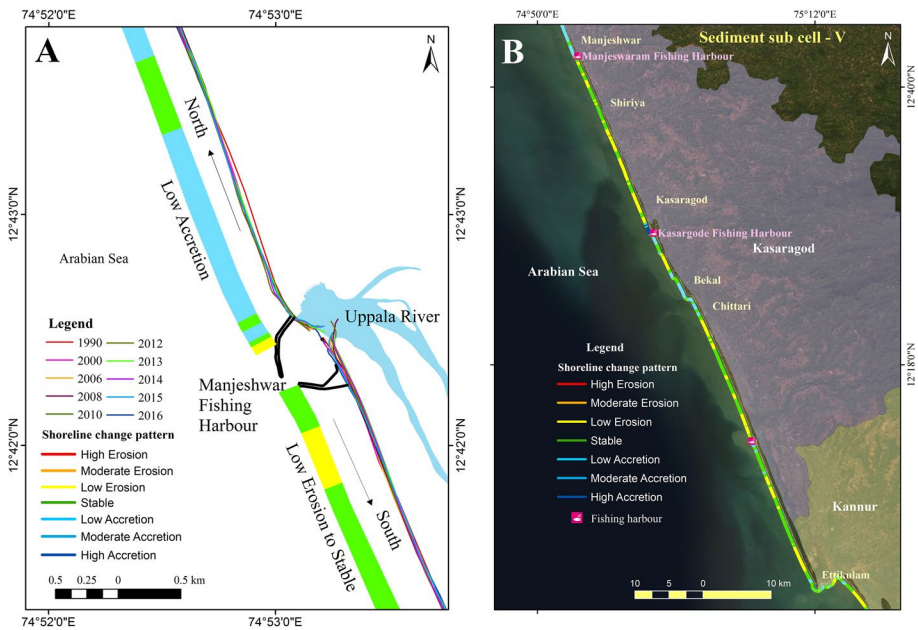
Fig. 7 **a** Shoreline change result on either side of Manjeshwar Fishing Harbour. **b** Long-term shoreline rate for sediment cell V

The shoreline status indicates 36% of the coast falls under erosion category. But, 47% of the coast was seen in stable condition. Only 17% of the coast was noticed with accretion pattern which was mainly at the north of Manjeswar, Kasaragod and near Bekal coast. Long-term shoreline change pattern for sub-cell V is shown in Fig. 7b.
