# Assessment of wood utility poles' deterioration through natural frequency measurements

## Abstract

**Keywords** Wood poles · Wood damage · FEM · Experimental mechanics · Structural dynamics

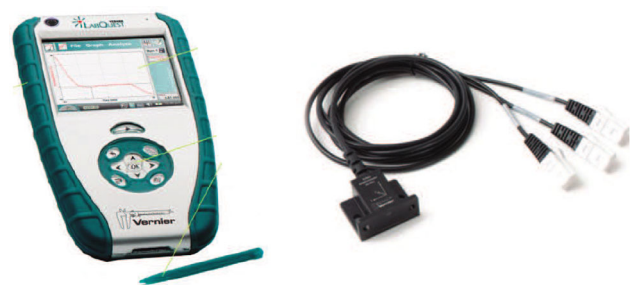
**Fig. 1** Devices for the acceleration measurement

A *Vernier LabQuest<sup>TM</sup>* interface [12] was used using to record the acceleration. A 3-axis accelerometer was employed for acceleration values between  $\pm 49 \text{ m/s}^2$  according to three orthogonal axes with frequency response between 0 and 100 Hz (Fig. 1). The vibration of the pole was induced by a sudden strike from its static equilibrium state applied with a rubber hammer at the free end. Accelerations were registered with a sensor on the pole tip, so that it does not coincide with a node of the element structural. Using a USB connection, the *Vernier LabQuest<sup>TM</sup>* was linked to a laptop where the *Logger Pro* software was installed. The data was collected at a rate of

The *Logger Pro* software provides a graphical and tabulated record of accelerations based on time, obtained during the duration of the study. The software allows to know the resonance frequencies of the system from a acceleration record by applying FFT to those data. Through this tool, the time domain signal is transformed to the frequency domain and it is possible to evaluate the frequency content of the analyzed signal.

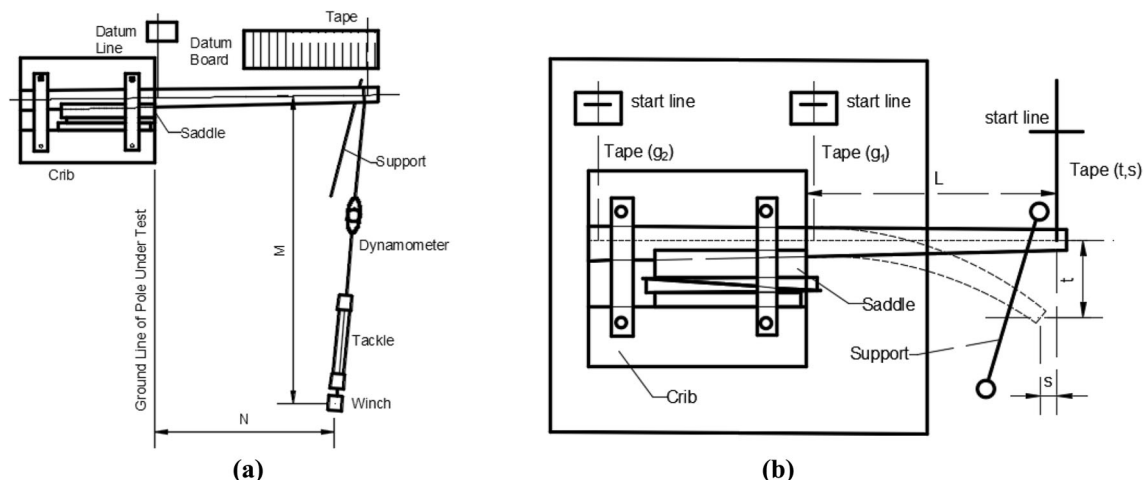
**Fig. 2** Schematic layout of field mechanical test of wooden poles: **a** general scheme [3], **b** detail of record for correction of translation and rotation at the clamping system [13]

After physical measurements were taken and recorded, cantilever bending tests were carried out according to the procedures of the American standard ASTM-D1036 [3] which were also adopted by the Argentinian standard IRAM 9529 [13]. The goal of this experiment was to determine the values of modulus of elasticity to be used in the numerical calculation as reference (see, Sect. 3.4). Each pole was placed in the testing setup so that its ground line coincided with the front face of the crib. The ground line distance from base was at least 15% of the length of the shortest pole and at 5 m from the tip and the loading point at 0.6 m from the tip in all cases. Load was applied by means of a winch capable of pulling at a constant rate of speed. The winch was set far enough from the pole so that the small angle between the initial and the final position of the pulling line may be disregarded, at distances  $N$  and  $M$  indicated in the standard [3], being, in this case, 4.7 m and 33.5 m, respectively. A schematic diagram of test setup may be appreciated in Fig. 2, and a image of the test setup can be observed in Fig. 3.

graduated in 0.04 kN. Deflections at the loading point in the direction perpendicular to the initial pole axis  $t$  were measured by means of a tape capable of registering 1 mm and a datum board was also utilized for facilitating the measurements. The displacements  $s$  in the direction of the axis of the pole were registered to perform the correction of the applied load and take only the perpendicular to the original axis of the pole component. A minimum of 15 simultaneous readings of deflection and load were taken at intervals of the load equal to 0.1 kN. The pole to be tested was fixed from the bottom end to ground line in a crib. The crib was built in such a manner that the movement of the lower end of pole during the test was minimized. The displacements at  $g_1$  and  $g_2$  points on the crib were recorded to make the correction of  $t$  by vertical and rotational motion in the ground line.

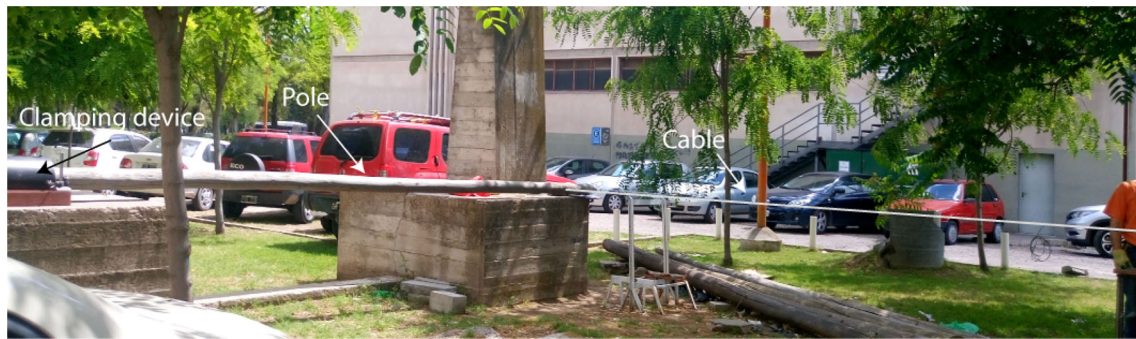
Fig. 3 Load-displacement test setup

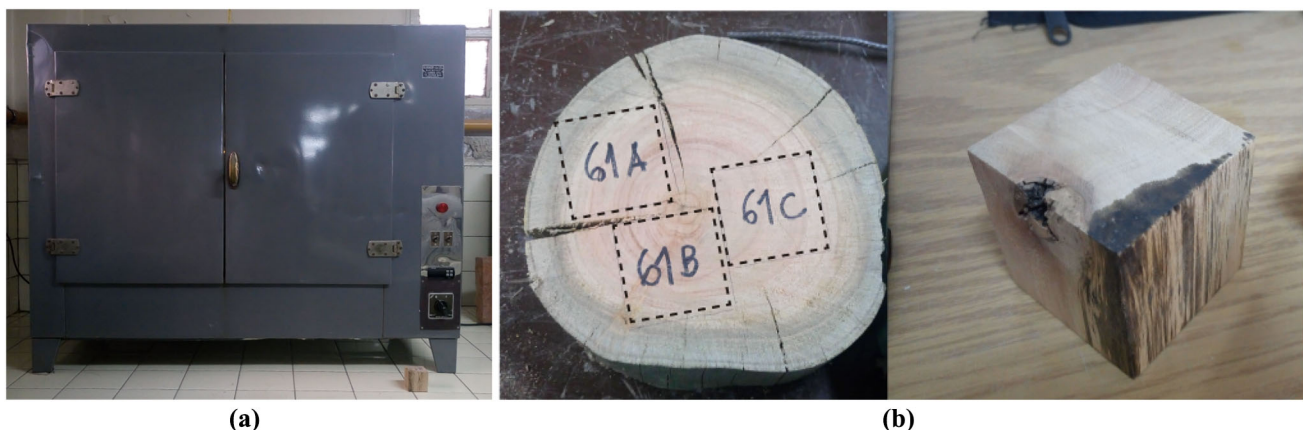
Fig. 4 Drying of the wood samples **a** oven and **b** samples with their position in the trunk of pole

The moisture content and density were determined according to the procedures established in ISO 3130 [14] and ISO 3131 [15], respectively, using a knot-free disk taken from the proximity of the fixing point after the static test. The specimens were obtained by sawing pole slices in the area to the ground line, cutting cubes of approximately 50 mm of edge. The dimensions of each test piece were taken with an accuracy of 0.05 mm in wet and anhydrous state after oven drying. The weight was recorded with a digital scale at 0.1 gr of accuracy.

The moisture content was determined according to ISO 3130 [14]. By weight difference, the mass loss of the test pieces in the initial state to their anhydrous state was calculated. To achieve this last condition, the test pieces were placed in an oven at  $103^{\circ}\text{C} \pm 2^{\circ}\text{C}$  for at least 24 hours until constant weight (Fig. 4). In this state, both the weight and volume were determined, then the moisture content and the dry density were calculated.

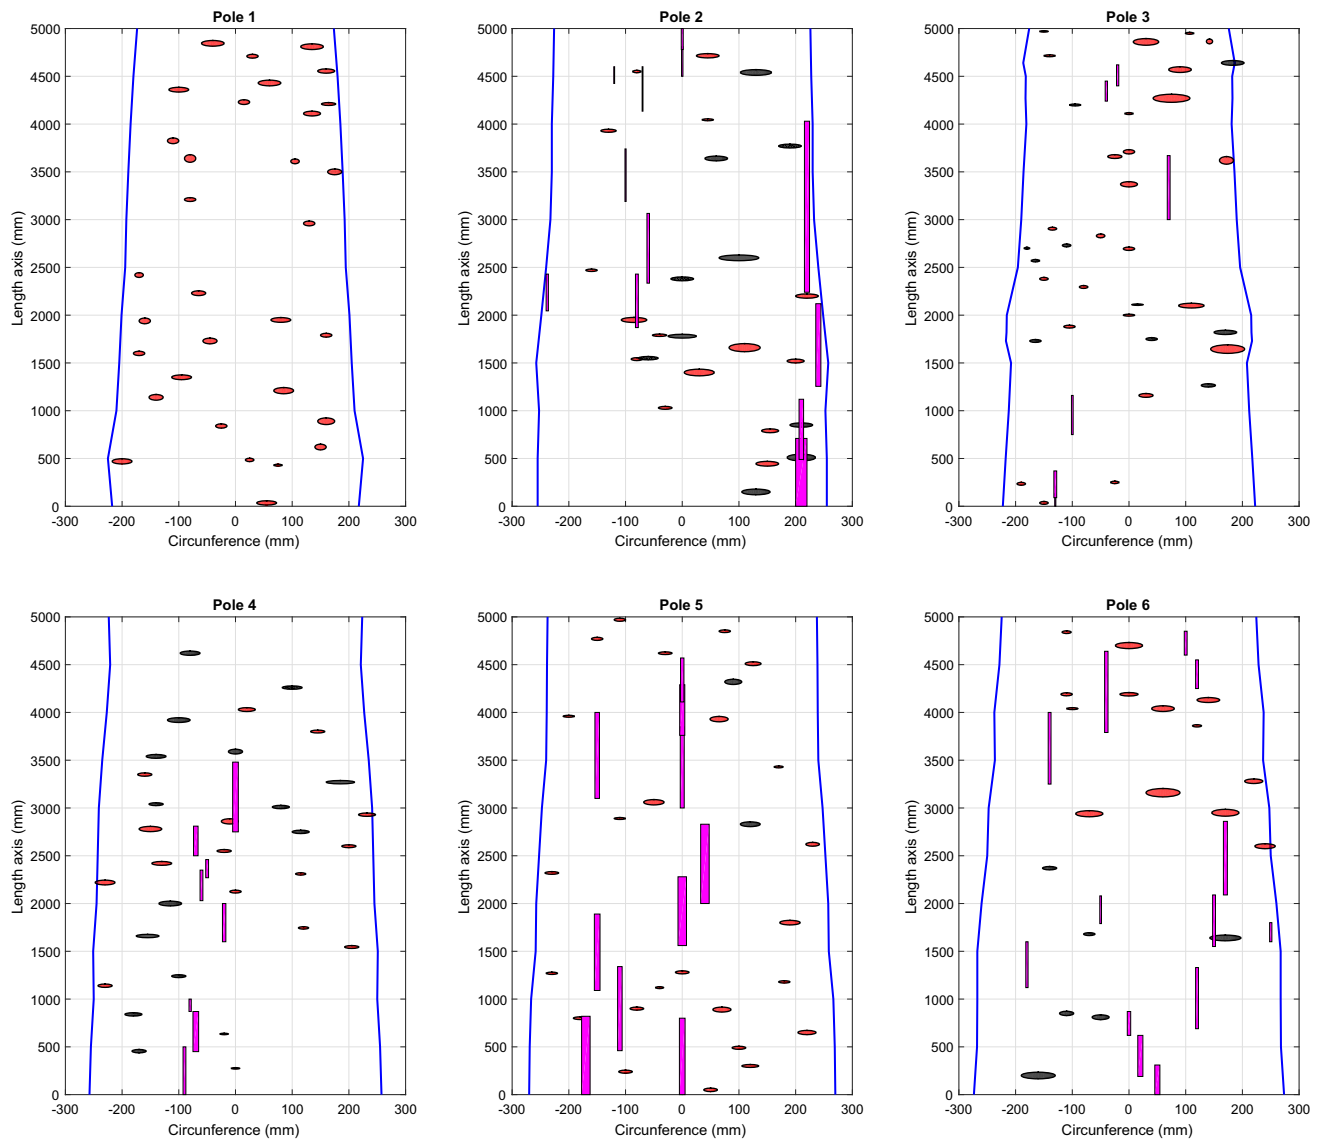
**Fig. 5** Record of knots and cracks from visual survey: visible knots (red points), hidden knots (black points), cracks (magenta lines) and circumference limits (blue lines) (colour figure online)

In Fig. 5, the recorded knots and cracks are shown graphically. On the X axis, the measurements on the circumference with respect to a proposed longitudinal axis of reference are indicated. The Y axis goes from the ground line to the applied load point. It should be noted that the two axes scales are different. The blue lines indicate the circumference values along each pole. The knots are represented by the red and black points where their size indicate the observed dimensions. The red points represent knots that reach the surface, and the black points, knots that do not reach the surface, but are visible as protuberances. The magenta lines indicate the position of the cracks and their thickness is representative of the registered width.

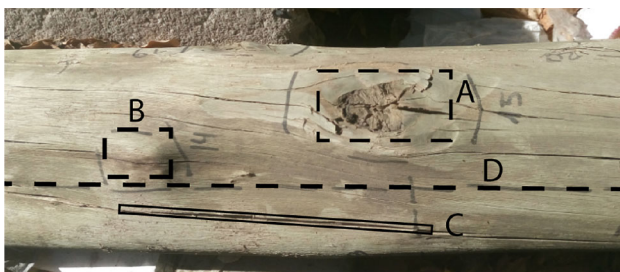
**Fig. 6** Record of visible knots (a), hidden knots (b), cracks (c) and the reference line (d)

In Fig. 6, it is shown how the visible knots (A), the knots that do not reach surface or hidden knots (B), and the cracks (C) were registered. The reference axis adopted along the pole (D) is also indicated.

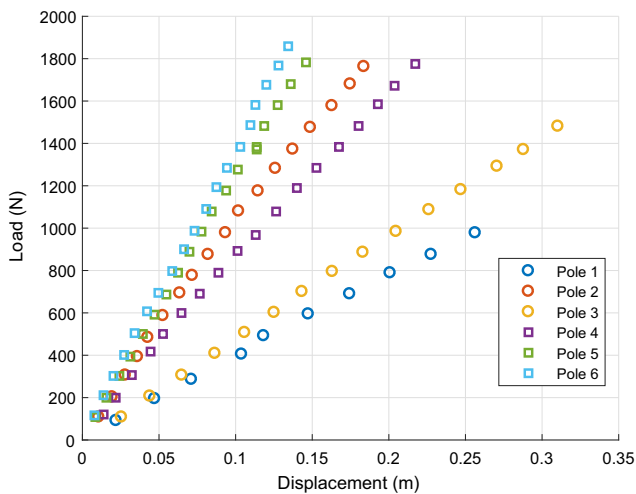
Fig. 7 Results of the load-displacement test

Fig. 7 shows the results of the load-displacement test for all the poles. Based on these values and in accordance with the ASTM standard [3], the MOE values for each one were calculated. These values are shown in the first column of the Table 2.

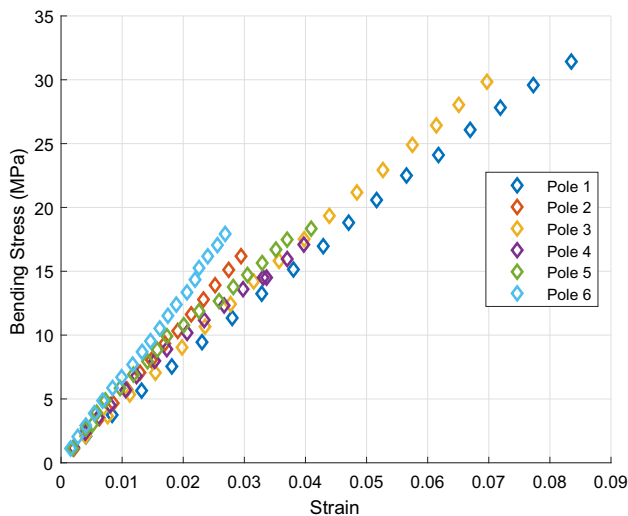
Fig. 8 Stress-strain curves obtained from the experiments

In Fig. 8, the stress–strain values are shown, calculated according to Eq. 2.

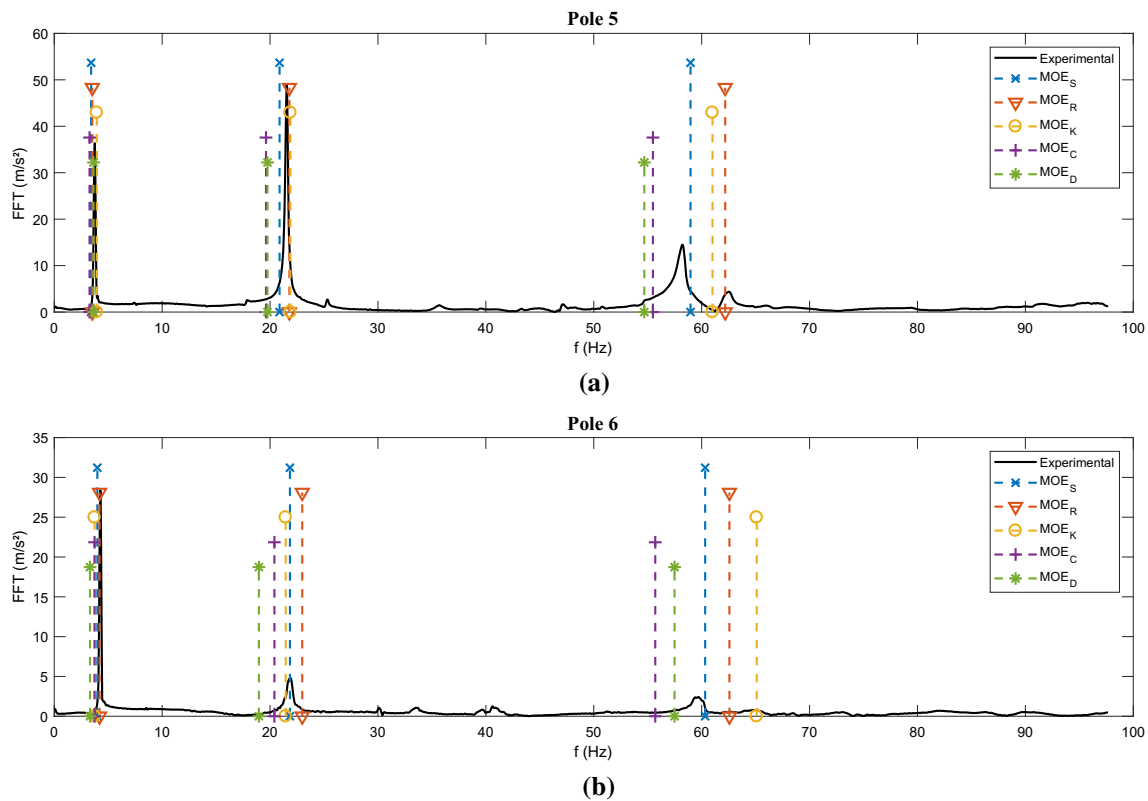
**Fig. 9** Frequencies spectrum. **a** deteriorated pole 5; **b** healthy pole 6

In Fig. 9, as an example, the results of a deteriorated and a new pole are shown. In both cases (Fig. 9a, b), the first frequency of vibration calculated with all proposed numerical models (vertical lines) matches very closely with the value measured experimentally. Higher frequencies exhibit more discrepancy among the numerical and experimental results, being different more pronounced for the third one. The higher is the frequency, the more sensitive it is to parameters such as the density and MOE.

The percentage differences between the results found with  $MOE_S$  and  $MOE_C$  (see Fig. 9,  $\times$  and  $+$  symbols, respectively) in the case of the pole 5 are:  $-7\%$ ,  $-6\%$  and  $-6\%$ , from the first, second and third frequency, respectively. In general, the differences are small for all cases.

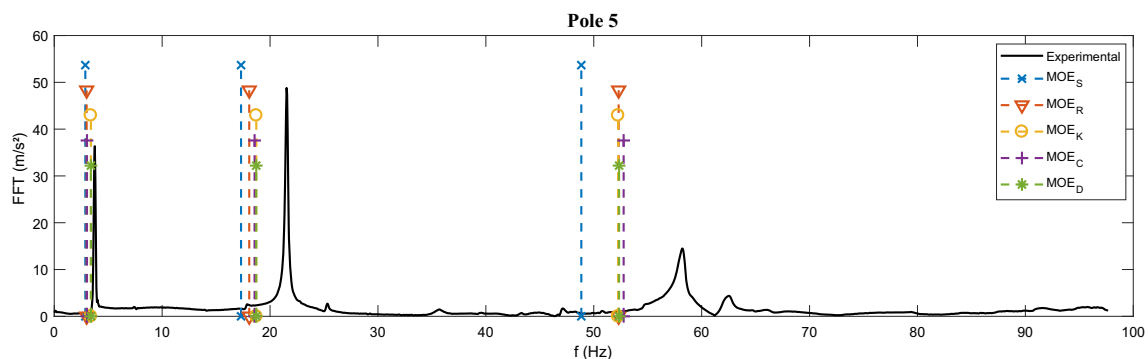
**Fig. 10** Frequency spectrum. Pole 5. Numerical natural frequencies found with healthy pole mass density

As mentioned in Sect. 3.3, the deterioration of the material causes an appreciable variation of the density, with respect to the healthy wood. According to the standards recommendations [14, 15], the wood mass density determination implies a destructive test. That is, this data is not usually available for poles in service. To assess the influence of mass density on the frequency values, numerical results were found for all the MOE alternatives in the case of pole 5 but setting the mass density of the healthy pole 6 (all others parameters are kept fixed). These results are shown in Fig. 10. By comparing the plots of Figs. 9a and 10, the effect of mass density on the frequencies values with and without deterioration is apparent.

To make this issue clearer, Table 4 depicts the corresponding numerical values of the frequencies. It was clear that the use of the healthy pole mass density leads to lower values of frequencies.
