DEVELOPMENT OF A NOISE RELATED TRACK MAINTENANCE TOOL

Yezhe Lyu, Stefan Björklund, Ellen Bergseth and Ulf Olofsson

The purpose of this work-package within the Quiet-track, FP7, is to develop a noise related track maintenance tool, in the form of an on-board measurement system. As a first step, lab scale tests using a pin-on-disc tribometer were used in order to distinguish how noise changes when the wear mechanism in a sliding contact shifts from normal wear to severe wear. Once the potential for using sound as an indication of severe wear transitions was established, full scale tests were carried out with a rapid transit (metro) train, type C20. The train was equipped with microphones that continuously measured the sound pressure near the wheel rail contact. In order to provoke severe wear, the test train was run in a curve with small radius, and the rails and wheels were carefully cleaned before the tests. The same kind of transfer from mild to severe wear was identified on the full scale test as in the laboratory scale test, confirmed by studying the surface topography and the morphology of the wear particles. Moreover, the full scale test results showed that the sound pressur

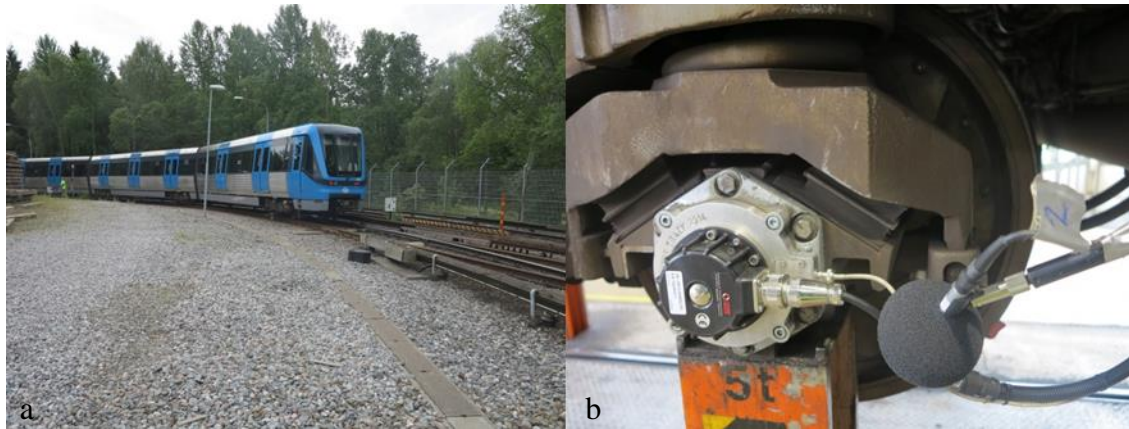
Figure 1. The instrumented C20 rapid transit train running on the test curve (a) and the mounted microphone instrumentation near the wheel (b).

The full scale tests were carried out with a rapid transit train, type C20 (eight axles), equipped with microphones that continuously measured the sound pressure near the wheel rail contact, Figure 1. In addition to the on-board monitoring microphones mounted under the vehicle (located at both the inner and outer rail), eight additional microphones were used to measure the noise close to each wheel on the outer rail. A stationary microphone was also utilized in this test set up. **In order to provoke severe wear, the test train was run back and forth in a curve with a 200 m radius. The track**

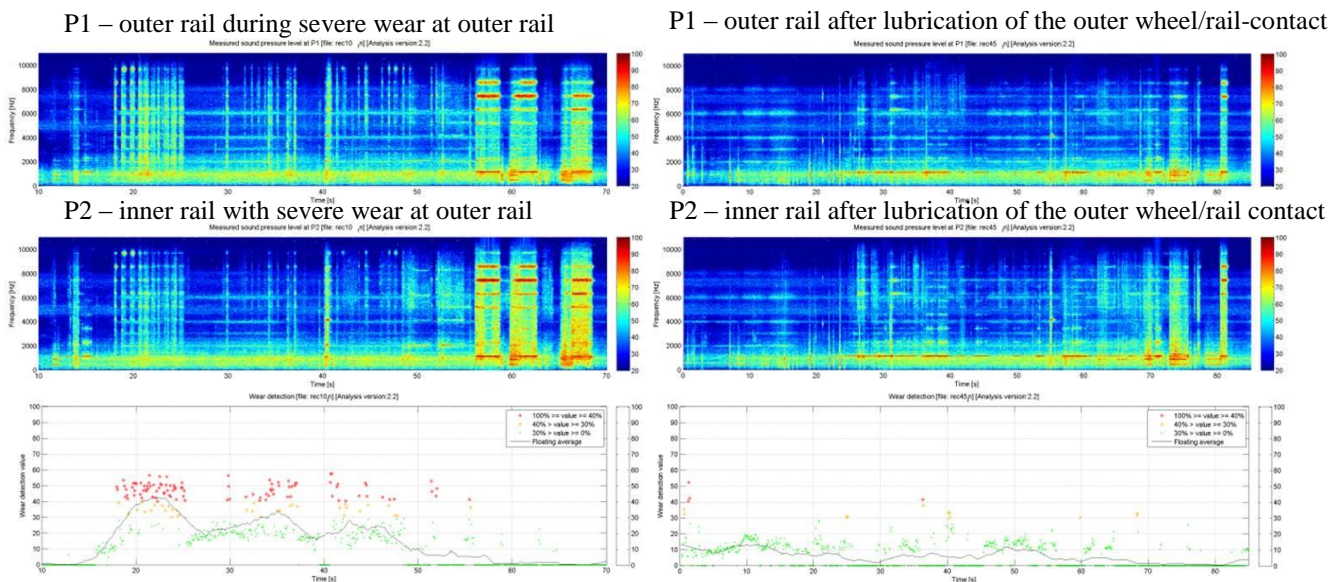
Figure 9. A-weighted sound pressure level close to outer (P1) and inner (P2) wheel/rail contact, one passage with severe wear (left) and one passage after lubrication (right). The bottom figures represent the wear detection parameter that is developed and calibrated within the Quiet Track project.

In Figure 9, the measured A-weighted sound pressure level, registered in two positions under the vehicle, is shown for two different passages during the tests. The data to the left in Figure 9 represents a measurement with severe or severe wear, whilst the data to the right represents a measurement after lubrication. P1 is located close to the wheel/rail contact for the outer rail and P2 is located close to the wheel/rail contact of the inner rail. For the first 55 seconds, the data to the left in Figure 9, the noise measured at P1 is higher than the noise measured in P2. This means that the noise from the outer rail, caused by severe wear in the contact between the rail head and the wheel flange, is dominating. The higher levels towards the end of the measurement are dominated by P2 and represent squeal noise from the inner rail. The data to the right in Figure 9 shows the same type of behaviour but after lubrication of the track. The outer rail does not dominate the noise, and there is no wear or minimal wear in the contact between the wheel flange and the rail head. The wear indication value, which has been developed within the Quiet track project, shows much lower levels. The wear indication value compares the noise coming from the inner and the outer wheel/rail contact and estimates the probability of severe wear based on difference between P1 and P2, amplitude of the noise. In the comparison between the two signals frequencies representing the wheel resonances are ignored.
