Irradiation Update from Brown

Brown University, Providence
9 June 2020

4-sensor Test Fit

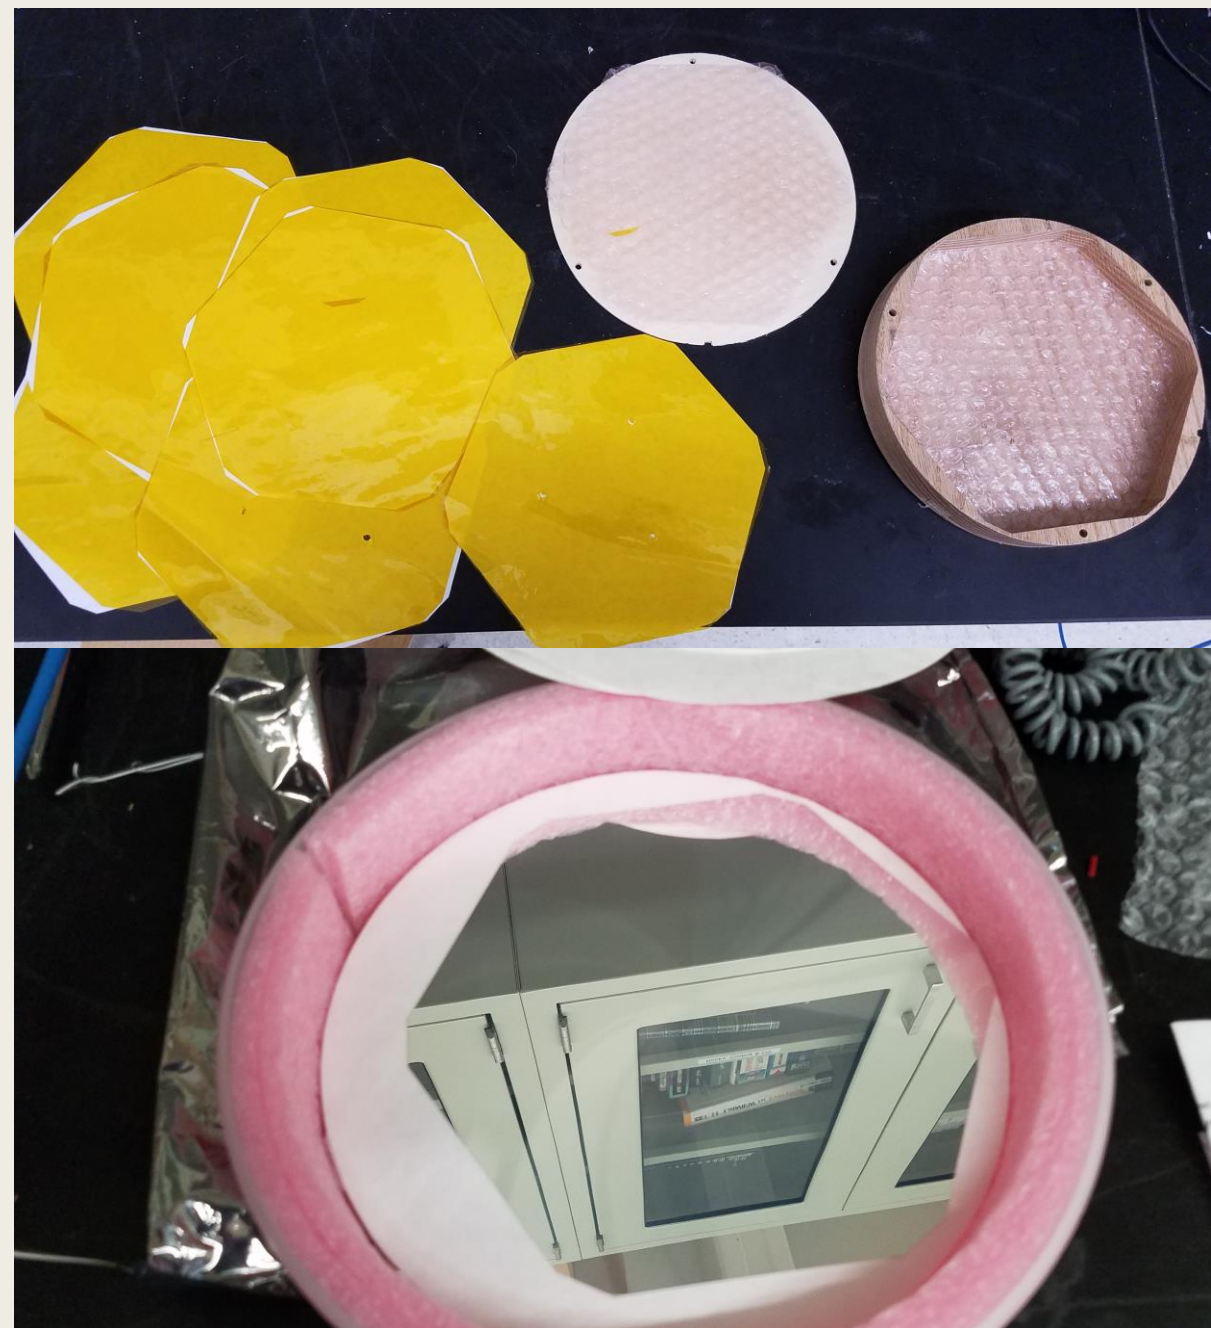
- Mechanical sensor dummies used for 4-sensor fit test
- Stack up of material in puck:
 - Puck
 - Bubble wrap
 - Kapton foil, sensor (x4)
 - Kapton foil
 - Bubble wrap (x3)
 - Puck lid

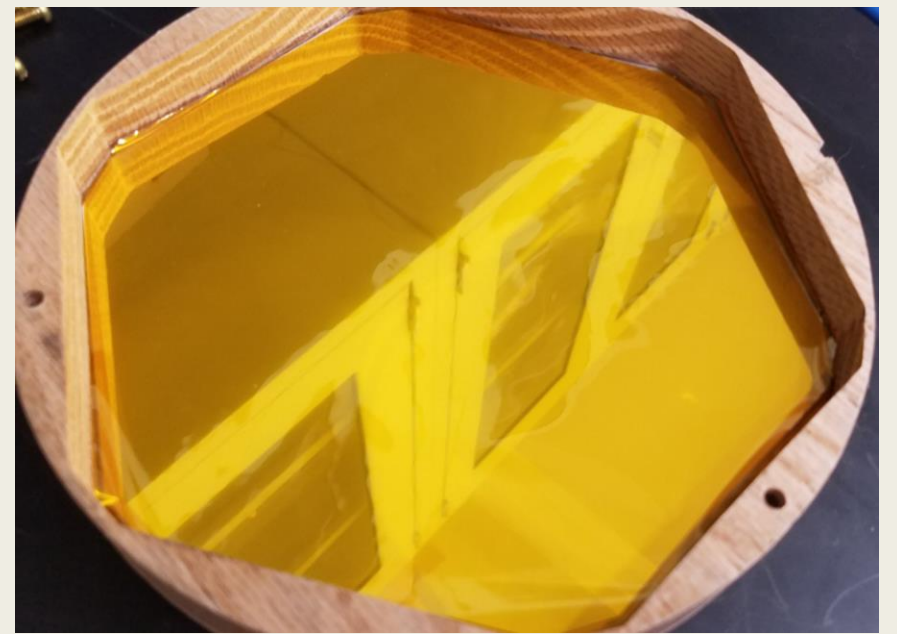
- 1 layer of bubble wrap on either side had ~12mm of space remaining
- 2 additional layers of bubble wrap filled the gap
- Only 1 layer of Kapton foil between sensors
