JOPPA SALT PAN WORKS

Archaeological Excavations

for Edinburgh City Council

May 2011

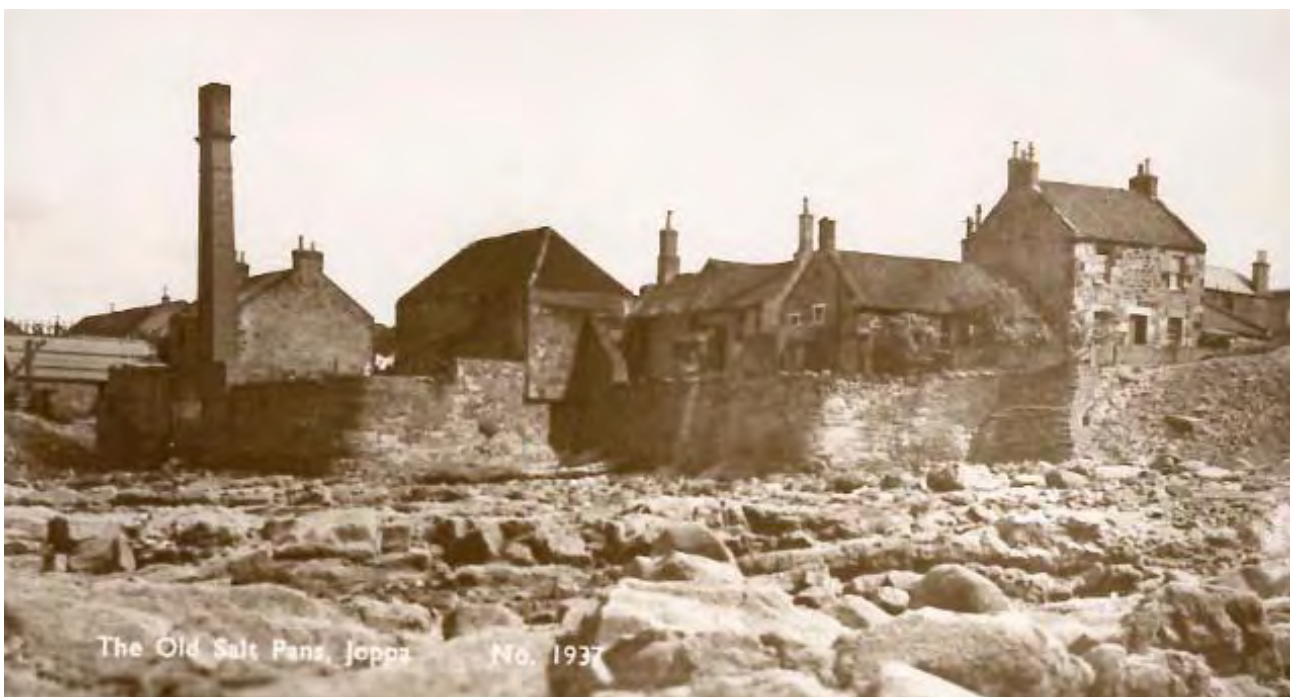
Illus 3
Postcard photo

Postcards from 1908 show two chimneys belonging to the salt works. This early photographic evidence of the site shows a complex series of buildings most of which seem to be constructed of rubble stone. A tramway ran east to west to the south of the salt works and Seaview terrace opposite the works was constructed between 1896 and 1908 suggesting that Joppa expanded during this time.

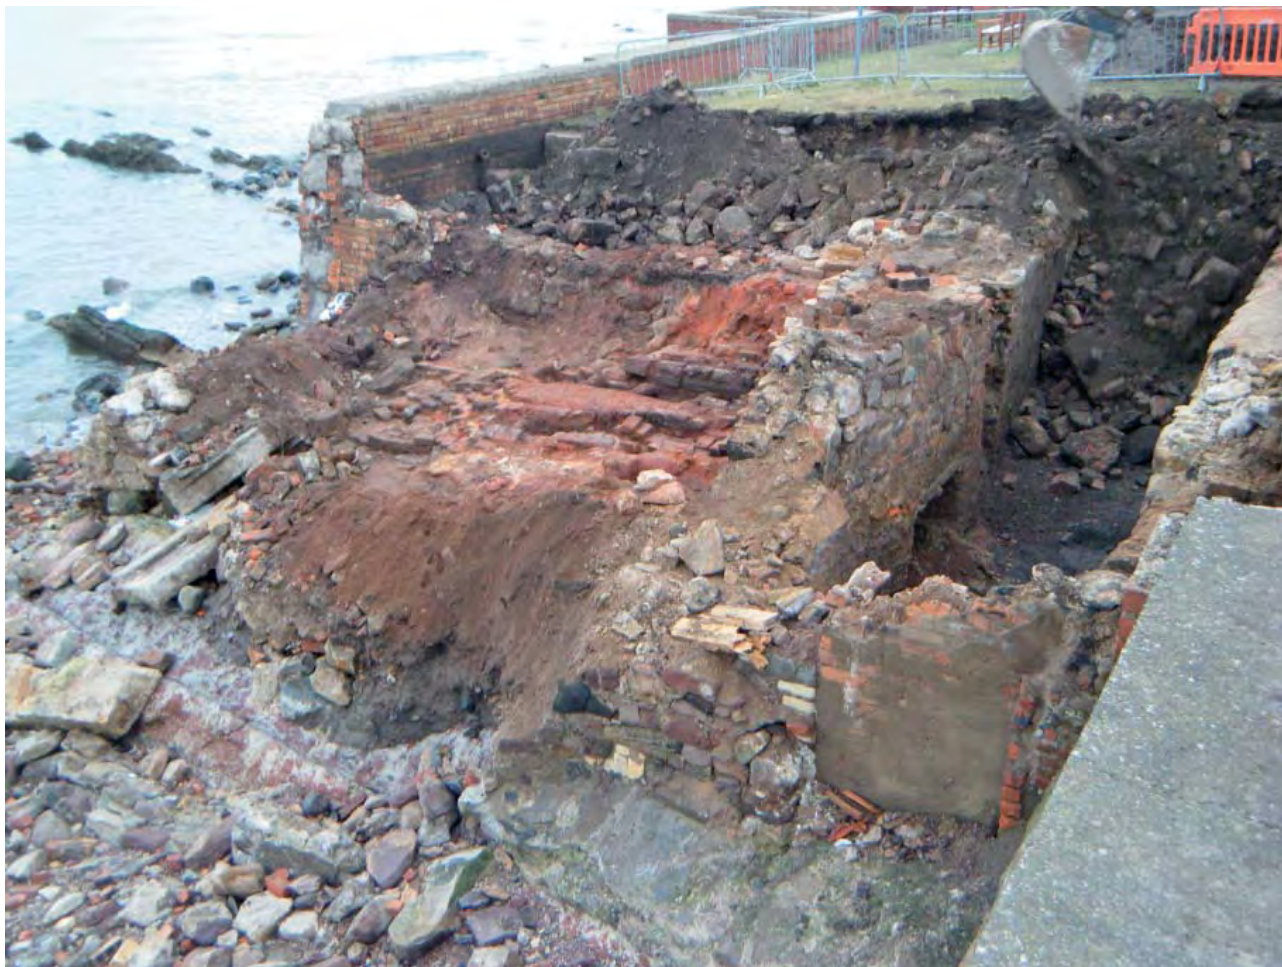
**Illus 5**

View of excavation area facing NE

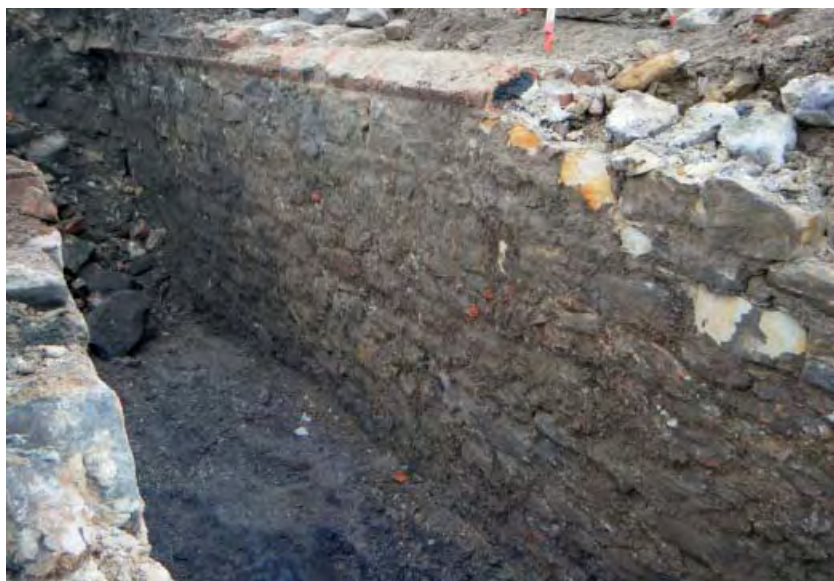
Illus 6

View of N elevation of stone wall [019] facing SE

Three lime mortar bonded rubble stone walls ([019], [020] & [022]) formed the earliest phase of activity within the excavation area. The southern edge of the excavation area was bounded by wall [019] that comprised an east-west aligned stone wall standing 1.8m tall. The wall was built upon on the underlying bedrock and it was topped with a course of red bricks [027] set at an angle in order to form the base of a brick arch. Wall [020] located 2.1m to the north and aligned parallel to [019] would have supported the opposing side of this arch creating a covered channel between the two walls. This second wall [020] was keyed into wall [022] at its eastern end (the wall actually continued eastwards beyond the limit of the excavation). Wall [022] was aligned north-south running between wall [020] to the south and the surviving sea wall to the north. Both these walls stood to a maximum height of 2.1m with the foundations again built on the bedrock.

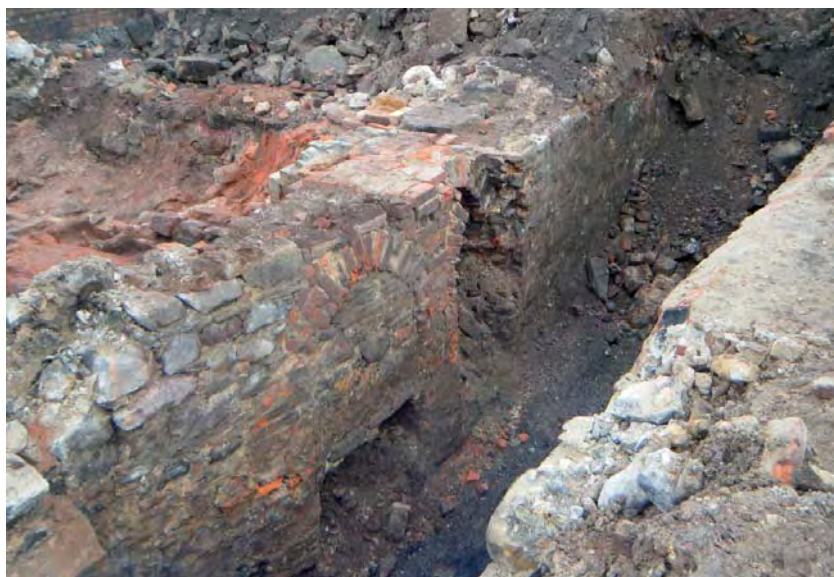
**Illus 8**

View of brick arches [023] and [024] facing NE

Wall [020] was the only one of these stone walls that had been significantly altered. Two large brick arches ([023] & [024]) had been inserted into the wall. The bricks were all un-frogged hand made bricks bonded with soft sand. Some of these bricks had been stamped 'Hunter & Co Patent Portobello' indicating a local source for the bricks. It was clear that these arches had been inserted into an existing wall because on the south elevation of wall [020] the brickwork on the west side of arch [024] was irregular and clearly constructed to cover the damage caused from its insertion. Also the north elevation of this wall [020] was entirely faced with brickwork that butted up to the existing stone wall at the east and west ends. The two arches stood to a maximum height of 1.6m and were 0.95m wide on the southern elevation. The width of these arches reduced significantly as they ran through the wall being only 0.45m wide on the north elevation.

The brick arches ([023] & [024]) and associated flues ([052] & [053]) had been inserted into an already existing stone wall [020]. At least one and probably two further arches had been inserted into wall [020] to the east side of wall [022]. This suggests the existence of a second pan house immediately to the east. Whether this second pan house ran in conjunction with the excavated pan house or was an earlier or later replacement is conjecture. Given that the section of the third flue revealed in wall [020] seemed to be part of a continuous series of arches, it was probably contemporary with those recorded to the west. The bricks stamped 'W. Hunter & Co' used in the arches were made at Westbank Brick and Tile Works in Portobello between 1873 and 1881 (Douglas *et al.* 1985).

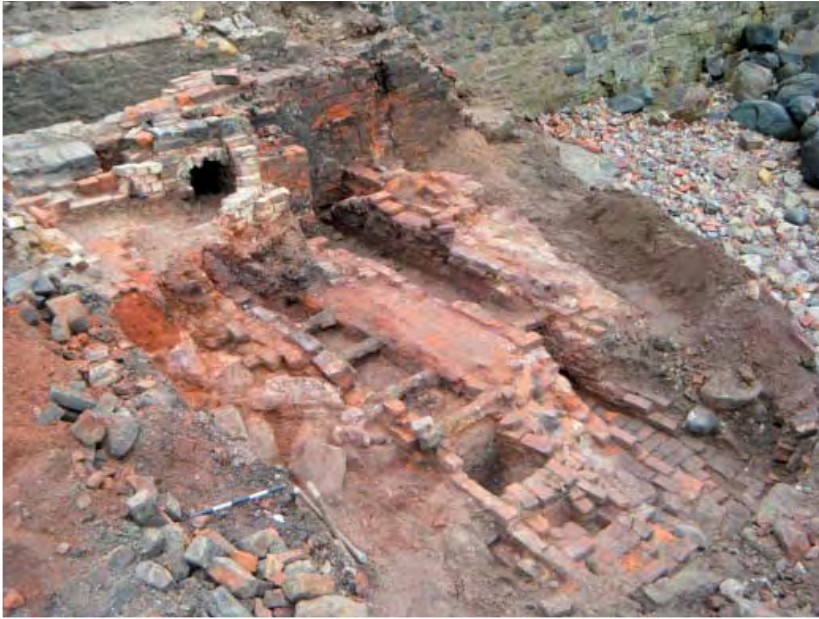
Illus 9
General view of pan house flues [052]
and [053] facing SW

Two long brick flues ([052] & [053]) were attached to the arches on the north side of wall [020] and continued to the northern end of the excavation area. Both these flues were 0.42m wide and 3.15m long and were constructed of hand-made bricks. The flues ran parallel to each other with a 0.62m wide sand and brick in-fill [055] between them. The side walls of the flues stood to a maximum height of 0.9m although this reduced significantly at the north end, due to damage caused by the collapse of the sea wall. The tops of the walls had been significantly discoloured due to heat action. The eastern wall of flue [053] also included a single course of large heat affected bricks [062] that had chamfered inner faces. A large amount of corrosion was also recorded on the inner faces of these bricks. A series of heavily corroded iron supports approximately 1m apart and aligned east-west along the tops of the flue walls were also recorded. A section through the flues revealed a shallow 0.12m thick layer of coarse grey ash [063] at the base.

The brick arches and flues formed the main heating element of the salt pans although it was not fully clear how this operated. The heat was created either close to the arches and drawn through the flues or within the flues themselves, with the fuel possibly sat on a grate below the pans. The iron supports across the top of the flue walls are thought to have supported a grate. Ash at the base of the flues may represent the burnt remains of the fuel placed on these grates that were used to heat the pans. The heated iron salt pan would have been placed over these flues with the intense heat causing corrosion and heat damage to the bricks. The narrowing of the flues at

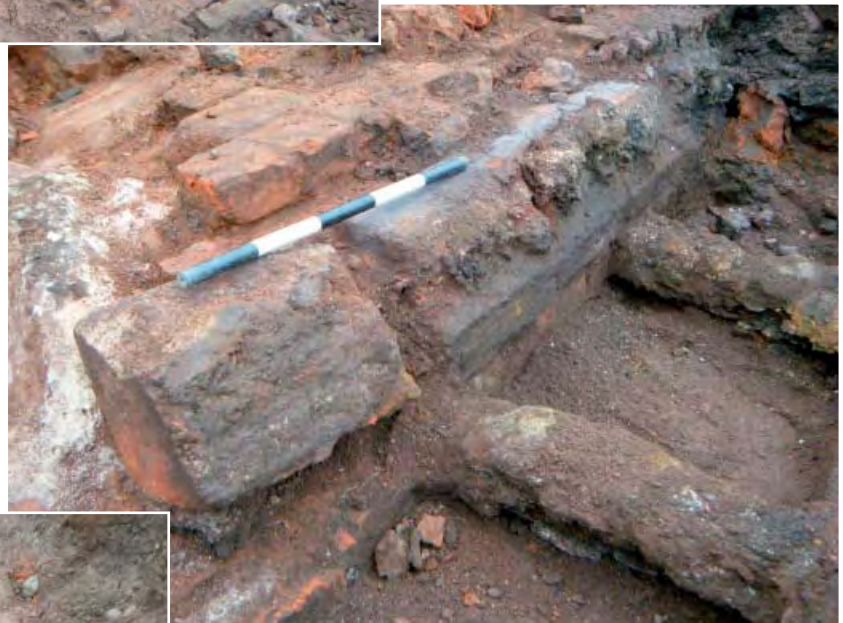
Illus 10
Detail of bricks [062] on flue wall

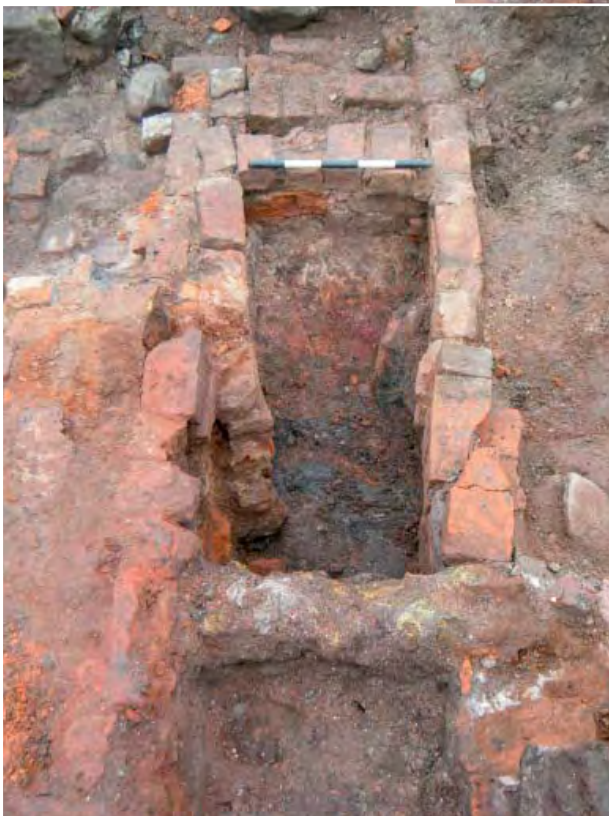
Illus 11
Detail showing the narrowing of flue [052]

The brick sides of the flues gradually curved inwards close to the north end forming a slightly narrower channel. Only the base level of the flue survived at the far north end and this was formed by an irregular course of bricks set above a foundation layer of poorly sorted stones and sand [058]. The construction at the north end of the flues

the north end may have been in order to create a stronger draft through the flue as well as possibly causing the heat to re-circulate through the flue instead of escaping out the end. Although much of the structure at the north end was truncated, it is thought that the heat and fumes would have been regulated by apparatus at this end of the flues before the fumes were carried through to a chimney. This chimney, as depicted on the early photographs (see Illus 3), seems to be located slightly further to the east beyond what is thought to be the second pan house. As the site is known to have had two chimneys, the second one being located to the east side of a central water capture tank, it is possible that another series of pans also existed on the east side of the salt pan works.

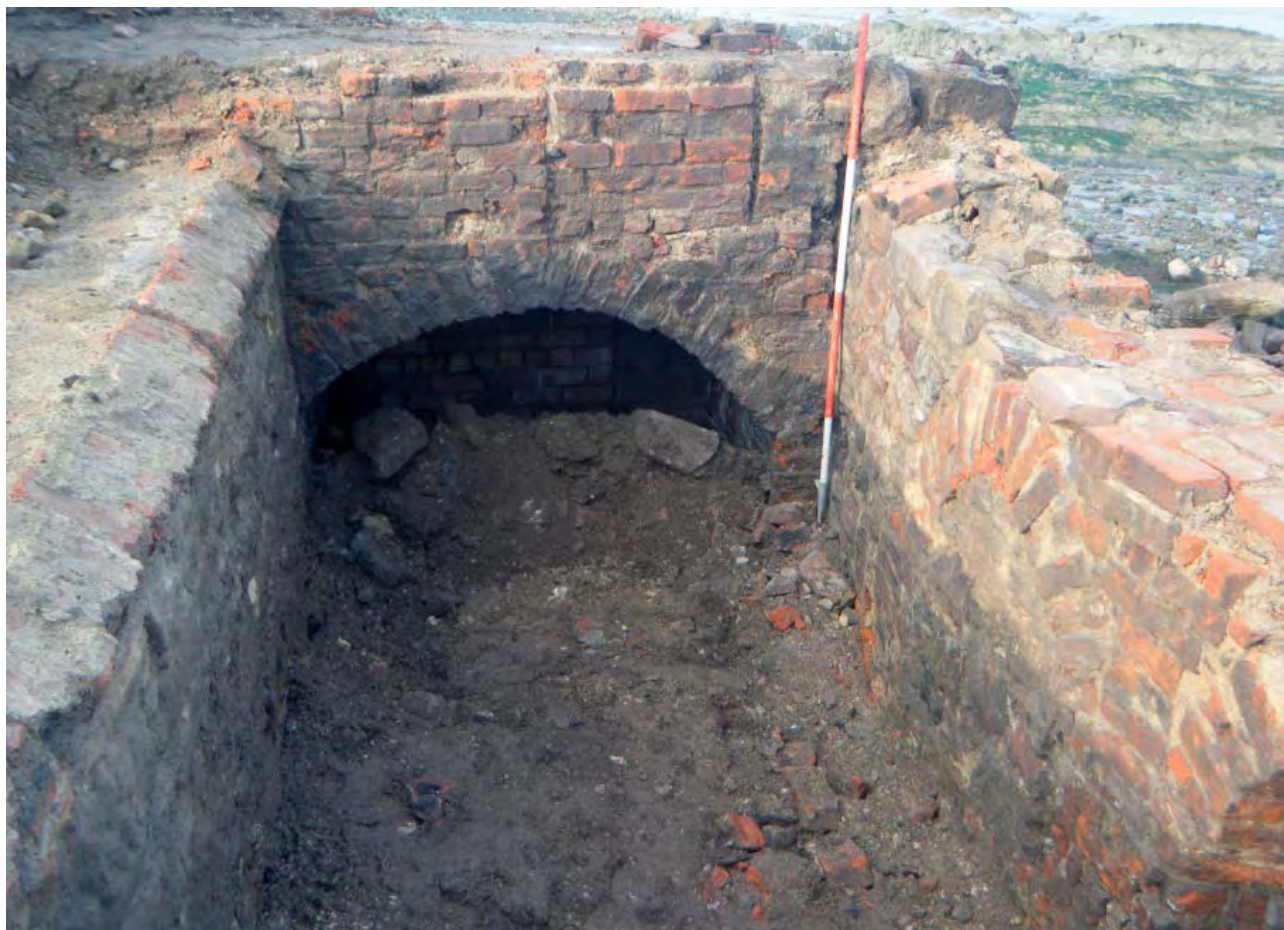
**Illus 12**

View of brick arch [021] facing W

The western ends of stone walls [019] and [020] were linked by a substantial brick arch [021]. This formed a large opening 2.15m wide and over 3m high at the west end of the channel created by walls [019] and [020]. This arch [021] had subsequently been brick-blocked with a large concrete slab placed over the top of the arch to support the construction of the modern sea wall.

The brick arch [021] at the west end of the stone walls ([019] & [020]) was clearly a later phase feature than the walls themselves and was probably associated with the phase that included the insertion of the arches and flues. The opening led through to the beach and may have been used as an entrance for the delivery of locally sourced coal which was known to exist in seams along the beach. The angled bricks capping on top of wall [019] suggested the whole channel would originally have been covered with a brick arched roof, although this would have been set at a slightly higher level than the arch recorded at the west end.

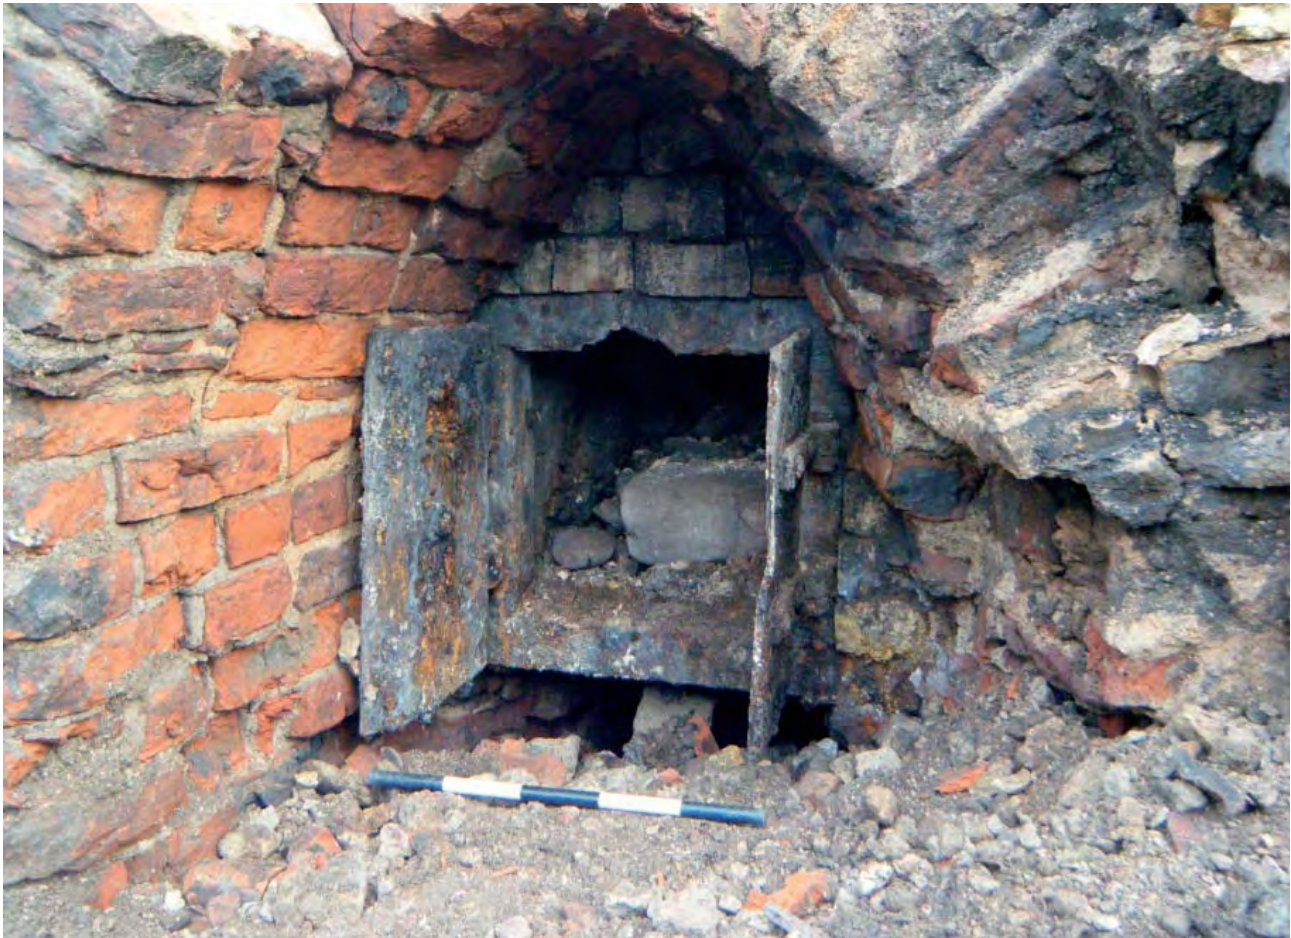
Illus 13

Detail of flue door [051] inserted in arch [023]

Once the pan flues had gone out of use Phase 3 saw a much smaller flue inserted in one of the existing arches. The metal doors inserted in the archway leading from the south side of wall [020] formed the opening for a small firebox or oven, suggesting that fuel was introduced from this side. The 'ETNA' fireclay bricks surrounding the firebox were made at Armadale in West Lothian and were produced from 1890–1947 (Douglas *et al.* 1985). The slabbed stone surface above the later flue may have been constructed for a small pump or similar piece of equipment that required more stability than a brick surface could provide. Although the later flue had been badly truncated by modern disturbance its smaller scale indicated that it was not being directly used in the production of salt and was more likely to have been a heating duct or utilised for some other purpose that involved the transfer of heat.

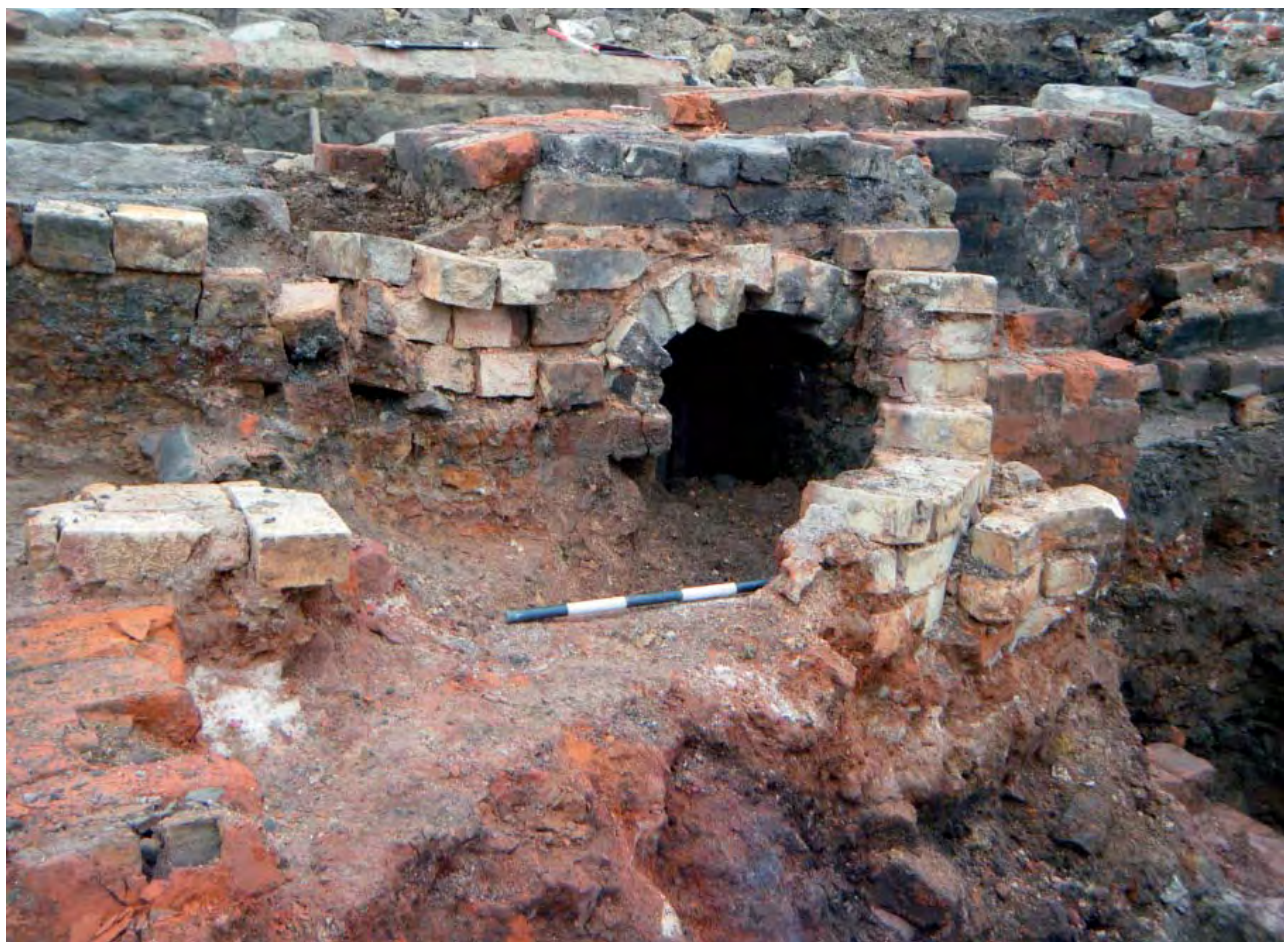
**Illus 14**

Detail of later phase flue [032] facing S

After the flues ([052] & [053]) had gone out of use the western arch [024] had been blocked with stone [049]. The second arch [023] to the east had been in-filled with beach cobbles with a cast-iron double door [051] inserted close to the top of the south face of the arch. These doors formed an opening 0.4m² within the original arch and were held in place by a surround of 'ETNA' stamped fire bricks. The opening continued through wall [020] leading to a narrow brick-lined flue [035]. The flue was 0.25m wide and 0.5m high with brick sides and base. Immediately beyond the north elevation of the wall [020] the flue turned 90° to the east continuing 1.6m along the wall face until it reached the W face of wall [022]. At this point the flue turned north continuing along the west face of wall [022] for approximately 2.5m beyond

which the flue had been truncated by modern activity. The flue was approximately 1m above original flue [053] on a deep red sand foundation that had been discoloured due to heat.

A number of features associated with the later phase flue [035] were also recorded. These included a series of flat concrete slabs [030] forming a platform on top of wall [020]. To the west side of the flue a square brick structure [048] was recorded. This abutted the north elevation of wall [020] and also partially sat over flue [052]. This small structure (0.62m x 0.58m in plan and 0.84m high) included a small shelf, the side walls of which had evidence of burning or soot. It was unclear what the feature [048] represented and whether it was related to the later phase flue, although it was clear that it was a later phase than the main pan flues below.
