Experiment 3: Measurement of the Bonding Strength of METLBOND on Carbon Fiber, Aluminum, and PTFE in Shear

ME 411 Engineering Measurement and Instrumentation Systems

Portland State University

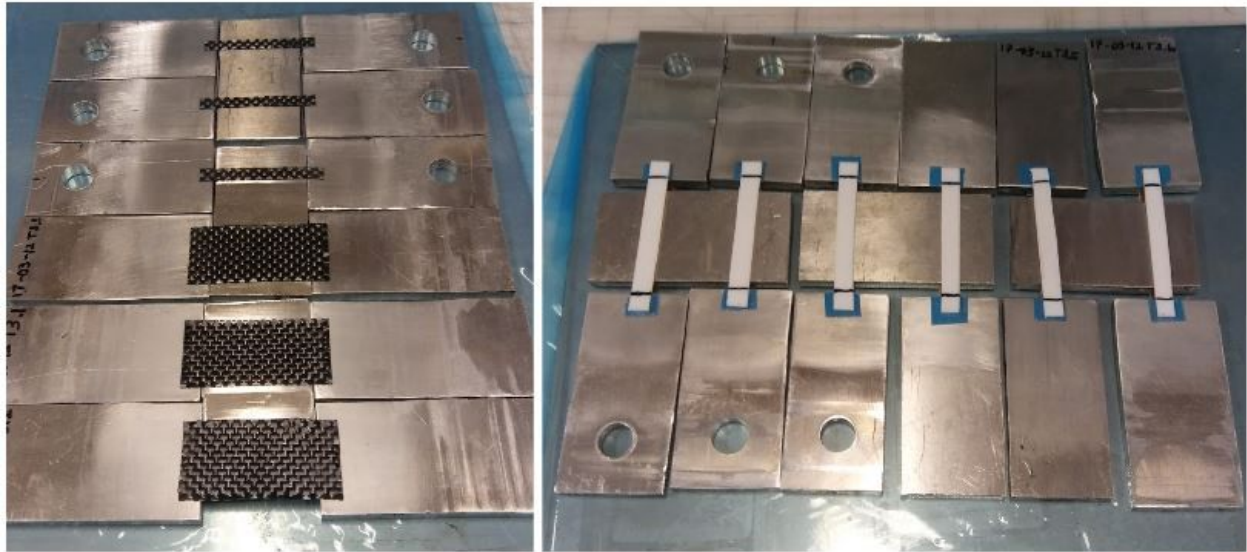
Two sets of test coupons were prepared. A set was made for each material interface and test type combination. Each test coupon was made using two rectangular pieces of aluminum cut from the same piece of 0.25" thick plate. A hole was drilled into each aluminum piece along its vertical axis to allow a hook to pass through.

Figure 1: Test Coupons-- Aluminum & CF (Left), Aluminum & PTFE (Right).

The material being bonded to the aluminum was lapped over both pieces, on both sides, as shown in Figure 1, for a total of four bonding zones per coupon¹.

For each coupon, the four bonding zones were equal in area. This was accomplished by cutting 0.25" x 0.25" squares of METLBOND film for the carbon fiber coupons.. The size of the aluminum PTFE interface was controlled by cutting the PTFE strips 0.25" wide and marking 0.25" from the edge (marking the edge of the bonding surface). The Adhesive film portions were measured out with a ruler, marked with a Sharpie, and cut using a razor blade. (The accuracy of these areas was restricted by half the resolution of the ruler used, 1/32", resulting in an area uncertainty of +/- 0.015 in² per bonding zone, or +/- 0.06 in² per test coupon). Once the coupons were assembled, they were wrapped in a special release film, further wrapped in a breather fabric, vacuum sealed, and cured in an oven (see Figure 2) using a time and temperature regime developed by a previous PSAS airframe capstone team and optimized for maximum adhesion².
