TITLE: Toyota_B_Harness

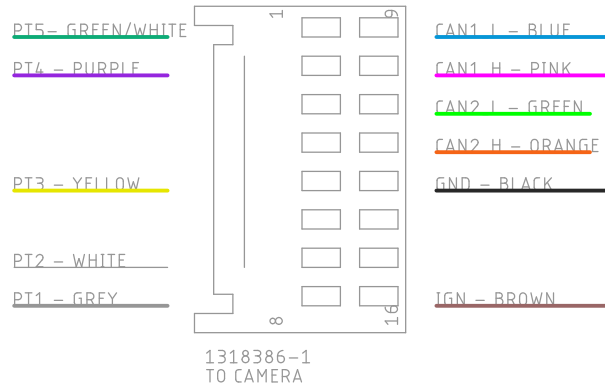
Looking at the back of the connector

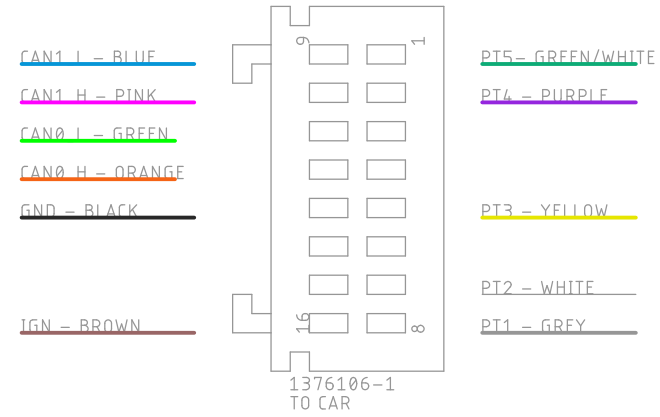
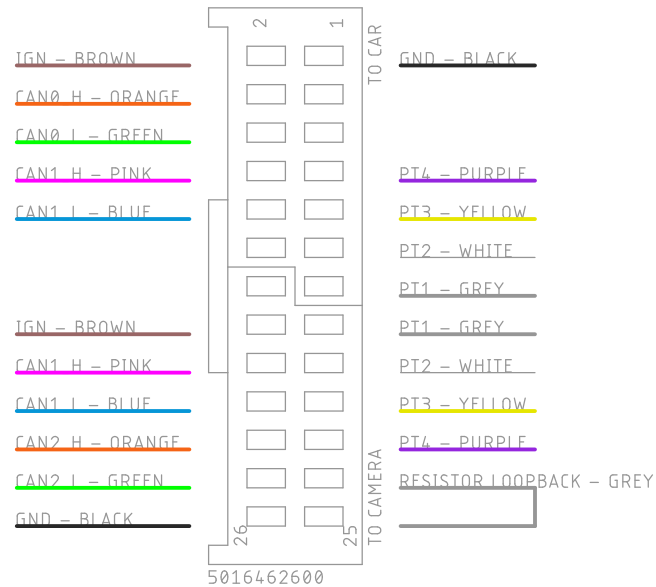
Looking at the back of the connector

PT5 WILL HAVE TO BE LOOPED BETWEEN THE TWO CONNECTORS.
26 PIN CONNECTOR DOES NOT HAVE ENOUGH PASSTHROUGH LINES
