To: Professor Pisano
From: Team 9
Team: Aerobatic BlackBox
Date: 4/29/22
Subject: Customer Installation Report

1.0 Details of Customer Installation

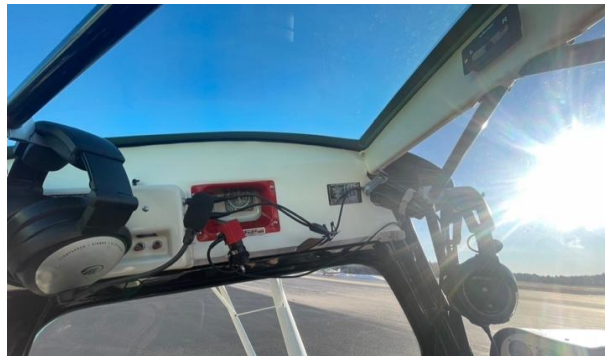
During the installation, we first selected the upper left corner of the aircraft cabin as the installation location for our Black Box body. The photo below is the upper left corner of the cabin:
