Report

Radiograph Analysis

Analysis Summary

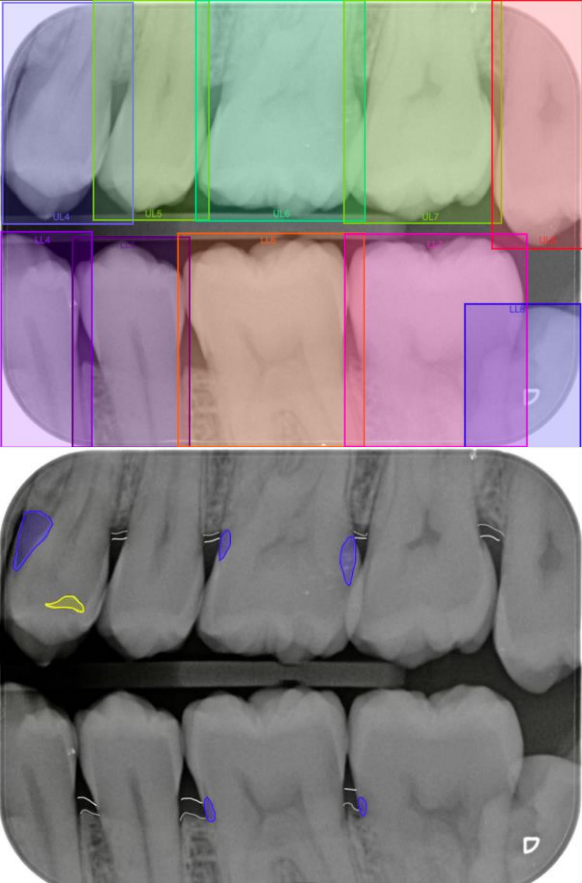
Tooth Number	Natural structures identified	Foreign structures Identified	Pathology Identified/ Notes
UL4	E,D,P		Caries, Cervical burnout
UL5	E,D,P,CEJ		
UL6	E,D,P,CEJ		Cervical burnout
UL7	E,D,P,CEJ		
UL8	E,D,P,CEJ		Over erupted
LL4	E,D,P,CEJ		
LL5	E,D,P,CEJ		
LL6	E,D,P,CEJ		Cervical burnout
LL7	E,D,P,CEJ		Cervical burnout
LL8	E		Horizontal impaction
Image

<p>The image is a composite dental radiograph. The top section shows a panoramic view of the upper teeth (UL4-UL8) with colored overlays: UL4 is green, UL5 is yellow, UL6 is green, UL7 is green, and UL8 is red. The bottom section shows a panoramic view of the lower teeth (LL4-LL8) with colored overlays: LL4 is purple, LL5 is orange, LL6 is pink, LL7 is pink, and LL8 is purple. Annotations include blue and yellow outlines on the lower teeth, indicating specific areas of interest or pathology.</p>

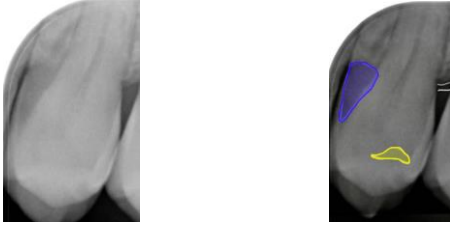
Tooth Number	Position on Tooth	Advancement Level	Indicators	Uncertainties	Confidence %
UL6	Occlusal	Dentine	Irregular shaped radiolucency. Average sugar frequency reported. Diabetic.	Check additional views if available! Visual assessment. 0% image restoration rate.	21%
Image

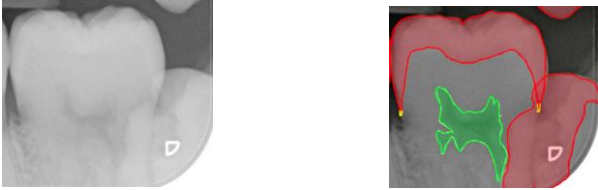
Tooth Number	Position on Tooth	Indicators	Uncertainties
UL7	Distal	Impacted LL8 Poor access. Average sugar frequency reported	Overlap of image
Image

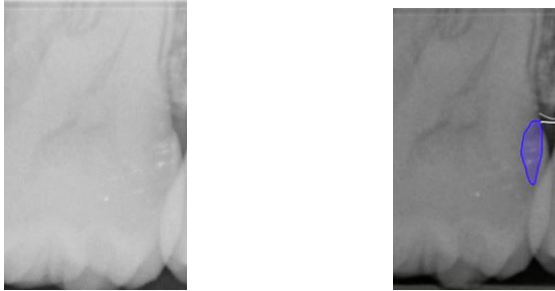
Tooth Number	Observation	Reason	Position on Tooth	Possibility	Suggestion
UL6	Cervical burnout	Enamel at knife edge at CEJ intact. Close to alveolar crest.	Distal	Caries. Low Risk. 0% image restoration rate. Daily interdental cleaning reported.	Clinical investigation
Image

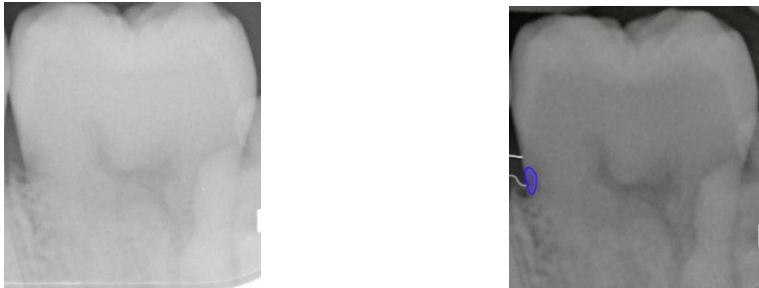
LL7	Cervical burnout	Enamel at knife edge at CEJ intact. Close to alveolar crest.	Mesial	Caries. Low Risk. 0% image restoration rate. Daily interdental cleaning reported.	Clinical investigation
Image
