Report

Radiograph Analysis

Analysis Summary

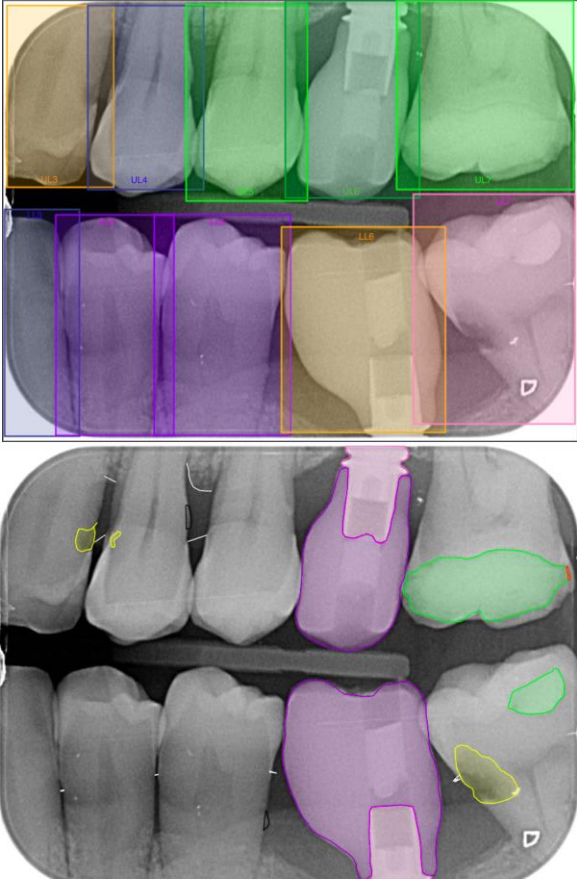
Tooth Number	Natural structures identified	Foreign structures Identified	Pathology Identified/ Notes
UL3	E,D,P		Caries, Bone-loss
UL4	E,D,P,CEJ		Caries, Bone-loss
UL5	E,D,P,CEJ		Bone-loss
UL6		Restoration, Implant	
UL7	E,D,P,CEJ	Restoration	Marginal Discrepancy?, Bone-loss
LL3	E,D,P,CEJ		Bone-loss
LL4	E,D,P,CEJ		Bone-loss
LL5	E,D,P,CEJ		Bone-loss
LL6		Restoration, Implant	
LL7	E,D,P,CEJ	Restoration	Caries, Bone-loss
Image

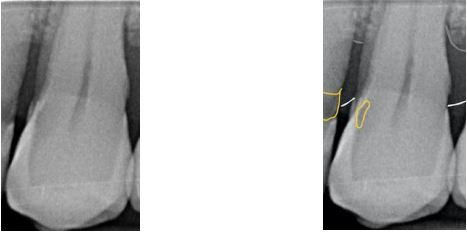
Tooth Number	Position on Tooth	Advancement Level	Indicators	Uncertainties	Confidence %
UL3	Proximal	Dentine	Irregular shaped radiolucency. Enamel blunting at CEJ. Diabetic. High Sugar Frequency reported. 40% image restoration rate.		87%
Image

UL4	Proximal	Dentine	Open contact point. Mirror caries on adjacent tooth. Diabetic. High Sugar Frequency reported. 40% image restoration rate.	Enamel Knife edge shape intact. Check additional views if available!	7%
Image

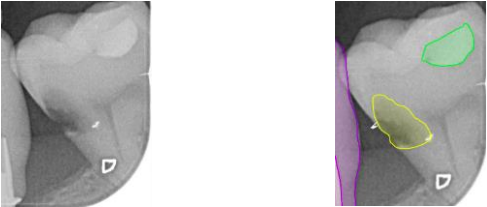
LL7	Proximal	Dentine	Irregular shaped radiolucency. Enamel blunting at CEJ. Diabetic. High Sugar Frequency reported. Tilted tooth. Potential food trap gap.		96%
Image

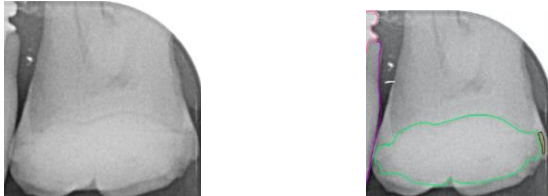
Marginal Discrepancy

Tooth Number	Position on Tooth	Indicators	Uncertainties	Confidence %	Suggestion
UL7	Distal	Break in outline form from restoration to tooth structure.	Check additional views if available! Visual assessment.	13%	Further investigation
Image

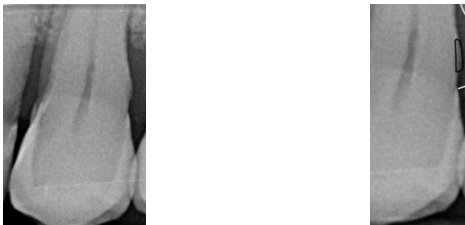
Tooth Number	Position on Tooth	Indicators	Uncertainties	Confidence %
UL4	Distal	Bulbous radiopacity.	Broad based. Smooth appearance. Check additional views if available! Tactile assessment advised.	33%
Image

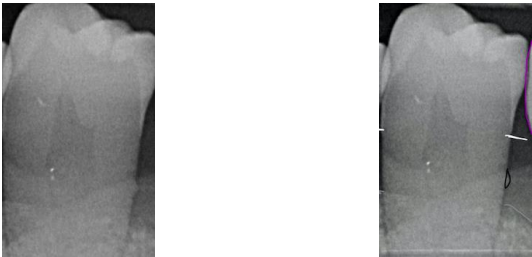
LL5	Distal	Bulbous radiopacity.	Smooth appearance. Check additional views if available! Tactile assessment advised.	37%
Image

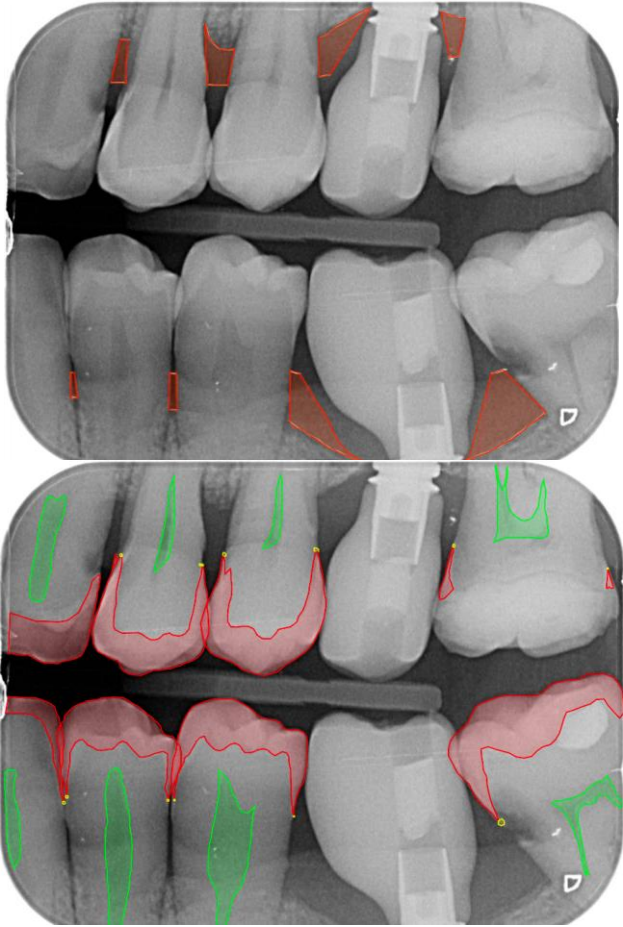
Diagnosis:
Generalized Mild-early moderate horizontal bone-loss
Angular bone loss associated with UL4

Number of Teeth identified on Xray	CEJ reference points identified	Current bone level tracing confidence %	Impediments to diagnosis identified	Confidence % in diagnosis
10	13	99%	Overlapping teeth on image.	96%
Image
