# nurow.di

## Report

### Radiograph Analysis

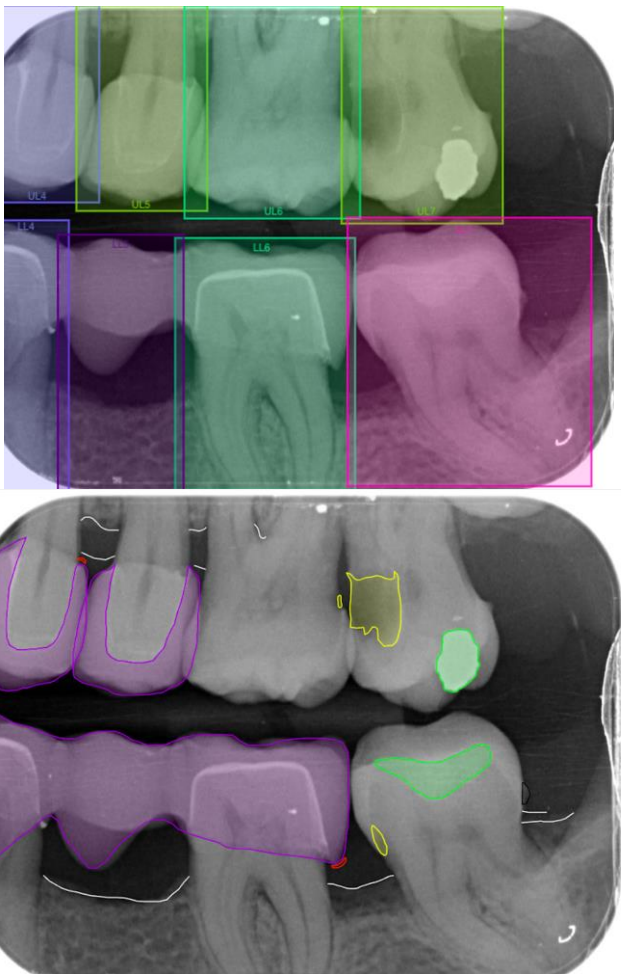
Tooth Number	Natural structures identified	Foreign structures Identified	Pathology Identified/ Notes
UL4	D,P	Crown	Overhang, Bone-loss
UL5	D,P	Crown	Bone-loss
UL6	E,D,P,CEJ		Caries, Bone-loss, Furcal bone-loss
UL7	E,D,P,CEJ	Restoration	Caries, Bone-loss, Calculus
LL8	E		Unerupted
LL4		Crown (Abutment)	Bone-loss
LL5		Pontic	
LL6	D,P	Crown (Abutment)	Overhang, Bone-loss, Furcal bone-loss
LL7	E,D,P,CEJ	Restoration	Caries?/Cervical burnout, Bone-loss, Calculus
Image

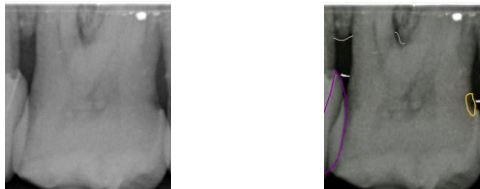
Tooth Number	Position on Tooth	Advancement Level	Indicators	Uncertainties	Confidence %
UL6	Proximal	Dentine	Mirror caries adjacent tooth. Blunting enamel at CEJ. Rare interdental cleaning reported. High sugar frequency reported. Irregular shaped radiolucency. 87.5% image restoration rate.	Check additional views if available!	87%
Image

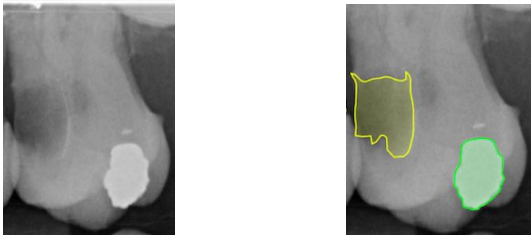
UL7	Proximal	Pulp	Mirror caries adjacent tooth. Blunting enamel at CEJ. Rare interdental cleaning reported. High sugar frequency reported. Irregular shaped radiolucency. 87.5% image restoration rate.		98%
Image

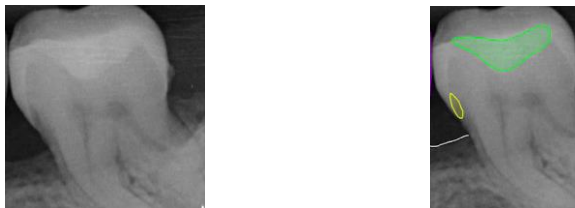
LL7	Proximal	Dentine	Overhang adjacent tooth. Early bone loss. 87.5% image restoration rate. Potential food trap gap.	Enamel intact at CEJ Close to alveolar crest. Check additional views if available!	6%
Image

Tooth Number	Observation	Reason	Position on Tooth	Possibility	Suggestion
LL7	Cervical burnout	Enamel at CEJ intact. Lesion close to alveolar crest.	Mesial	Caries? High ratio of historical restorations Potential food trap gap. Overhang adjacent tooth	Further Investigation. Check additional views if available.
Image	<div>

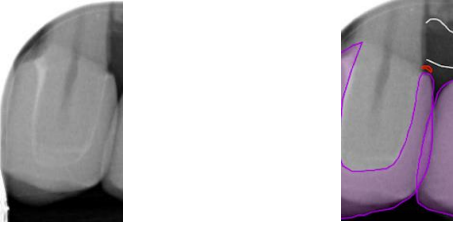
Tooth Number	Position on Tooth	Indicators	Risks	Confidence %	Suggestion
UL4	Distal	Positive ledge. Not continuous with outline form of tooth.	Caries	71%	Further investigation
Image

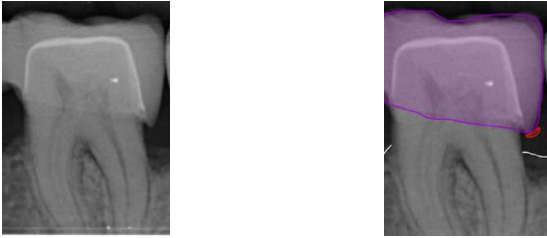
LL6	Distal	Positive ledge. Not continuous with outline form of tooth.	Caries	93%	Further investigation
Image

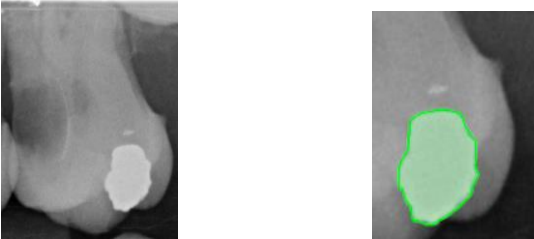
Tooth Number	Position on Tooth	Indicators	Uncertainties	Confidence %
UL7	Distal	Irregular radiopacity. Hard to clean area.	Check additional views if available! Tactile assessment advised.	57%
Image

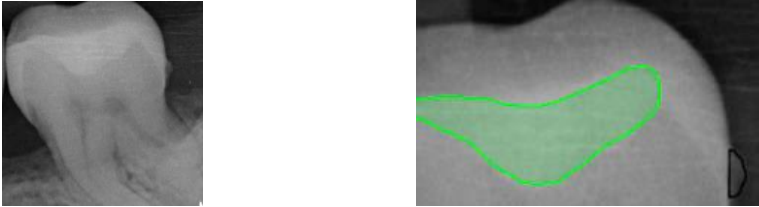
LL7	Distal	Irregular radiopacity. Hard to clean area.	Check additional views if available! Tactile assessment advised.	59%
Image

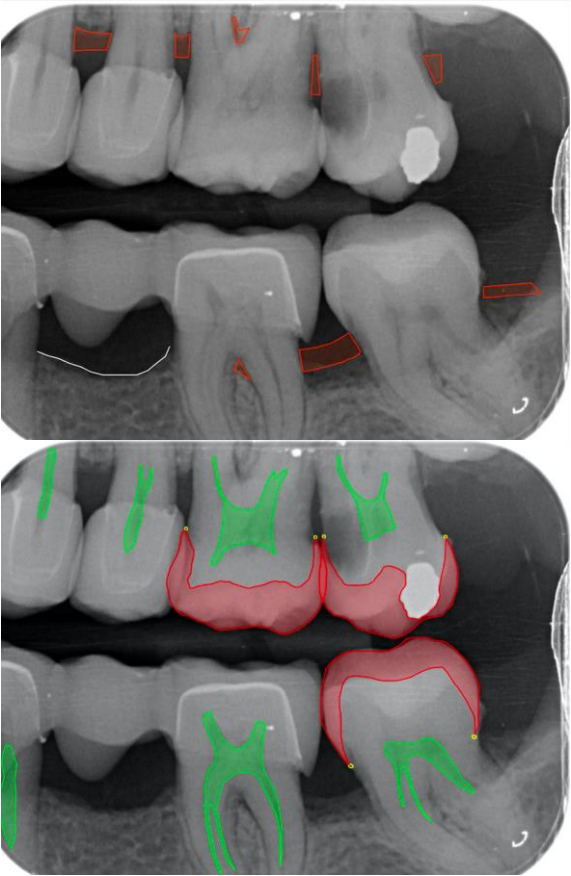
Diagnosis:  
Generalized mild to moderate horizontal bone-loss  
Furcal bone loss associated with UL6, LL6

Number of Teeth identified on Xray	CEJ reference points identified	Current bone level tracing confidence %	Impediments identified	Confidence % in diagnosis
7	6	97%	Restorations. Overlapping teeth on image.	97%
Image

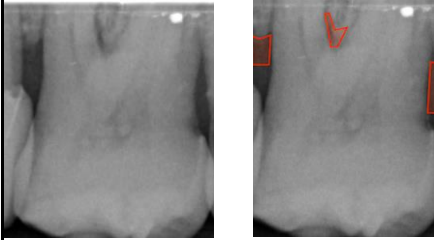
Tooth Number	Indicators	Uncertainties	Calculus detected	Confidence %
UL6	Radiolucency between furcation fornix and bone level detected.		N	23%
Image
